**SWAN LAKE FIRST NATION – MATRIX SOLUTIONS
INC. PARTNERSHIP**

INDIGENOUS CONSTRUCTION MONITORING

WEEKLY REPORT

SPREAD 9

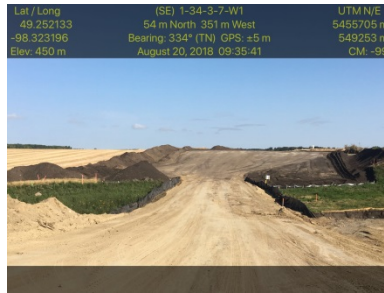
Aug 20/18 KP 1002+250

One of two signs clipped by dozer blade

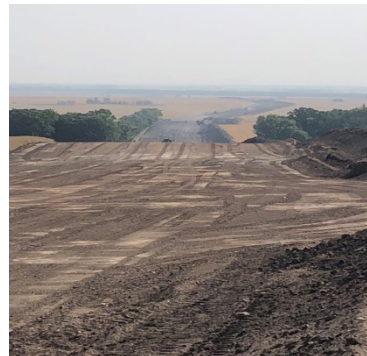
Aug 20/18 KP 1007+690

Opening in top soil and seconds for drainage

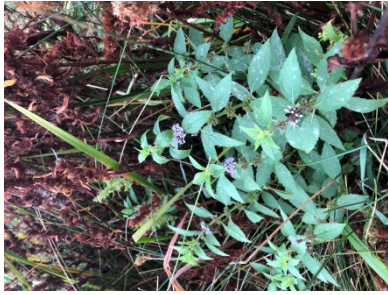
Aug 23/18 SSKP 1057

picture of plant and insects butterflies
