**MANITOBA METIS FEDERATION – MATRIX  
SOLUTIONS INC. PARTNERSHIP**

**INDIGENOUS CONSTRUCTION MONITORING**

**WEEKLY REPORT**

**SPREAD 7**

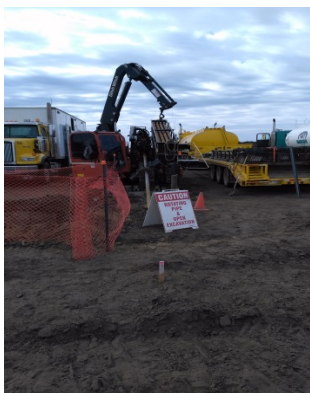
SF21 (827+400)

Preparing the pilot hole for the bore pipe.

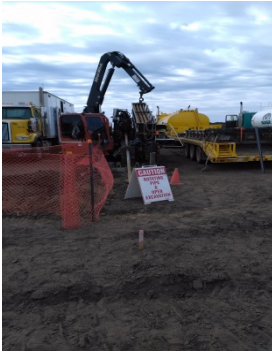
SF20 (KP826+000)

Monitor Banister. Preparing to pull bore pipe under roadways.

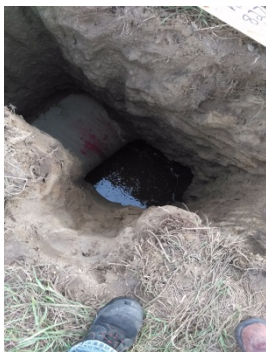
SF21(KP827+600)

Banister and Horizontal Drilling.  
Doing some hot lines work and pilot holes.
