Line 5 inspections

Regular examinations of the pipe, both inside and out

Line 5 Inspection Results

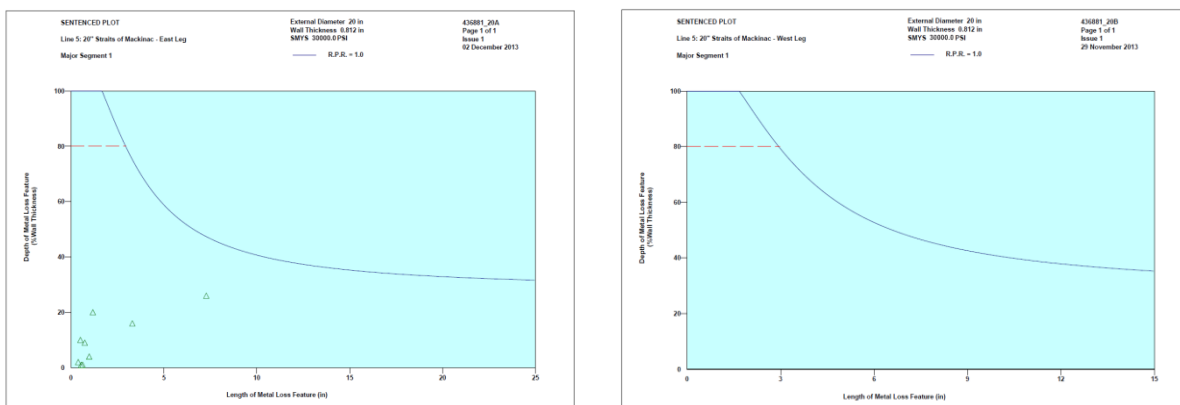
Figure 2 –2013 MFL Inspection Corrosion Results

As shown in the above figure, there were **nine metal loss corrosion features** identified by the MFL tool on the nearly five-mile East Straits pipeline, all of which were **located on the on-shore portion** of the pipeline. For these nine features, the average maximum depth was **10 percent of the wall thickness**, and the average length was 1.7 inches. The deepest was **26 percent** and 7.3 inches long, which makes it the longest feature as well—but still only half as deep as it would need to be to require repairs, as set out by regulatory standards. The allowable

limit for safety, as set out by those regulatory standards, is a function of the metal loss size, pipeline properties, and operating parameters, and is represented by the blue curved line in these figures. The features that were found fall well below the line, which means well within safety thresholds.

All of these features found by the MFL tool were on the inside of the pipe, which means there was no external metal loss features on the East pipeline (remember, the outside of the pipe is covered with a tough enamel coating that provides a barrier between the steel and the elements, namely water).

For the West Straits pipeline, there were **no metal loss features** identified by the MFL tool on either the inside or outside of the line, which is why there are no green triangles on the right-hand-side Figure 2 plot.

Additionally, Enbridge conducts its own assessments of these features, above and beyond those conducted by the ILI vendor, to assess and evaluate the accuracy of the ILI tool; all nine were assessed by our engineers, and considered well within safety thresholds. If they were found to be above the acceptability limits, or the blue line in Figure 2, preventative maintenance action would be taken.

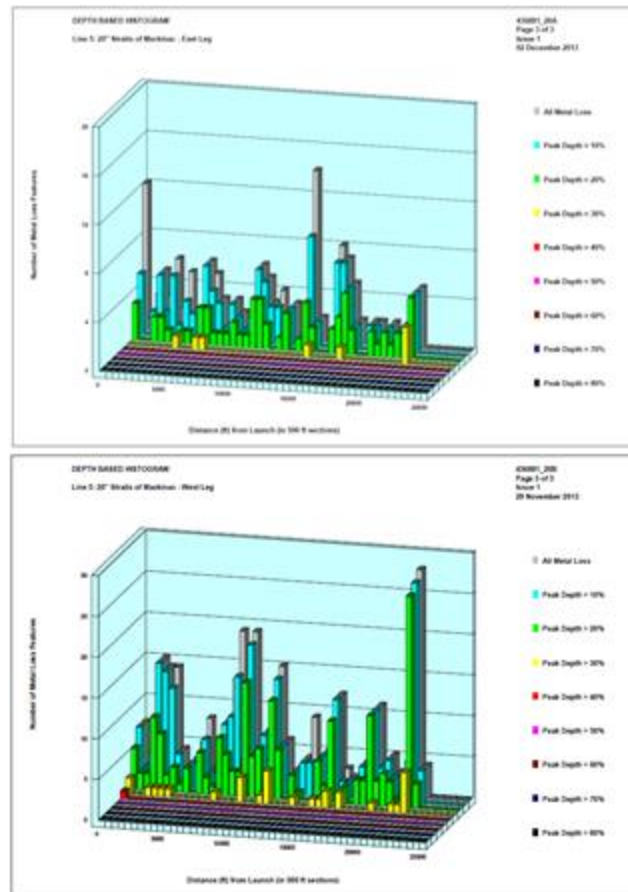
Figure 3 – Summary of Number of Features by Depth of 2013 (East Leg) Metal Loss Inspections

Taken directly from the 2013 ILI Metal loss inspection reports, Figure 3 gives a graphical representation of the depth of features found along the East and West pipelines, including both metal loss and mill anomalies. The chart is categorized by total features, and then subsequently by increasing depth from front to back. The peak depth of mill anomalies on the East and West pipelines was **37 and 41 percent** of the wall thickness, respectively. Table 1 below shows the distribution of features for both Straits pipelines, where there were **141 and 294 features** identified by the MFL inspections of the East and West pipelines, respectively. As stated above, these features all exhibited a depth below 50 percent of wall thickness and well within safety thresholds.

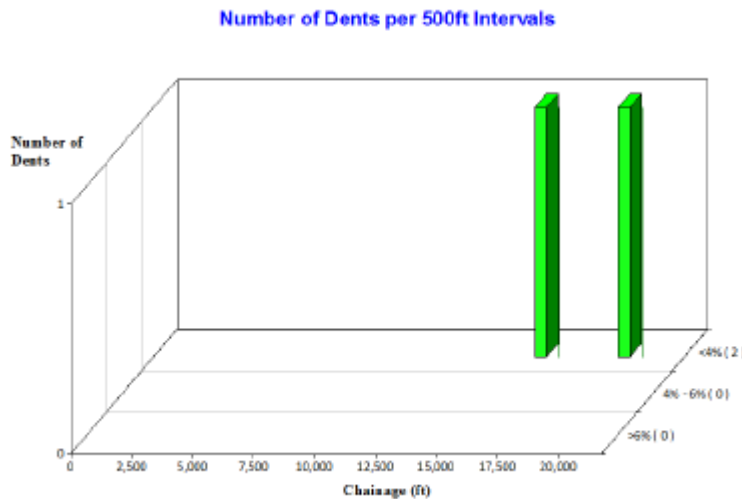
Figure 2 – Distribution of dents on East Straits pipeline as identified by 2013 Caliper ILI

The tool found **two dents** on the East Straits pipeline. The largest dent had a width of eight inches and a length of eighteen inches. There were no dents identified on the West Straits crossing.

Figure 2 was directly excerpted from the East Straits Caliper ILI report and shows the depth and location distribution of all dents identified during the 2013 inspection. There is no similar figure for the West pipeline because no dents were identified in the 2013 West Straits Caliper in-line inspection.

Engineering analysis tells us these dents pose no threats to the safety of the pipeline and they fall below the regulatory repair threshold, which is two percent depth for topside dents and six percent for bottom-side dents. Nevertheless, these deformations were further inspected by divers in 2014 to confirm our engineering analysis. In these locations there were no actual pipe wall anomalies identified on visual inspection, with the indications resulting from tool noise. We continue to monitor the condition of the pipe, and will take additional measurements with future in-line inspections to maintain the fitness of the pipelines.

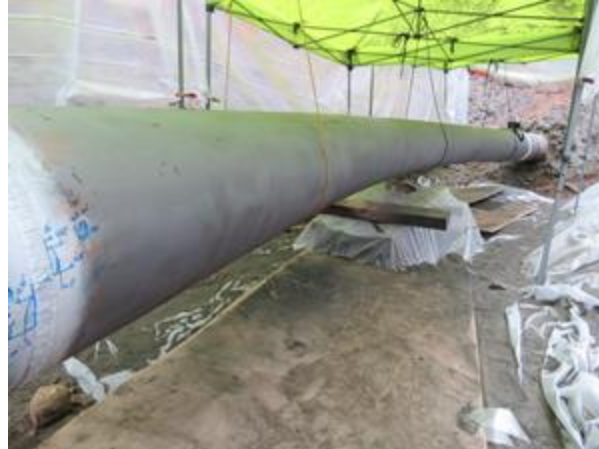
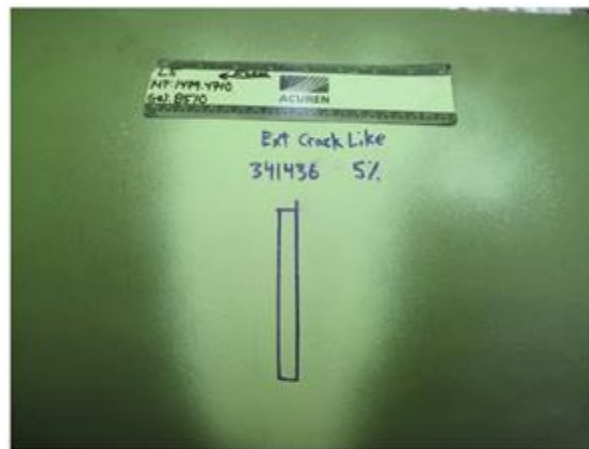
Figure 2 – Field Results of East Segment in-line Inspection

As an additional validation, field investigations were performed for the East and West segments on the onshore portion of the Straits pipelines. Figure 2 below, from the field inspection's non-destructive evaluation report, shows the inspection results for ILI feature 341436. This feature was identified by the ILI tool as an external crack-like feature less than five percent deep. Field investigation found no cracking, discovering instead a small surface anomaly that was removed by grinding. This reflects the sensitivity of the ultrasonic inspection tool to recognize the smallest of features and identify them for further assessment.

016 ILI 341436
L5 MP 1479.4710 GW 8510
