Line 5 inspections

Regular examinations of the pipe, both inside and out

Line 5 Inspection Results

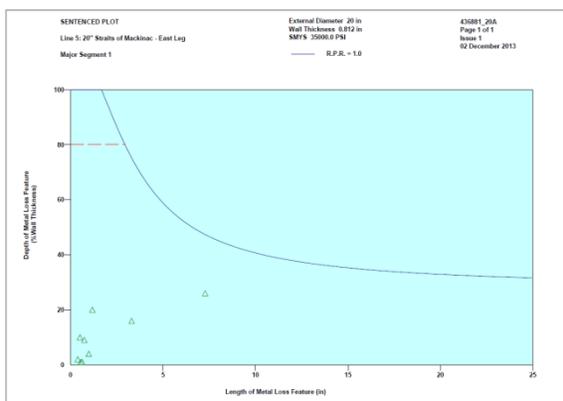
Figure 2 –2013 MFL Inspection Corrosion Results

As shown in the above figure, there were **nine metal loss corrosion features** identified by the MFL tool on the nearly five-mile East Straits pipeline, all of which were **located on the on-shore portion** of the pipeline. For these nine features, the average maximum depth was **10 percent of the wall thickness**, and the average length was 1.7 inches. The deepest was **26 percent** and 7.3 inches long, which makes it the longest feature as well—but still only half as deep as it would need to be to require repairs, as set out by regulatory standards. The allowable

limit for safety, as set out by those regulatory standards, is a function of the metal loss size, pipeline properties, and operating parameters, and is represented by the blue curved line in these figures. The features that were found fall well below the line, which means well within safety thresholds.

All of these features found by the MFL tool were on the inside of the pipe, which means there was no external metal loss features on the East pipeline (remember, the outside of the pipe is covered with a tough enamel coating that provides a barrier between the steel and the elements, namely water).

For the West Straits pipeline, there were **no metal loss features** identified by the MFL tool on either the inside or outside of the line, which is why there are no green triangles on the right-hand-side Figure 2 plot.

Additionally, Enbridge conducts its own assessments of these features, above and beyond those conducted by the ILI vendor, to assess and evaluate the accuracy of the ILI tool; all nine were assessed by our engineers, and considered well within safety thresholds. If they were found to be above the acceptability limits, or the blue line in Figure 2, preventative maintenance action would be taken.

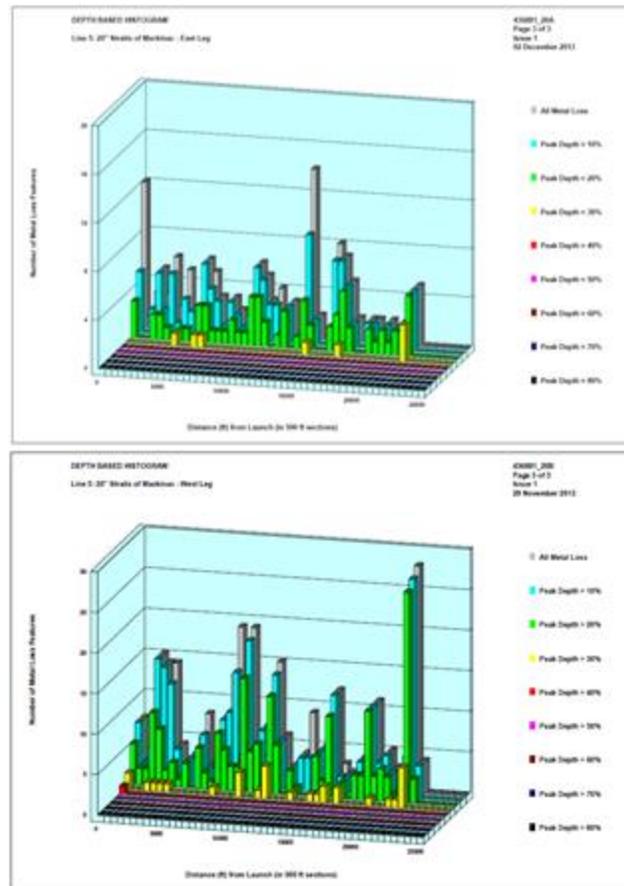
Figure 3 – Summary of Number of Features by Depth of 2013 (East Leg) Metal Loss Inspections

In addition to the metal loss anomalies shown in Figure 2, the ILI report also shows other features with reported length and depth that are characterized as mill anomalies. All pipe, even brand new, will contain some anomalies or imperfections, most of which will never grow or represent a threat. In the case of Line 5, which consists of specially manufactured seamless piping for extra strength and safety, some variations in wall thickness result from (and are expected from) the manufacturing process itself.

These wall thickness variations passed the original hydrotests and been safely accommodated by the pipelines since construction. They are picked up and reported by the corrosion tools, and while stable in nature, are nonetheless monitored and assessed from inspection to inspection, as shown in Figure 3 and described in Table 1.

Taken directly from the 2013 ILI Metal loss inspection reports, Figure 3 gives a graphical representation of the depth of features found along the East and West pipelines, including both metal loss and mill anomalies. The chart is categorized by total features, and then subsequently by increasing depth from front to back. The peak depth of mill anomalies on the East and West pipelines was **37 and 41 percent** of the wall thickness, respectively. Table 1 below shows the distribution of features for both Straits pipelines, where there were **141 and 294 features** identified by the MFL inspections of the East and West pipelines, respectively. As stated above, these features all exhibited a depth below 50 percent of wall thickness and well within safety thresholds.

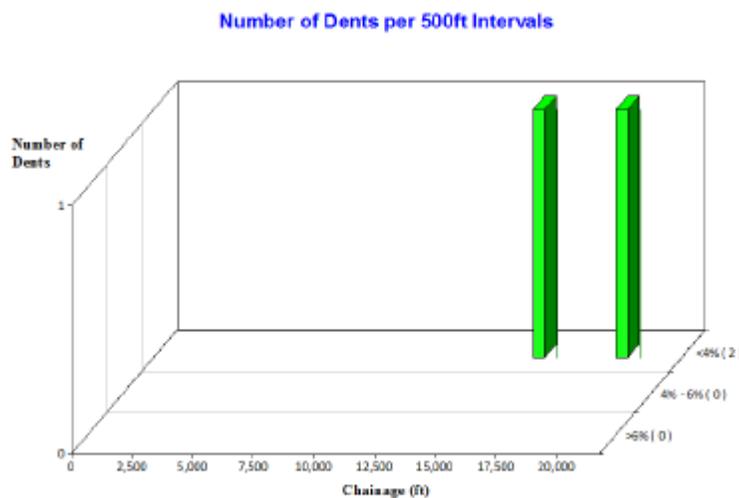
Figure 2 – Distribution of dents on East Straits pipeline as identified by 2013 Caliper ILI

The tool found **two dents** on the East Straits pipeline. The largest dent had a width of eight inches and a length of eighteen inches. There were no dents identified on the West Straits crossing.

Figure 2 was directly excerpted from the East Straits Caliper ILI report and shows the depth and location distribution of all dents identified during the 2013 inspection. There is no similar figure for the West pipeline because no dents were identified in the 2013 West Straits Caliper in-line inspection.

Engineering analysis tells us these dents pose no threats to the safety of the pipeline and they fall below the regulatory repair threshold, which is two percent depth for topside dents and six percent for bottom-side dents. Nevertheless, these deformations were further inspected by divers in 2014 to confirm our engineering analysis. In these locations there were no actual pipe wall anomalies identified on visual inspection, with the indications resulting from tool noise. We continue to monitor the condition of the pipe, and will take additional measurements with future in-line inspections to maintain the fitness of the pipelines.

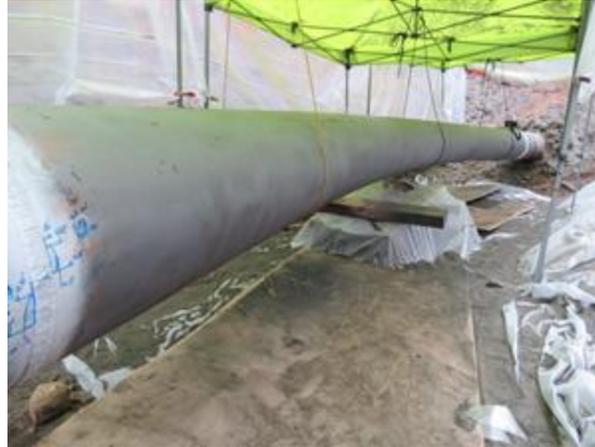
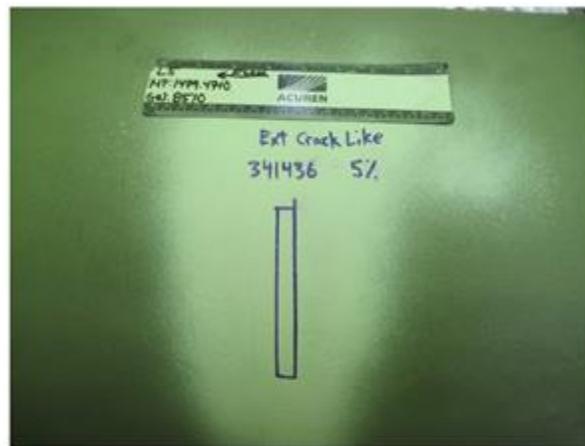
Figure 2 – Field Results of East Segment in-line Inspection

As an additional validation, field investigations were performed for the East and West segments on the onshore portion of the Straits pipelines. Figure 2 below, from the field inspection's non-destructive evaluation report, shows the inspection results for ILI feature 341436. This feature was identified by the ILI tool as an external crack-like feature less than five percent deep. Field investigation found no cracking, discovering instead a small surface anomaly that was removed by grinding. This reflects the sensitivity of the ultrasonic inspection tool to recognize the smallest of features and identify them for further assessment.

016 ILI 341436
L5 MP 1479.4710 GW 8510
