# SGS MUSCOWPETUNG

# **ABORIGINAL CONSTRUCTION MONITORING**

## **WEEKLY REPORT**

### **SPREAD 6**

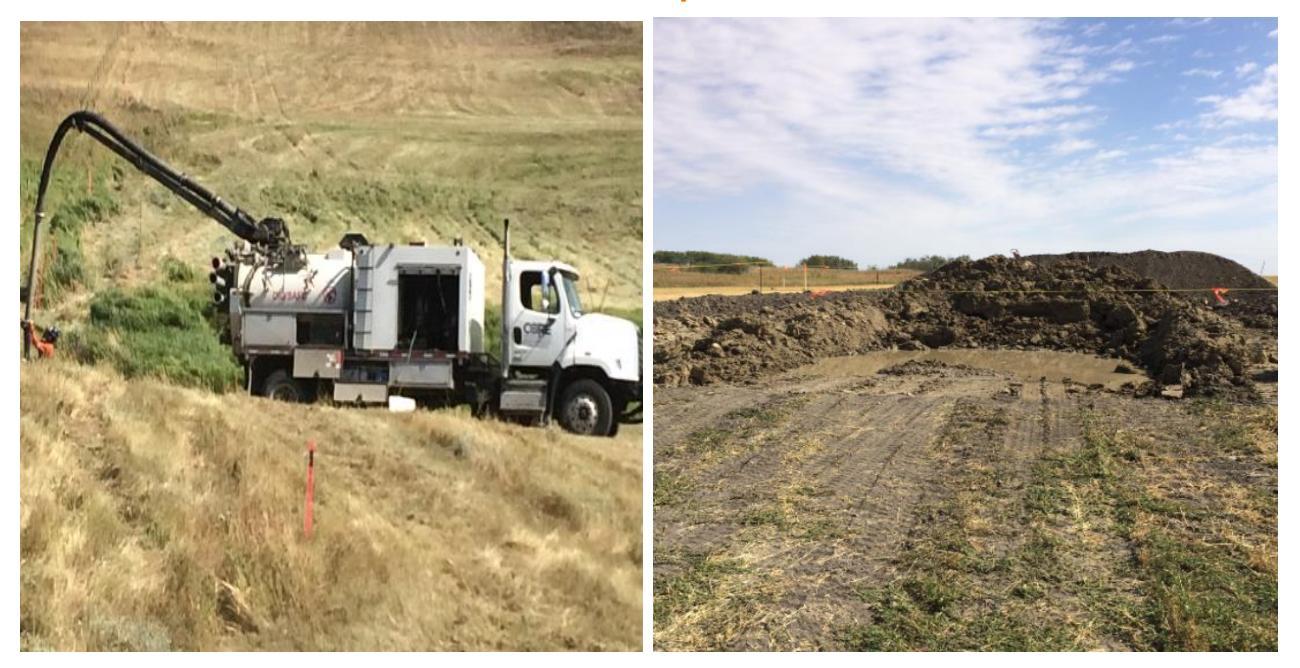
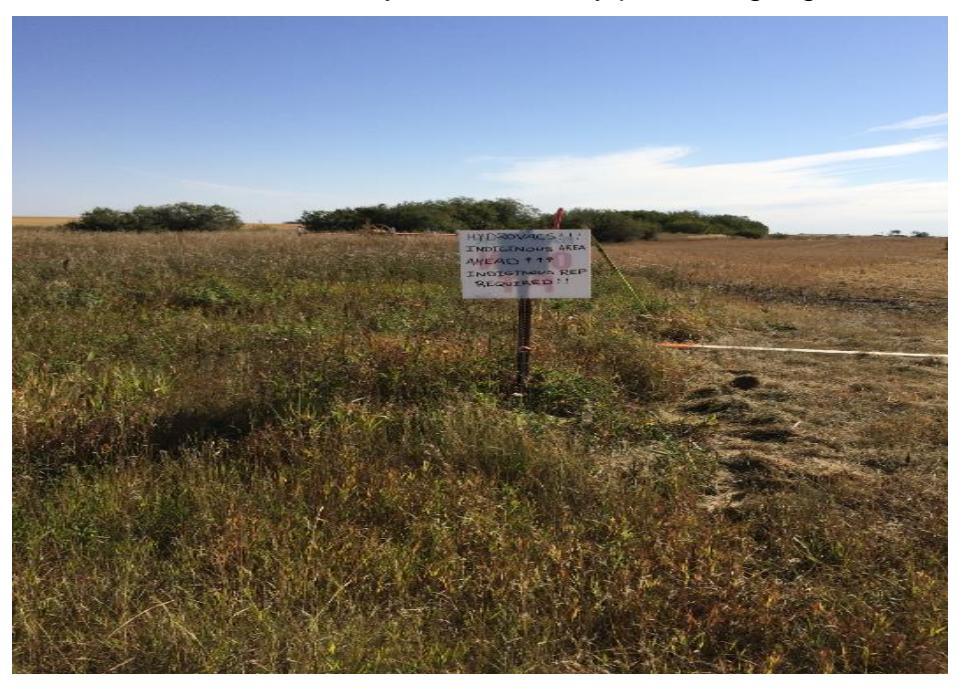
An area we monitored this week at 686 + 500 had an entry sign posted Hydro vacs, Indigenous Area Ahead, Indigenous rep required. This sign was erected to notify crews that Aboriginal Construction monitors had to be present during construction. With the numerous areas requesting Monitors at various stages of construction I recommend these signs be posted at all the locations.

Monitored hydro vac excavation from 686 + 500 to 387 + 300, Our team kept the safe distance away, waited until the hydro vac was finished, then conducted visual assessments of all the holes for possible signs of cultural deposits or items. (No items were observed) A crew was working in the area roping off all the wetlands. SK 680, seasonal marsh class III, SK 681, semi-permanent marsh class IV, SK 682, III Seasonal Marsh Class III, SK 683 seasonal marsh, x2 Class III, Sk 684 semi-permanent marsh class IV, Sk 693, seasonal marsh class III. The wetlands were properly staked (marked) and roped off. When the hydro vac trucks unloaded between 687+100 and 687 + 200 slurry pit we observed the slurry hydro vac catchments.

686 + 500 - 687 + 300 Hydrovac - slurry pit and signage

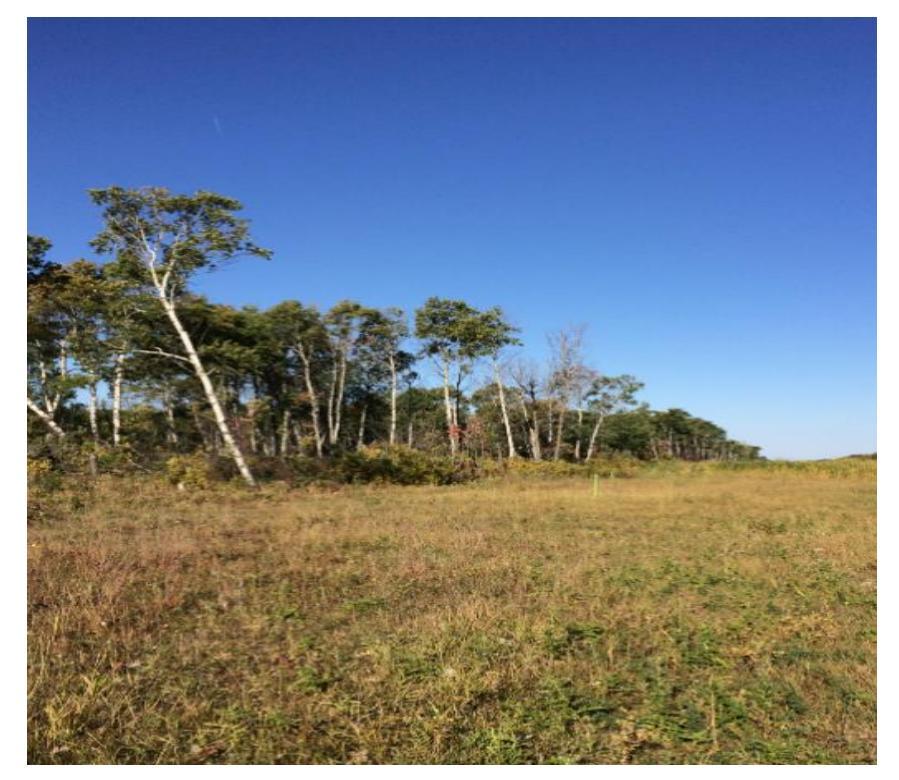
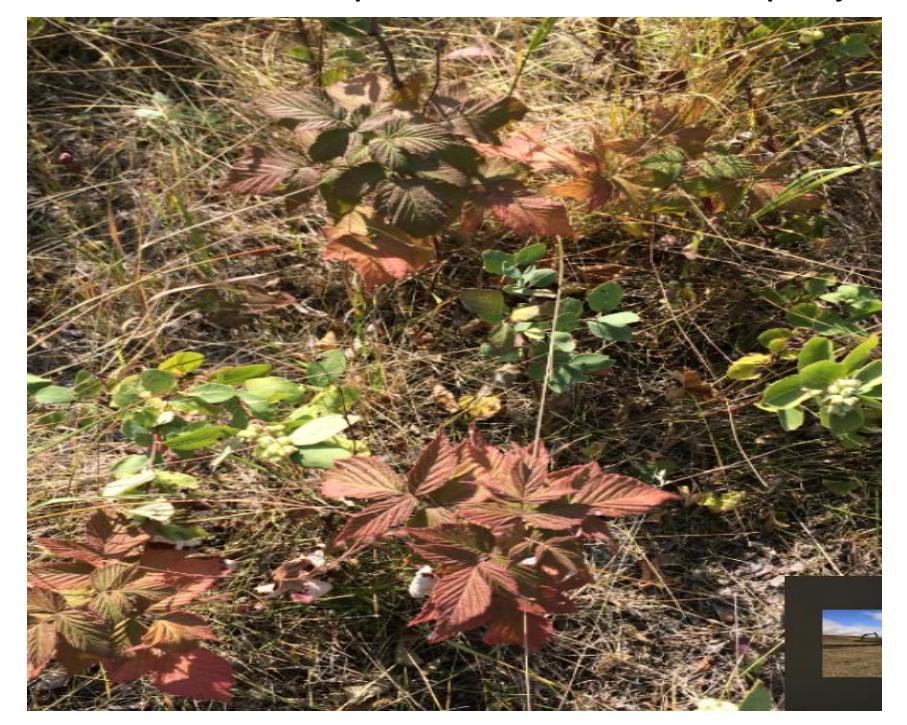
745 + 300 to 746 + 100 Treed pasture with wetlands - Wild raspberry bush

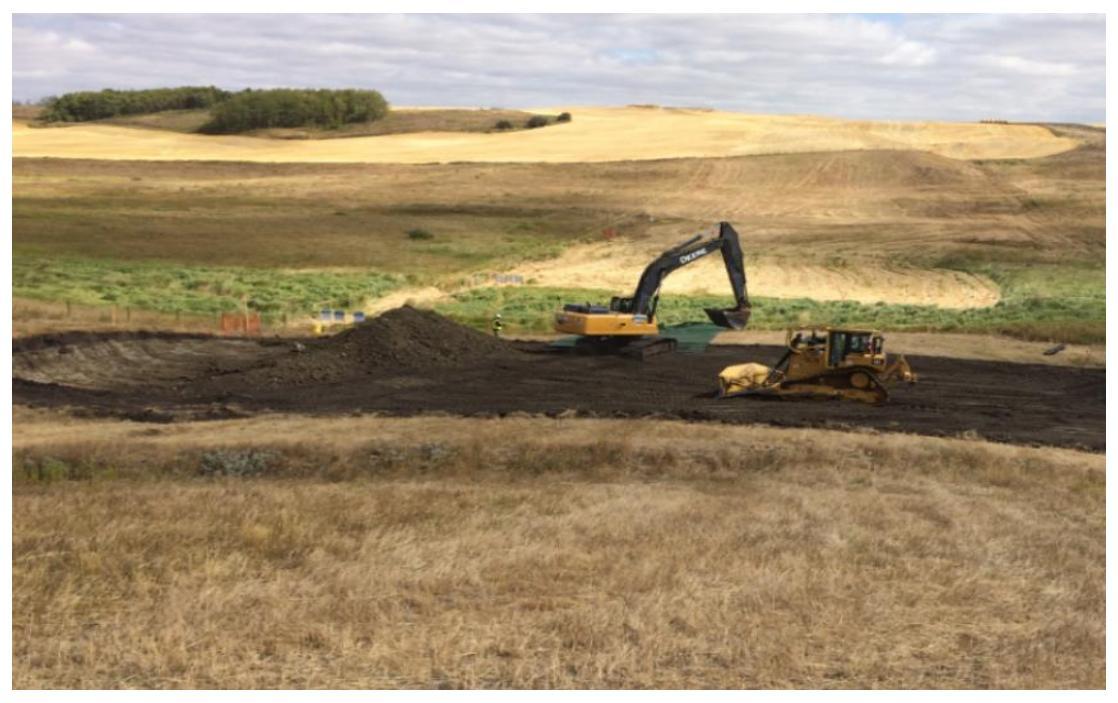
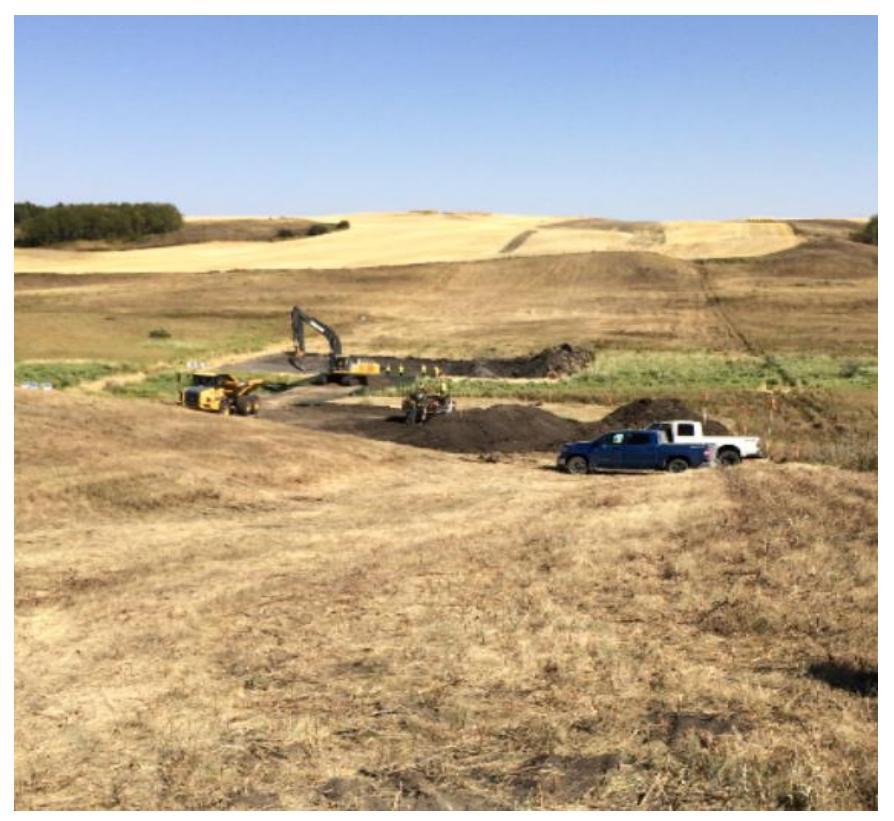
Vipond Creek sacred site east side had been disked 661 + 120 area up to the rough clean station on the west upper cultivated land. 661 + 125. The ramp on top of the Valley west side of the hill was completed at 661 + 125. The track hoe and dozer were clearing the right of way and moving the soil into piles on the south side. Crews were constructing the Clear span bridge for the water crossing (skWC 72) kp 653 + 52. They had laid geo textile, and skids were put in place, clay was used on top of the geo textile. Proper signage and markers were in place for the wetlands area sk 584 Class III. On the far south side of the right of way junior monitor found bones and a small rock, followed procedure and called (Archaeologist} who gave instructions to leave the items in area where they were found. Environment helped buffer the area with stakes, it turned out they were recent animal bones. Within these areas there is possibility for buried cultural deposits, before during and after excavations our team walk the areas looking for items of interest.

Photos taken looking East 661 + 120 - 661 + 125 Vipond creek Valley

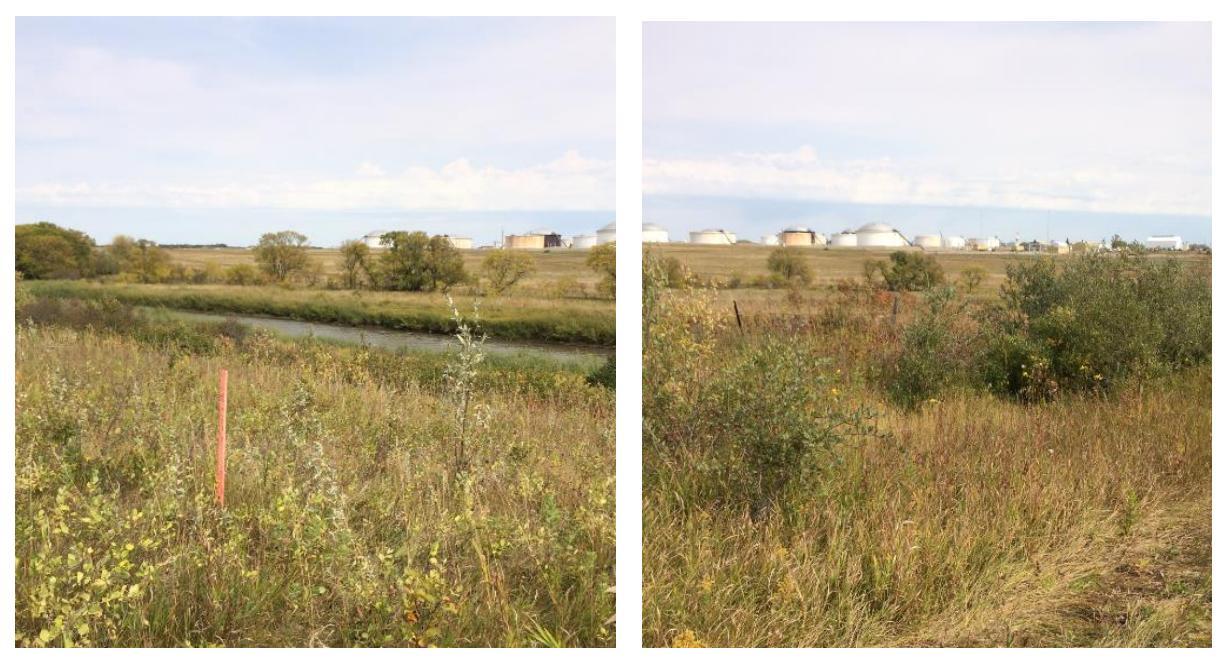
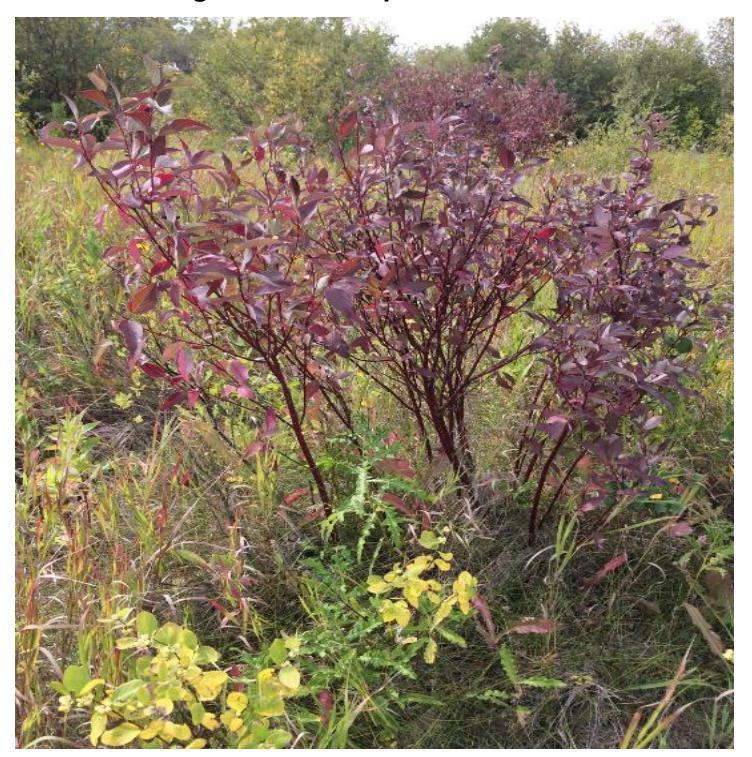
Pipestone River Valley Archaeological/ Sacred sites. The fencing crew were working on removing the fence at two locations of the pipestone creek. The environmental crew were sweeping for leopard frogs, Observed red willow trees and various medicinal/cultural plants.

805 + 200 Picture taken looking East at the Pipestone Creek Photo Below is a Red Willow
