SAMSON CREE NATION – MATRIX SOLUTIONS INC. PARTNERSHIP

ABORIGINAL CONSTRUCTION MONITORING

WEEKLY REPORT

NOVEMBER 5^{TH -} NOVEMBER 10TH

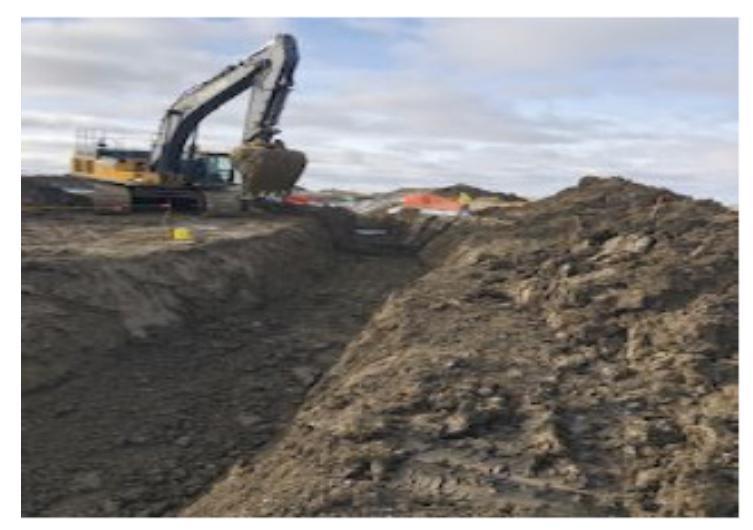
Backfill crew pulling soil - km 222+370 - Nov 5, 2018

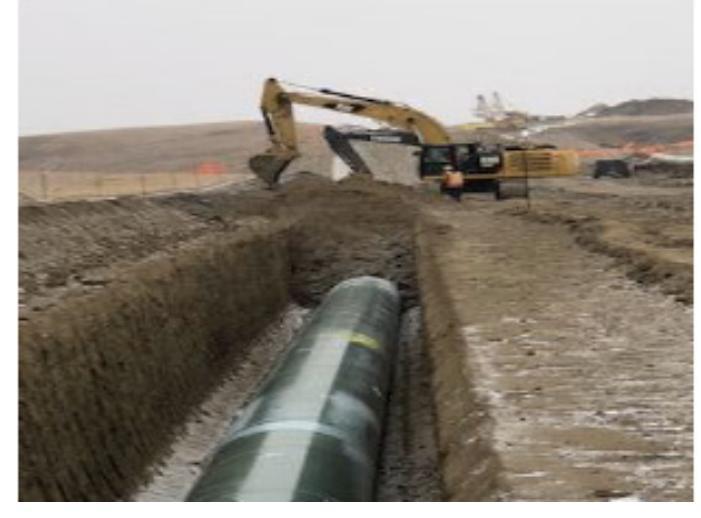
Tie-in excavator - km 197+360 - Nov 5, 2018

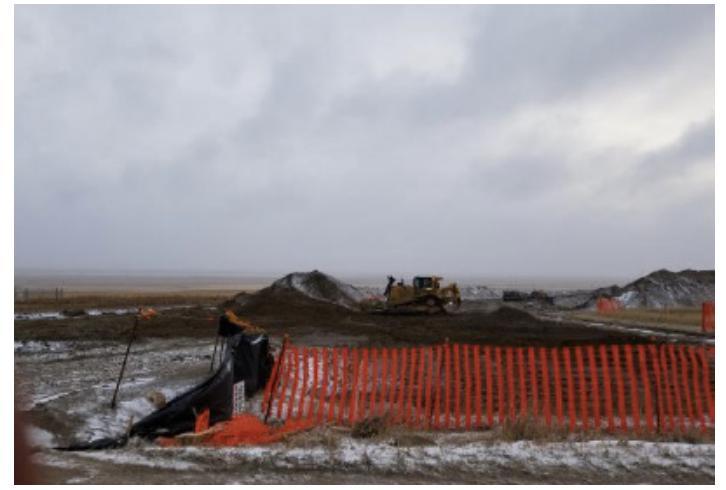
Moving dirt - km 172+100 - Nov 5, 2018

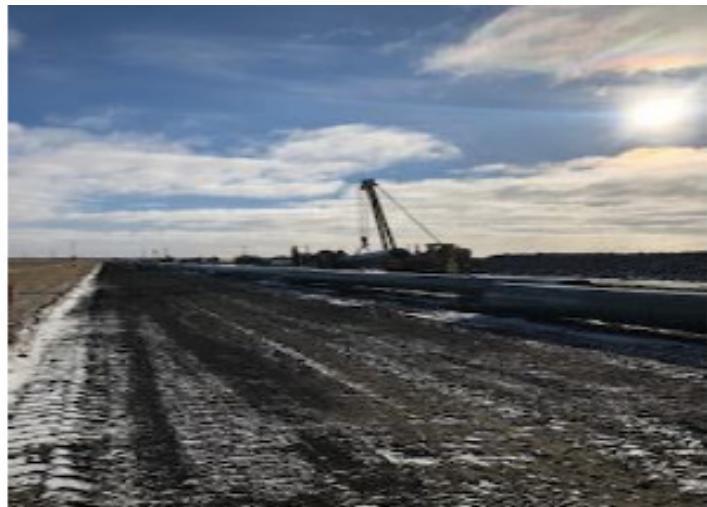
Bending crew pulling bends - km 211 - Nov 6, 2018

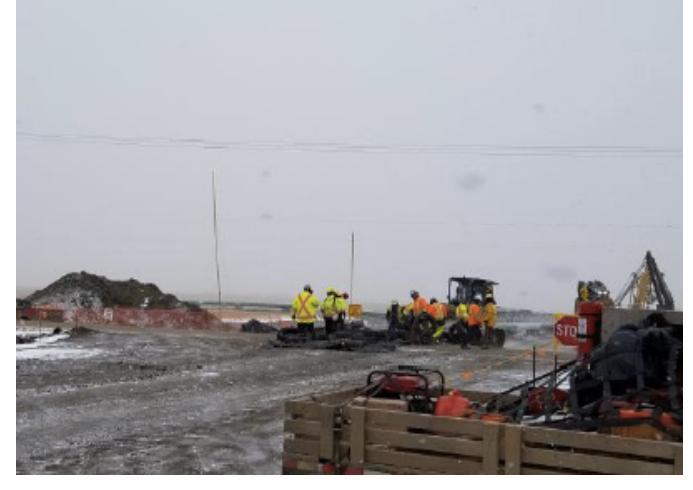
Crossing equipment- km 224+743 - Nov 5, 2018

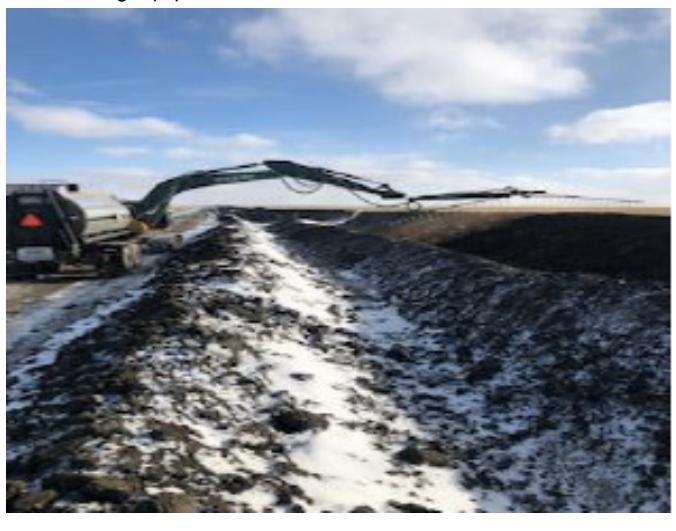
Excavator spraying piles- km 246+375 - Nov 6, 2018

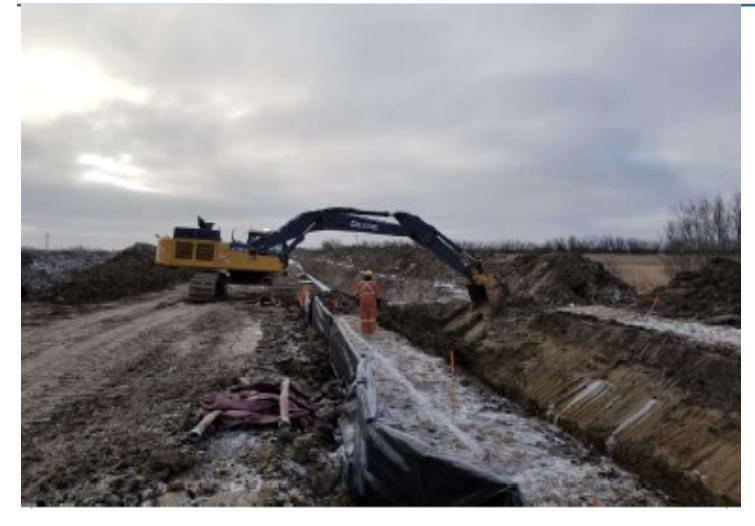
Digging ditch for tie-in - km 180+100 - Nov 6, 2018

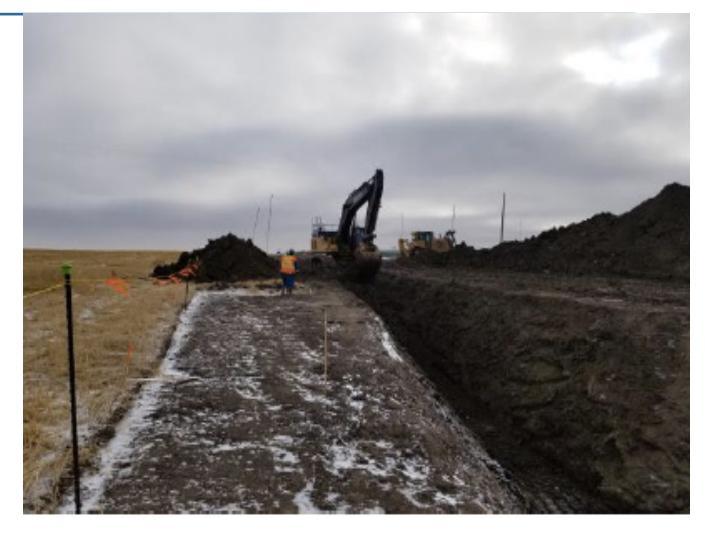
Digging tie-in section - km 197+500 - Nov 6, 2018

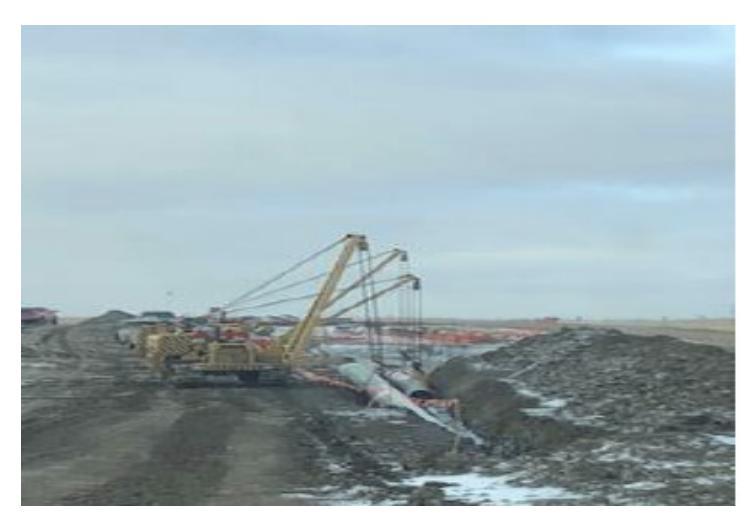
Welding crew and final tie-in - Km204+800 - Nov 6, 2018

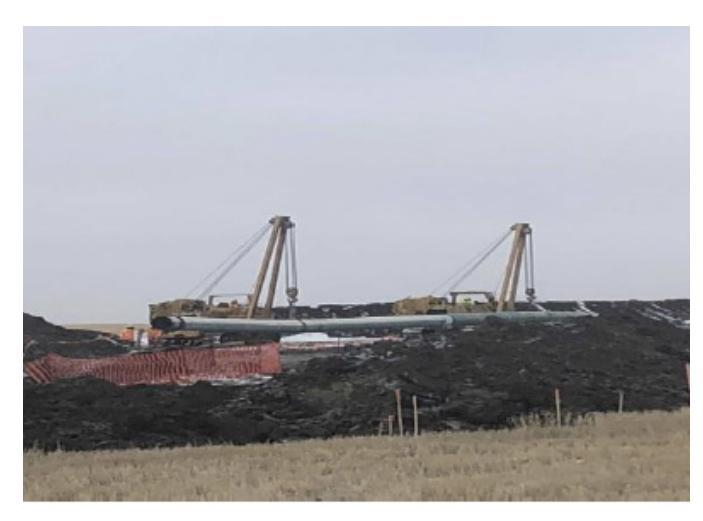
Tandem lift for tie-in - km 197+500 - Nov 6, 2018

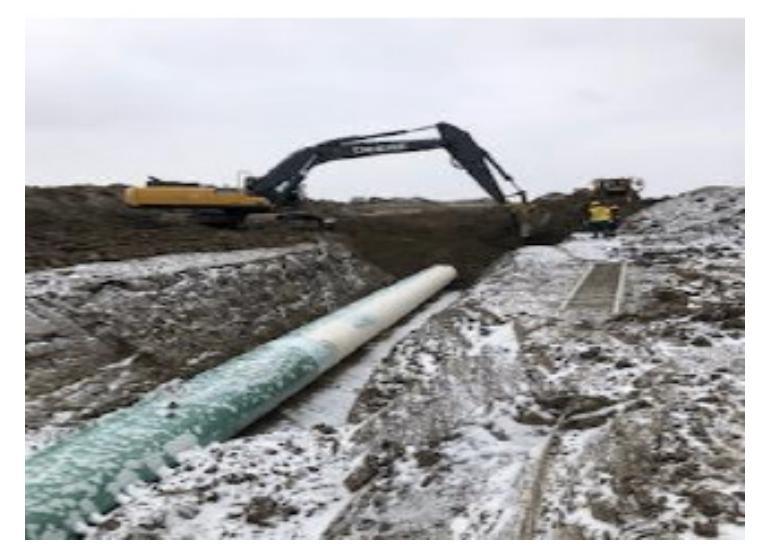
Tie-in backfill - km 175+170 - Nov 7, 2018

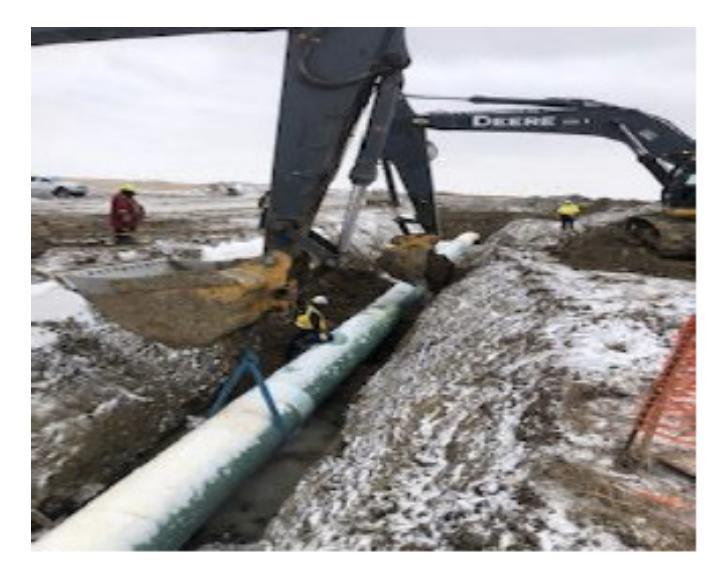
Excavator shading pipe at Plains mainline crossing - Nov 7, 2018

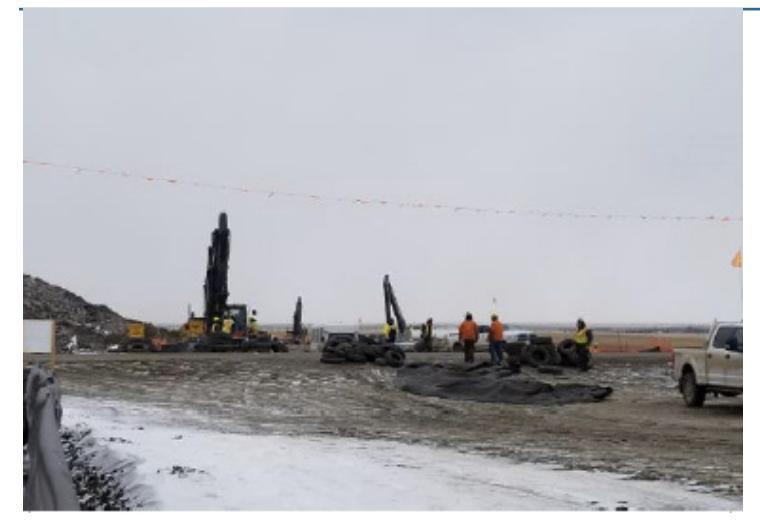
Getting ready to cross equipment - km 259+200 - Nov 7, 2018

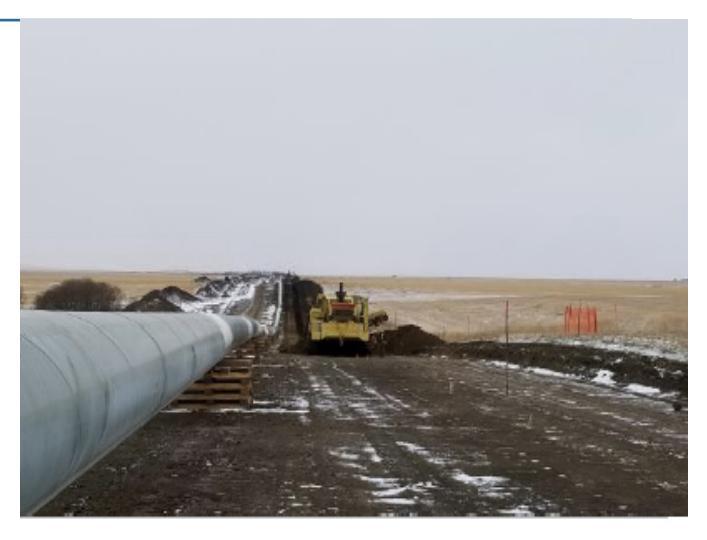
Digging the ditch - 236+070 - Nov 7, 2018

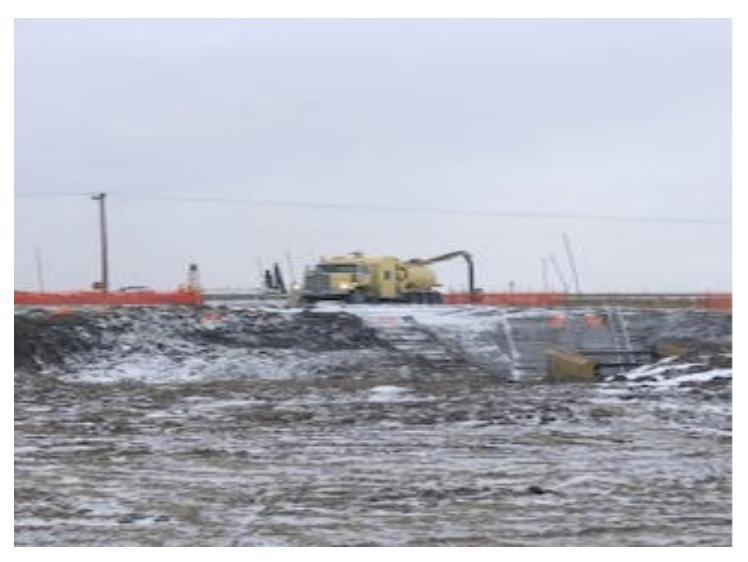
Hydrovac exposing hotline - SF 164 - Nov 7, 2018

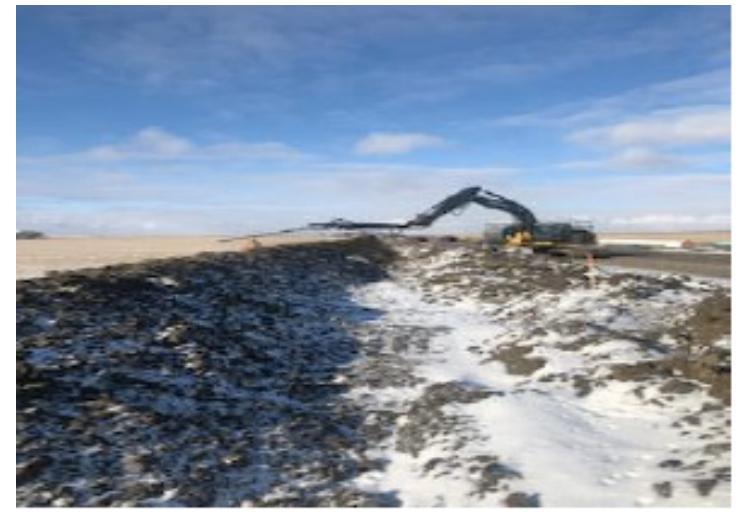
SITE crew spraying tackifier- km 259+800- Nov 8, 2018

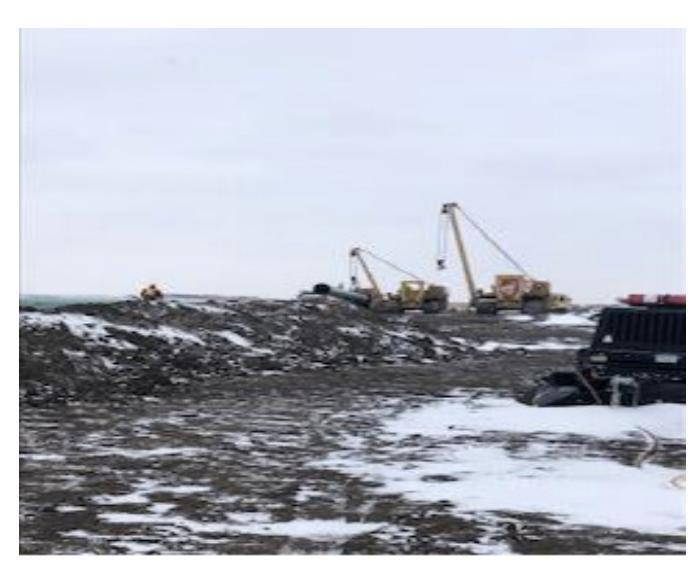
Bending crew - SF 167 - Nov 7, 2018

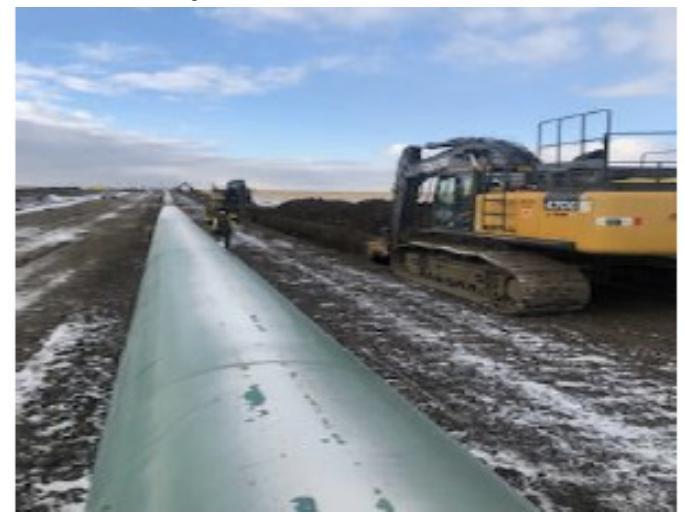
Digging mainline ditch - km 238+750 - Nov 8, 2018

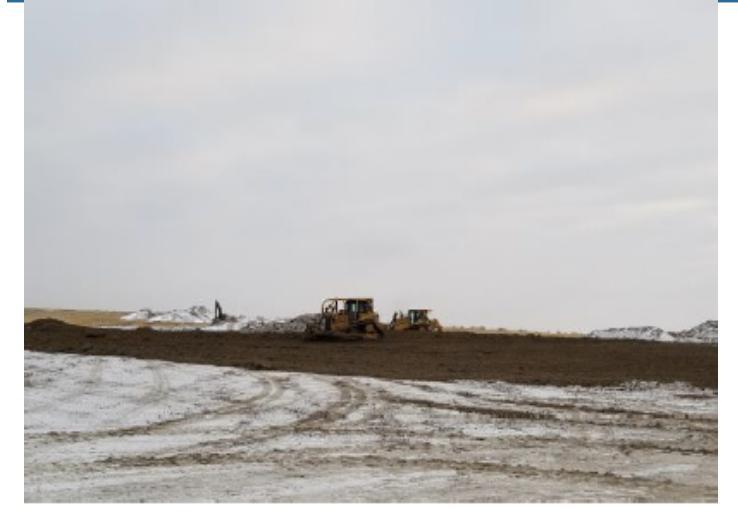
Grading ROW - km 170+940 - Nov 8, 2018

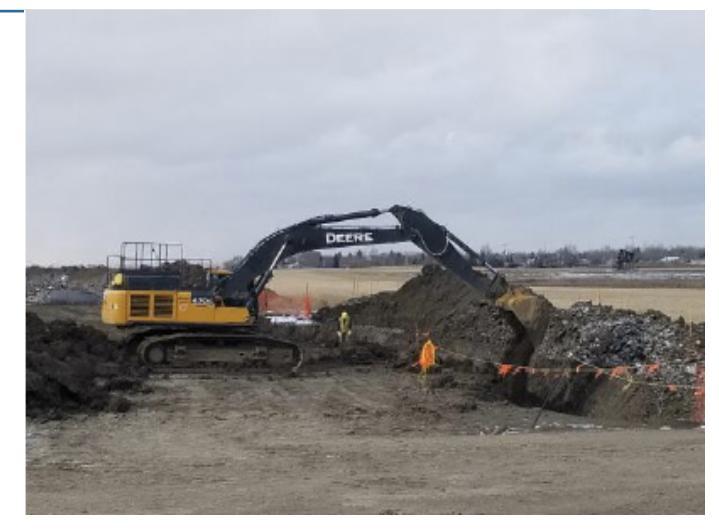
Shading tie-in section - km 197+400 - Nov 8, 2018

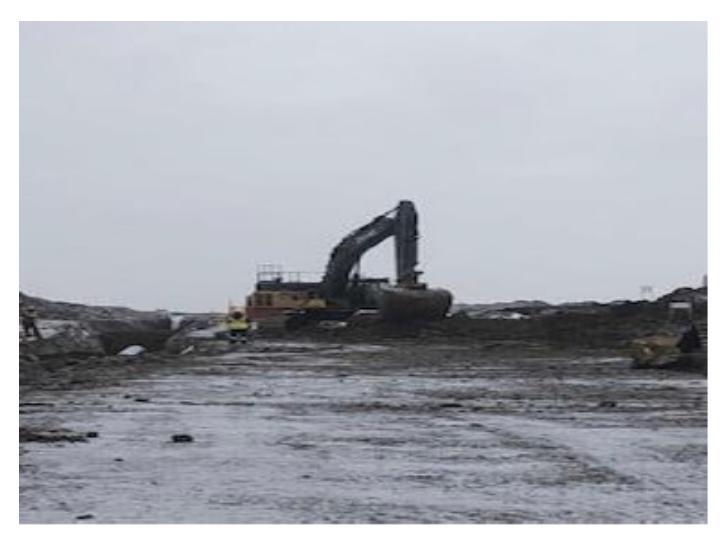
Excavator shading pipe for final tie-in – SF 112 – Nov 8, 2018

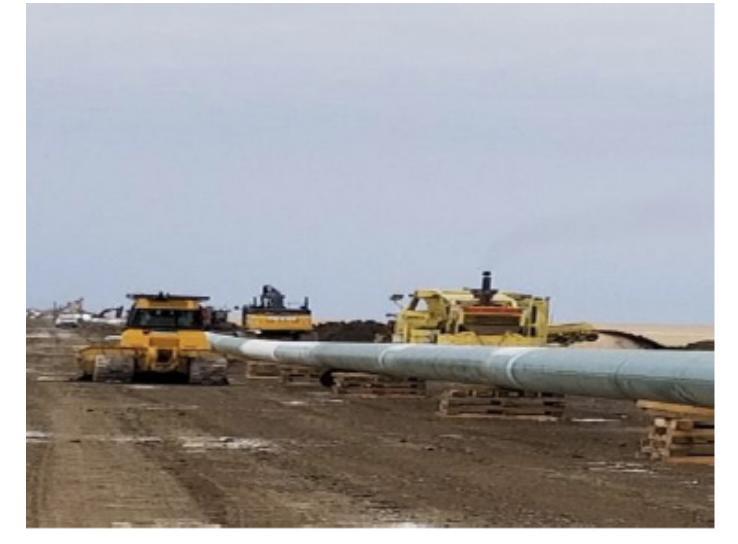
Ditching wheel - SF 193 - Nov 9, 2018

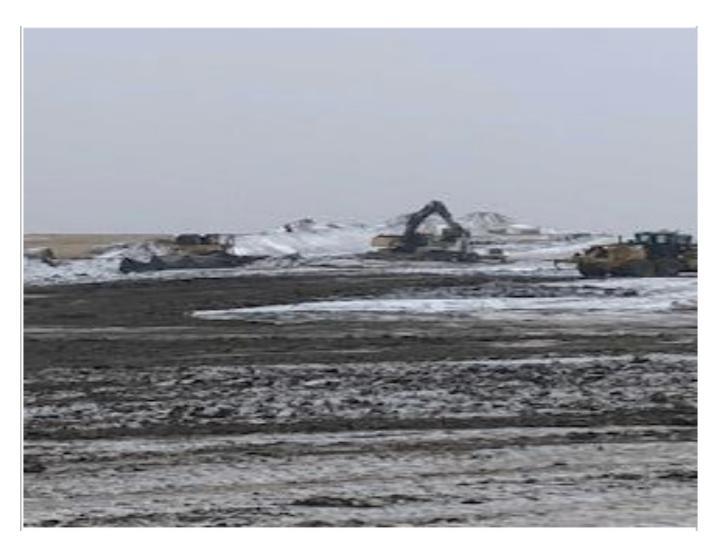
Excavator loading rocks - SF 101 - Nov 8, 2018

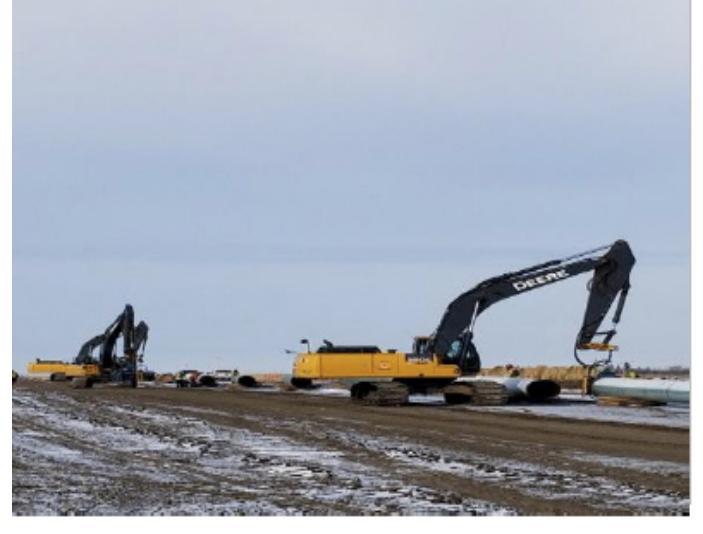
Prep crew - SF 168 - Nov 9, 2018

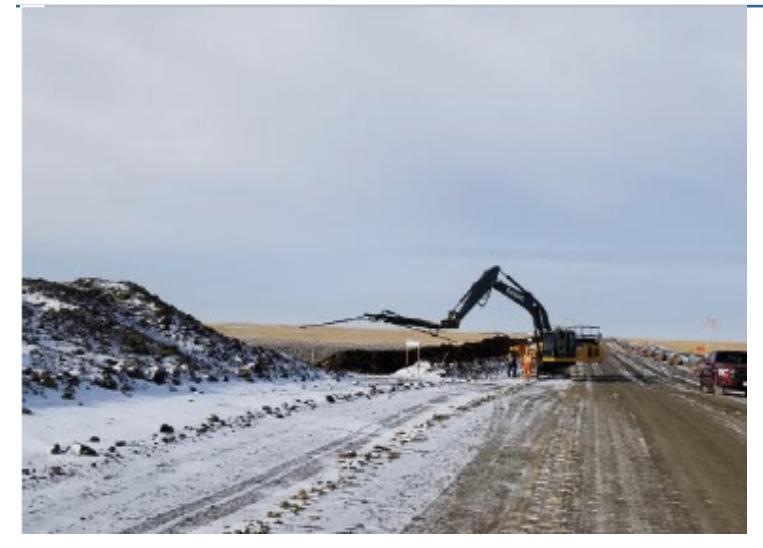
Tackifying soil - km 263+500 - Nov 9, 2018

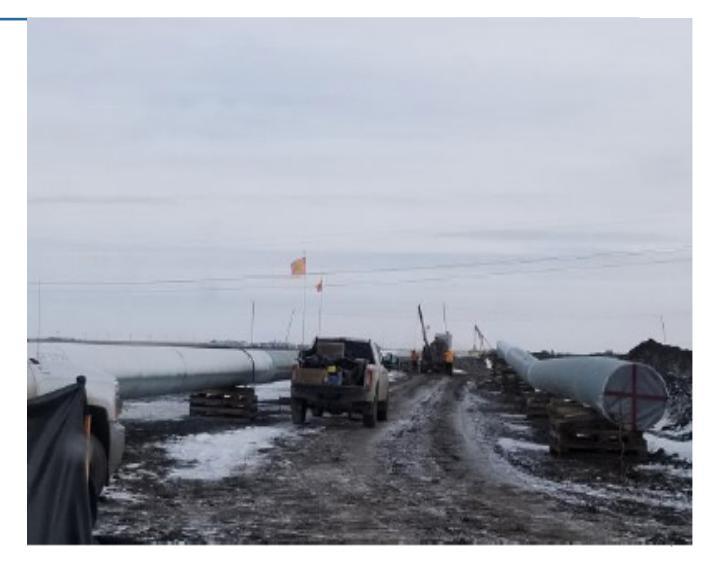
Coding crew - km 243+100- Nov 9, 2018

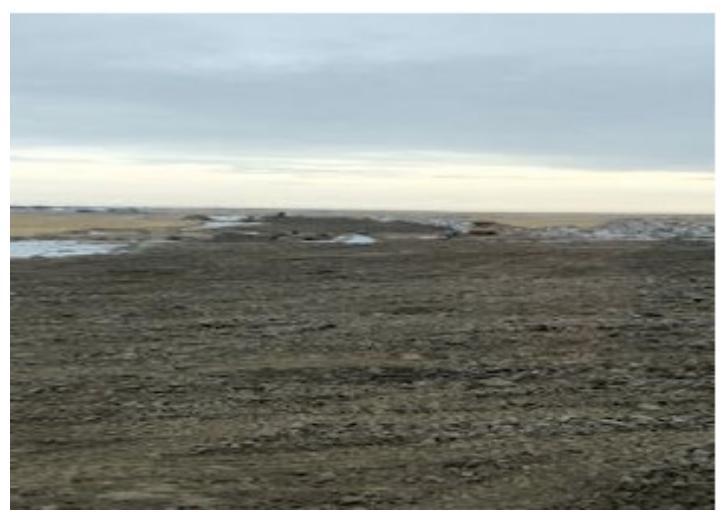
Reclaiming natural grade - km 169+455 - Nov 9, 2018

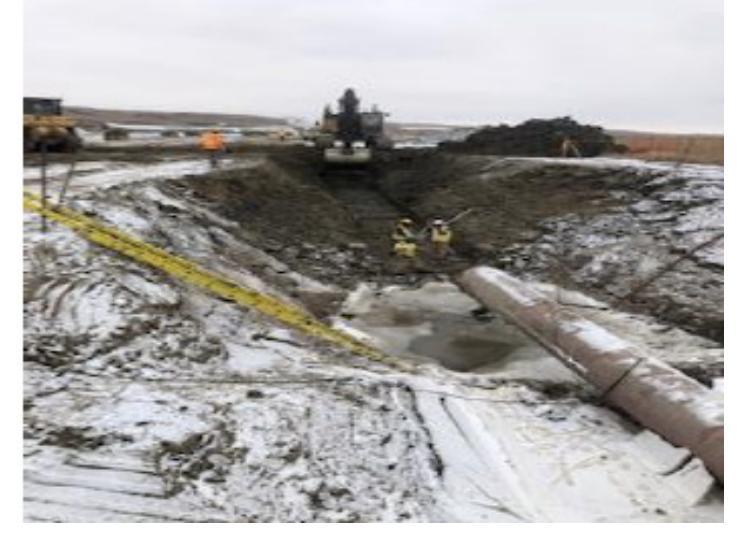
Digging tie-in ditch - SF 140 - Nov 10, 2018

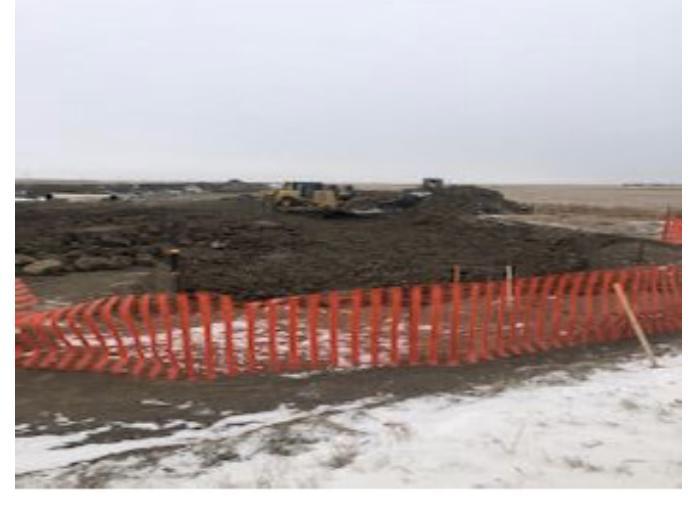
Tie-in backfill crew - SF 113 - Nov 9, 2018

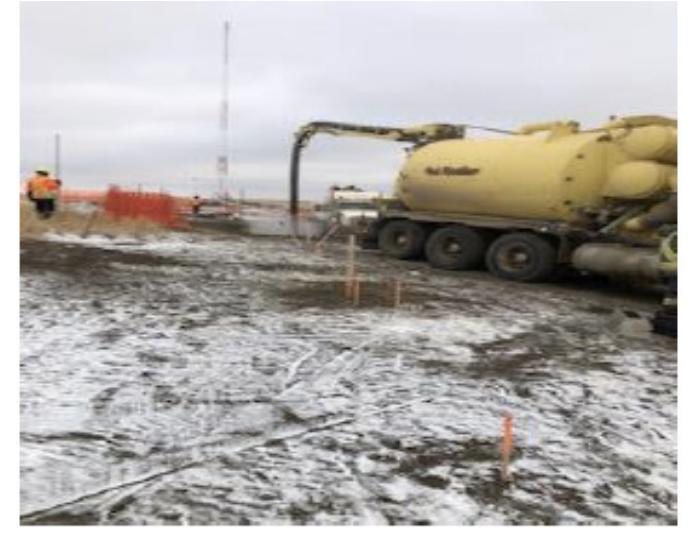
Hydrovac slot digging - km 2o9+703 - Nov 10, 2018

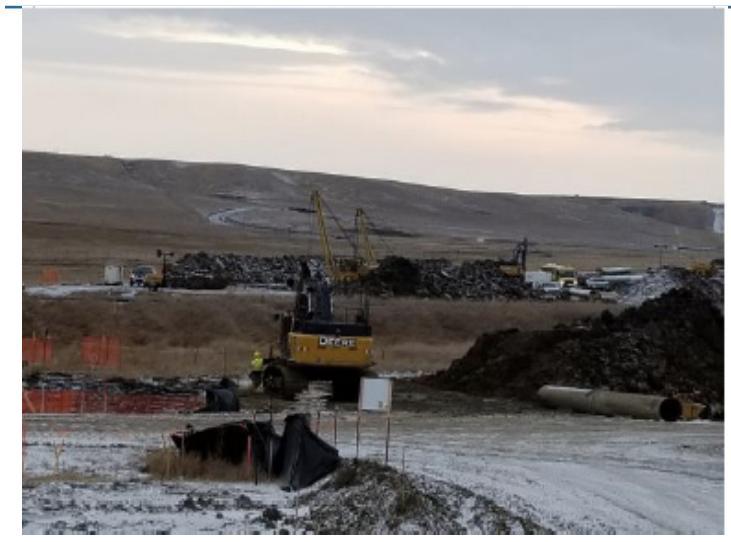
Bore crew- km 221+150 - Nov 10, 2018

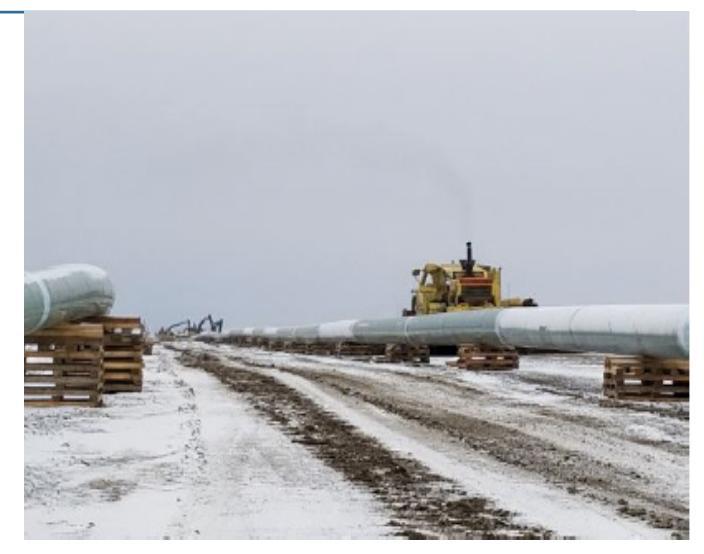
Digging ditch – km 241+640 – Nov 10, 2018
