SGS MUSCOWPETUNG

ABORIGINAL CONSTRUCTION MONITORING

WEEKLY REPORT

OCTOBER 28TH TO NOVEMBER 4TH, 2018

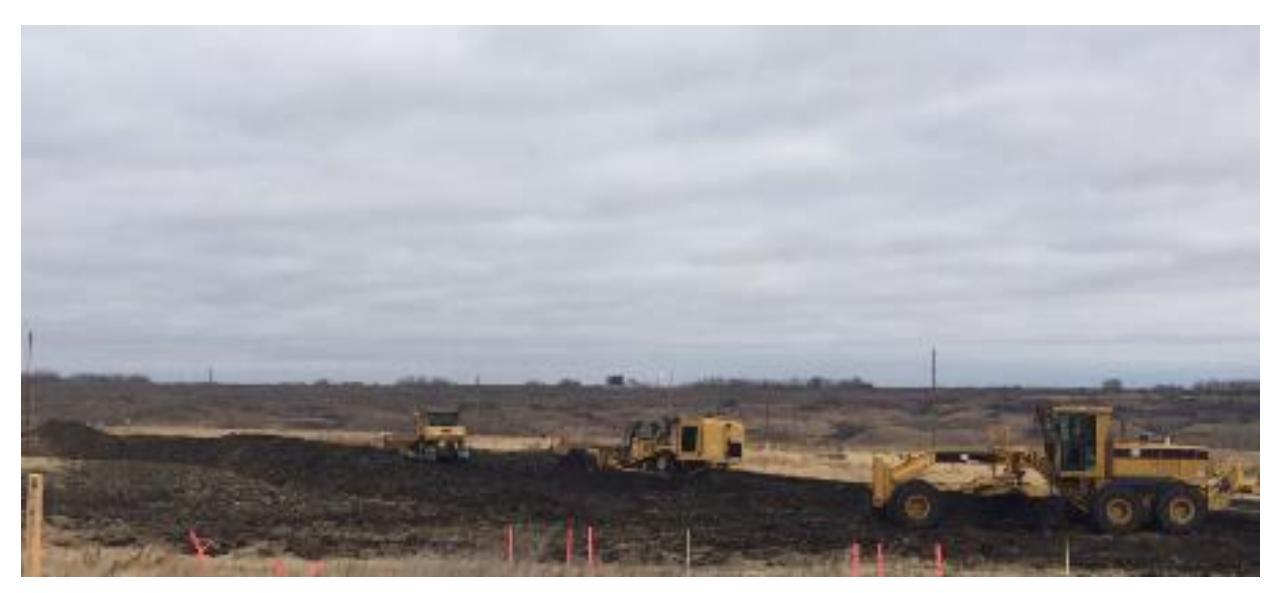
800 +902 Power dozers stripping topsoil

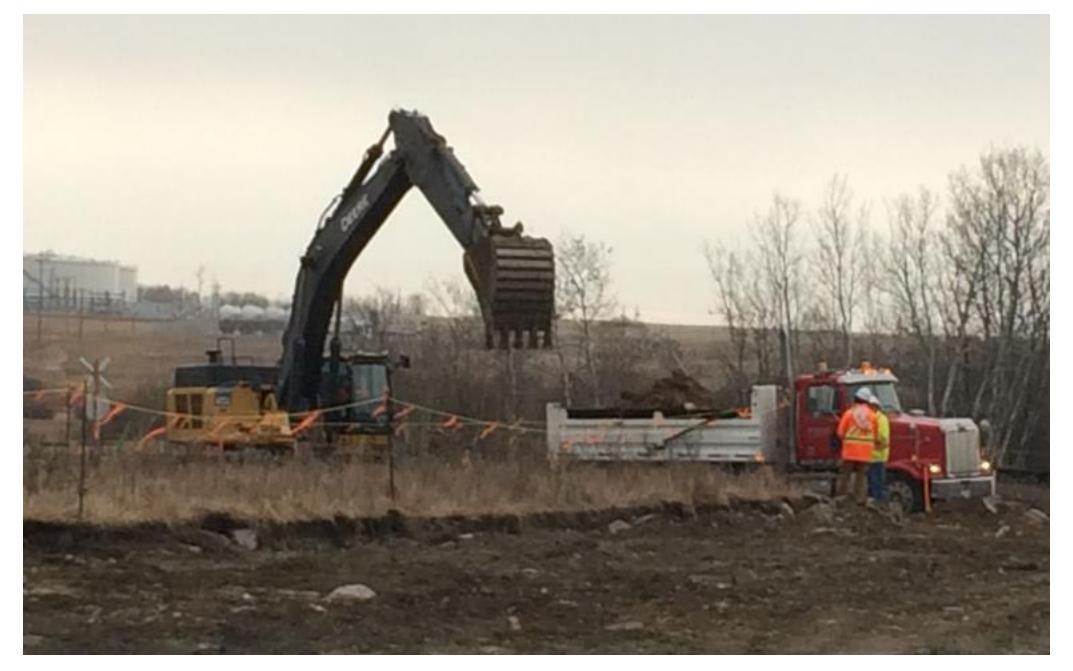
805 + 612 Digging track bore pit west side of the tracks at Pipestone Creek

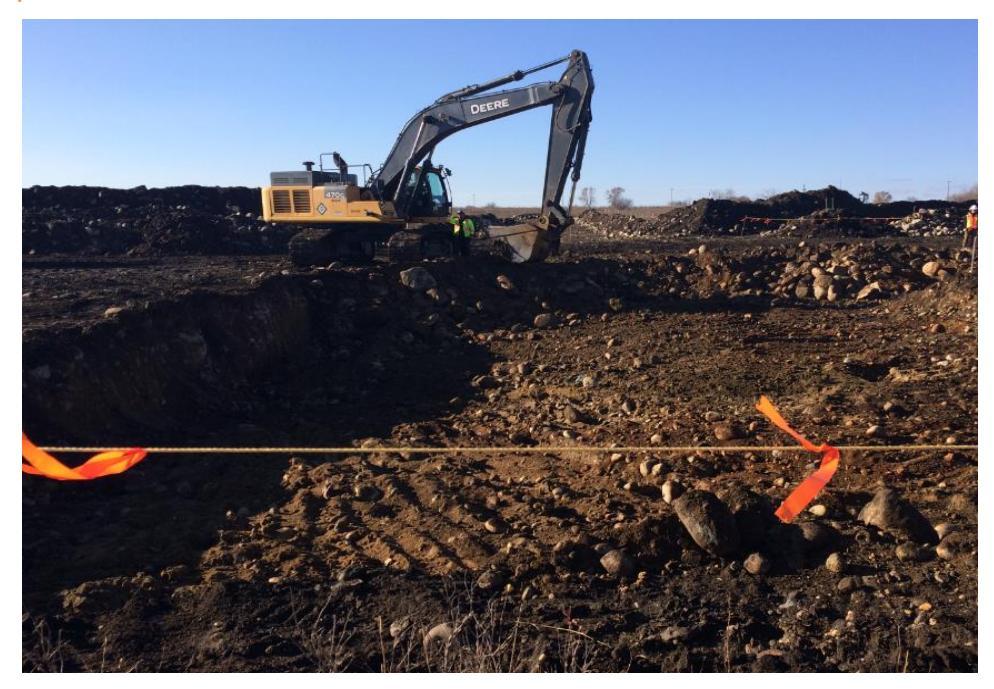
805 + 612 Track bore pit west side of the Pipestone Creek

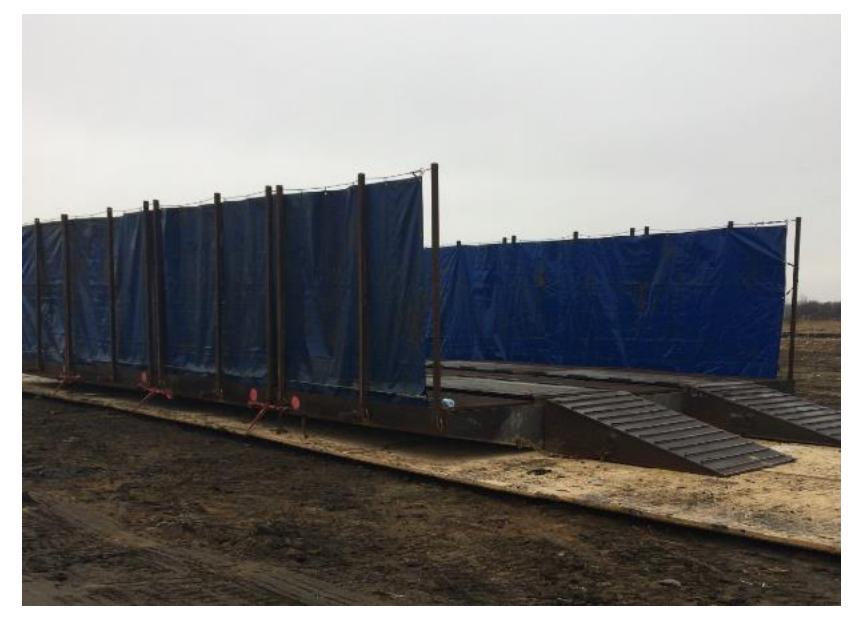
Our team continued to monitor at 803 + 494 West side of the Pipestone Creek Track hoe continued to dig track bore pit and loaded rock truck with soil/rocks, ICM's and Archaeologist were on site throughout the week. A wash station was constructed at entry, the slurry pit that was excavated had been roped off. The fencing and signage for the track bore pit were at the site. Drill sections, skids and additional equipment was brought to the area in preparation for the boring under the tracks

805 + 612 Wash station at Pipestone Creek 146a west side

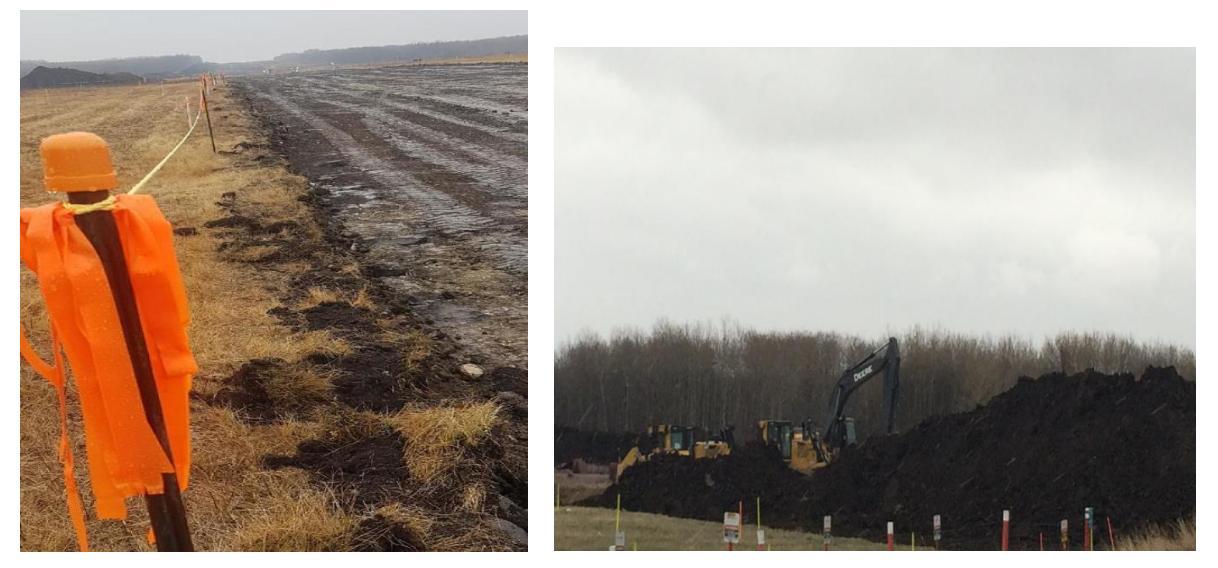
Stony Creek 785 + 051 our team monitored the area, right of way was being cleared with three dozers. A ramp was constructed over line crossing. Fence along the tree line south side had been replaced. The fence into the right of way was removed. The area of interest was clearly marked and roped off. All the soil piles that were in front of the area were relocated to piles South/east of the area. Geo textile was being placed at the creek crossing for the ramp. Entry access ramps on both east and west entries were completed, observed the dozers piling topsoil a meter from the boundaries in the extra work space and placing the seconds a meter in front of the topsoil.

785 + 051 Stony Creek Area of interest roped off and equipment moving top stripped topsoil

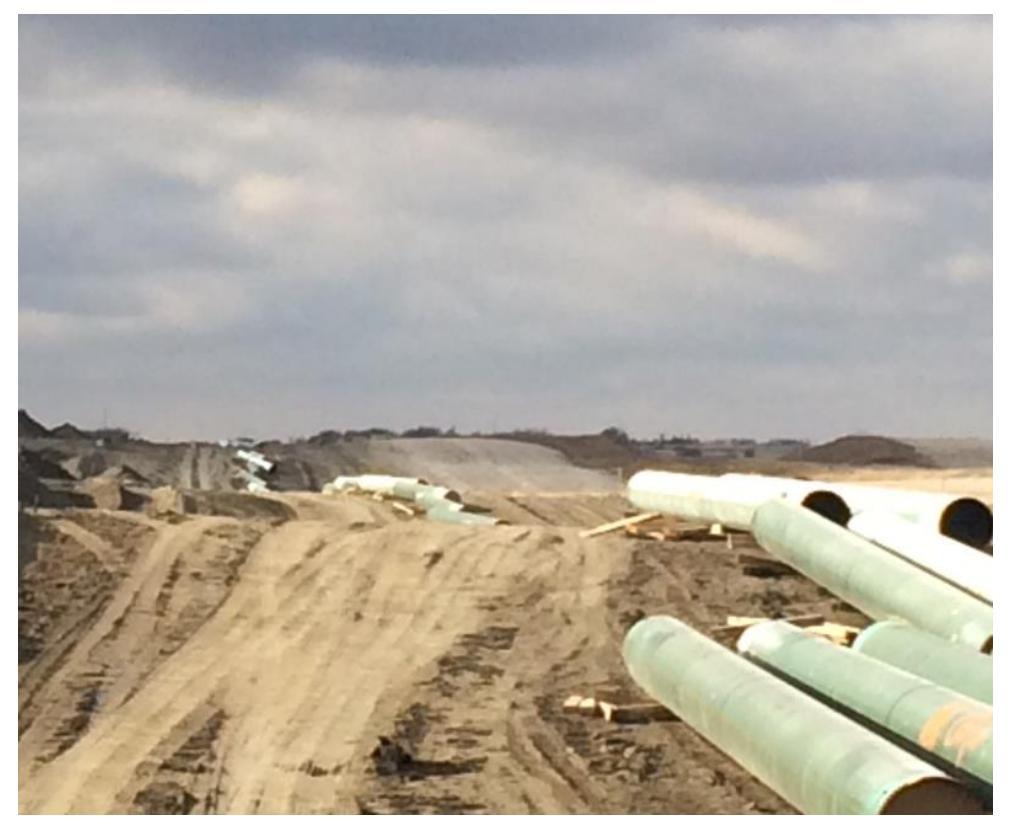
691 + 580 Pipe strung along the right of way

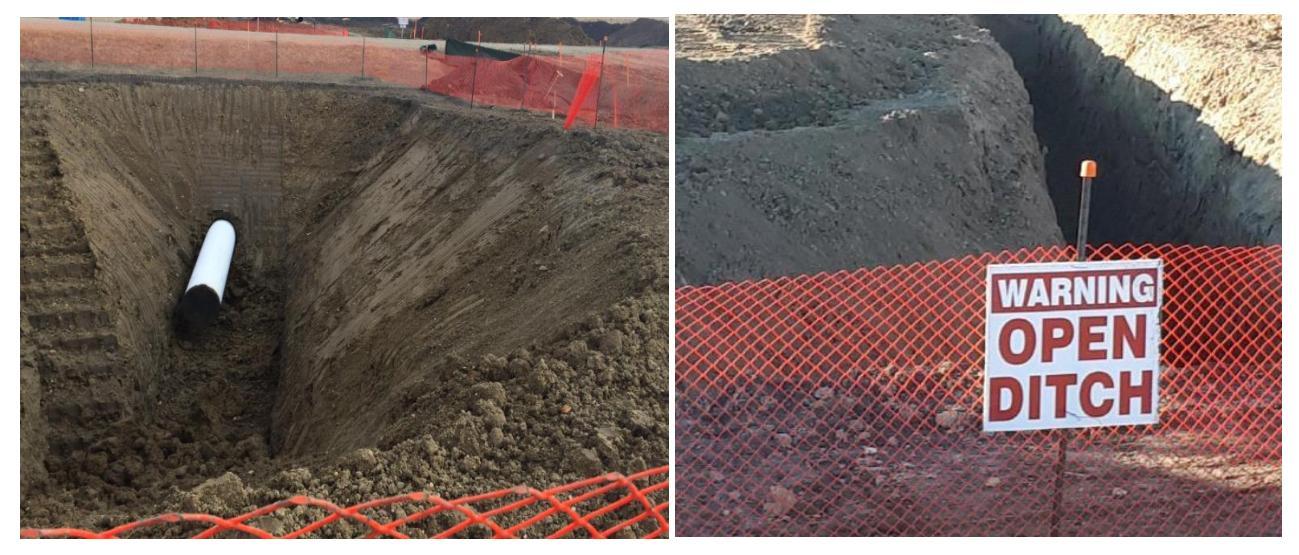
Observed bore pits excavated at entry crossings on both sides of the shoo fly road entries (bar ditch) and exit (tail ditch) for 36" heavy wall pipe to be bored under. Each excavation has a bell hole for the welders to do tie ins. All excavations completed had a snow fence put up around it with Warning Open Ditch signage. The side boom lowers the pipe with cradles in the bar ditch and the bore machine hooks up to the pull head, joining to the pipe and pulls the pipe through the bore hole under the road. Half section of the pipe is left exposed on either side ready for tie ins. Pipe bending was completed for areas that required side bends, sags, sag bends and over bends to maintain contour of the land and curves of the right of way.

748 + 737 Bore pit excavation for road crossing

691 + 580 Bore bay and tail ditch excavation

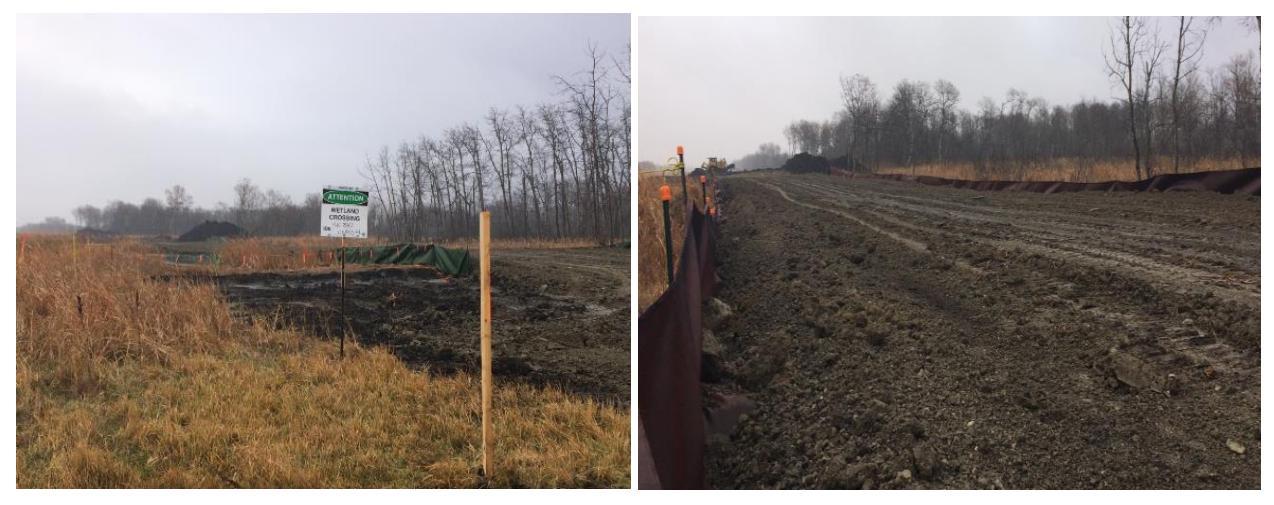
Our team walked the right of way at 740 + 101 to observe the wetland ramps and stripping around the rare plants. Fencing was put up between the ROW between wetland area and rare plants.SK 847 and SK 849 ramps were completed with Geo textile and clay and completed with wing walls. Dozer continued to push soil into windrow piles along the south side. The topsoil that was stripped from the wetlands were moved into separate piles and marked with stakes.

740 + 101 Ramp built over wetland crossings SK 847 an SK 849

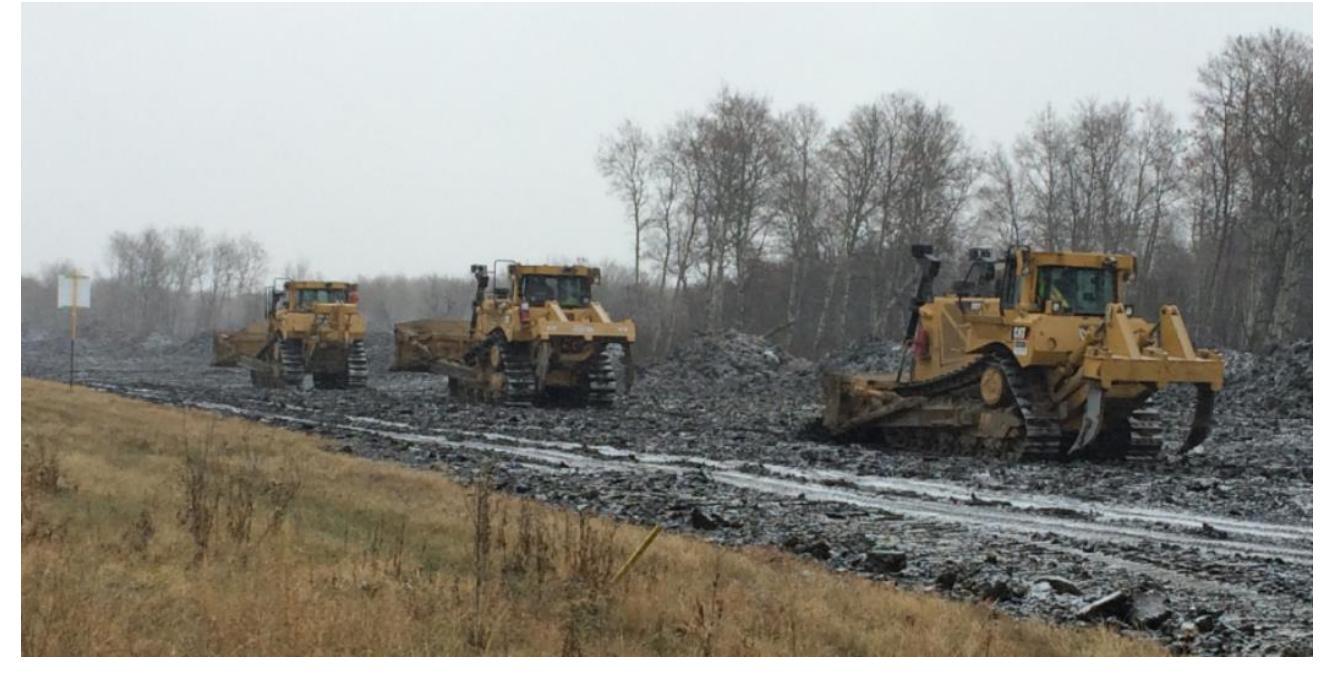
741 + 779 Dozers travelling on right of way to work location

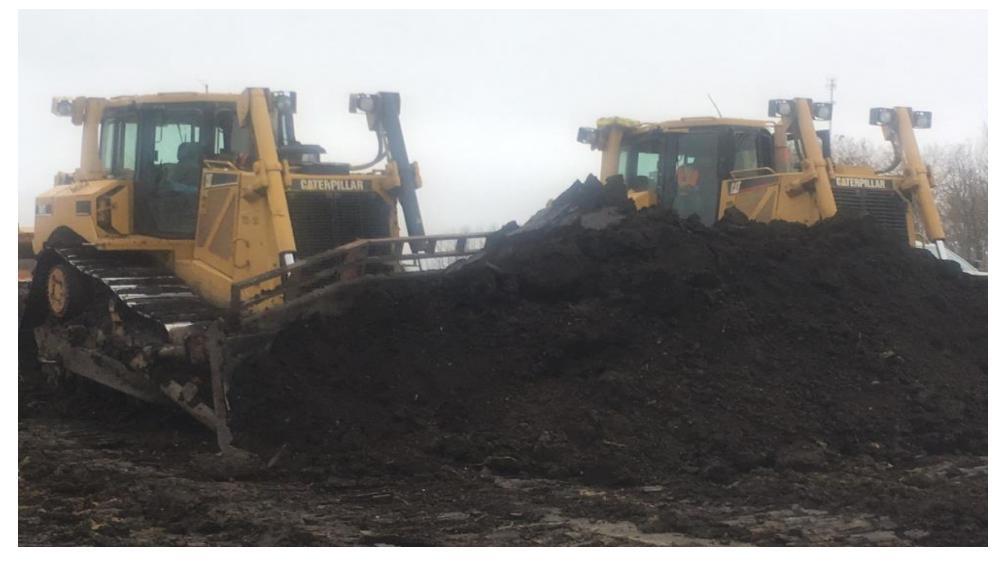
784 + 842 Dozers tandem pushing Stripping to windrow
