SGS MUSCOWPETUNG

ABORIGINAL CONSTRUCTION MONITORING

WEEKLY REPORT

SPREAD 6

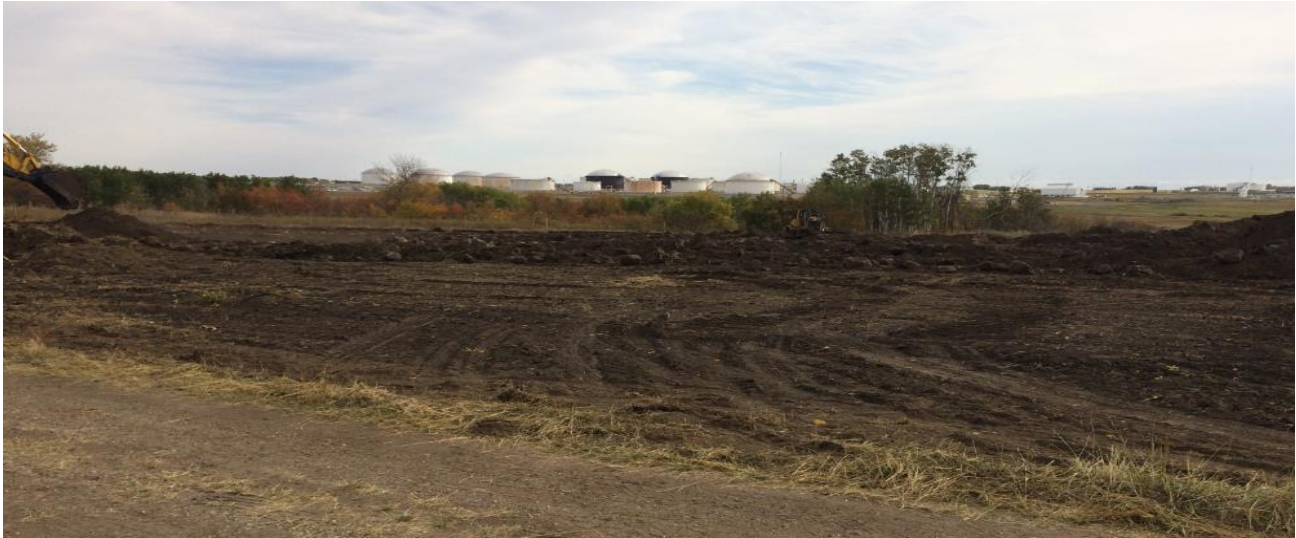
West side of Pipestone Creek Clearing for Laydown area.

This week our team monitored at Pipestone Creek, 805 + 200 to 805 + 350. On the west side, the area was hand slashes mowed then disked and stripped dozers continue to push soil into piles, separating the larger boulders and rocks up to the rare plants buffers at 805 + 596. The rare plants VG 77 Golden Bean VG 76 Pincushion Beardtongue and VG 75 Shining leaved arnica are, clearly staked and marked. Crews put up buffers on both sides of the Creek for the leopard frogs. An area with a round rock formation was determined to be a tipi ring the area has been marked and staked. Further assessments determined an area of interest, all the rocks within the area have all been marked. On the East side of the Pipestone Creek we located the right of way area where the hydro vac will be done and further observed the slurry pits inside the fenced area.

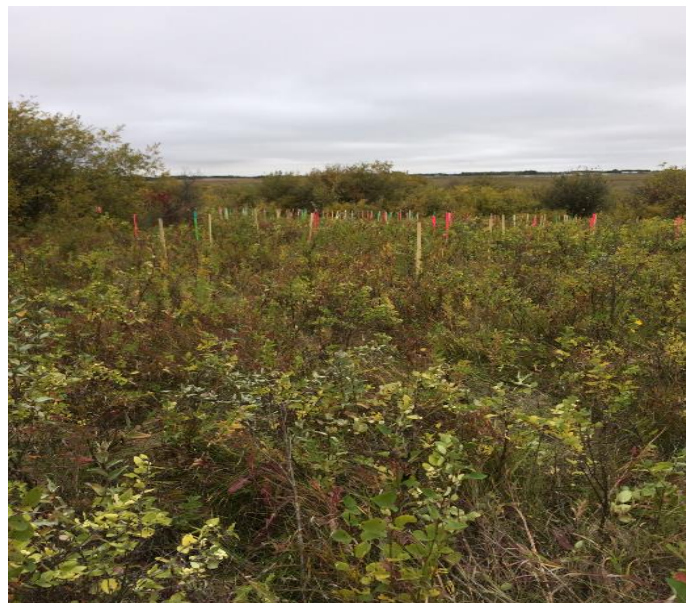
Pipestone Creek Rocks Marked

Field Observation	# of occurrences	Description and Mitigation Measures	Mitigation Status	Further Action Required (Yes/No)
Traditional Use Area (hunting, fishing, gathering, trapping)				
Rock Formations (rocks of significance, tipi rings, etc.)	1	805 + 300 Pipestone creek the rock circle (tipi ring) are staked and a buffer is put around the location and the Area of interest all the rocks have been marked and a buffer area has been out up.	The tipi ring rocks have been staked and a buffer is put around the location	Monitoring
Artifacts				
Bones				
Potential Gravesites

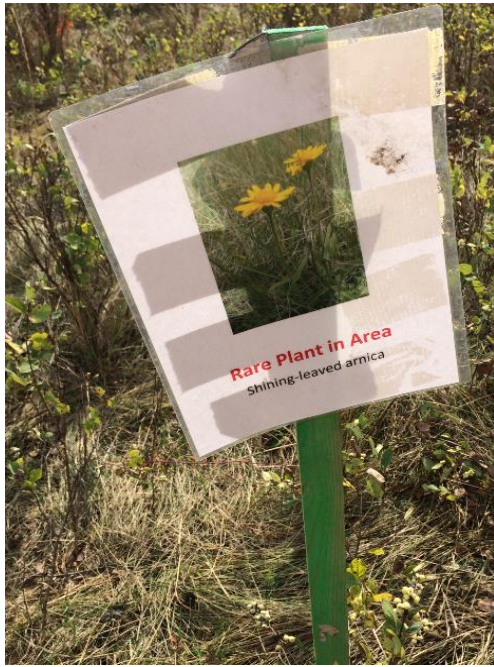
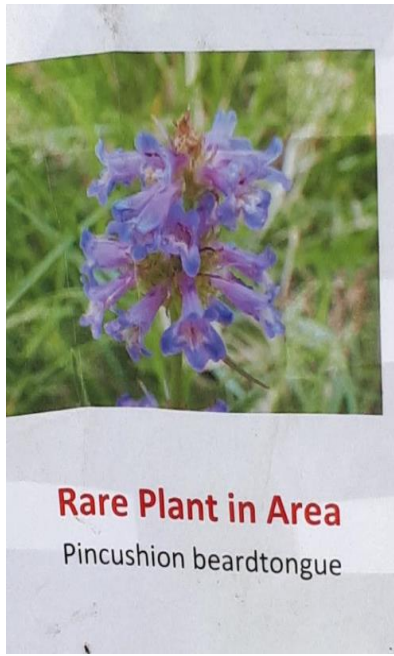
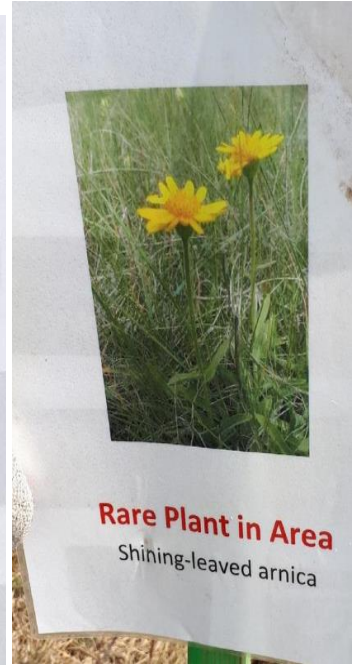
Pipestone Creek Rare plants on the west side

Field Observation	# of occurrences	Description and Mitigation Measures	Mitigation Status	Further Action Required (Yes/No)
Medicinal or Cultural Plants	3	VG 75 Shining leaved arnica VG 76 Pincushion Beardtongue VG 77 Golden Bean	Buffer around the area and proper signage	Yes / Will continue to monitor at various stages of construction
