SGS MUSCOWPETUNG

ABORIGINAL CONSTRUCTION MONITORING

WEEKLY REPORT

SPREAD 3

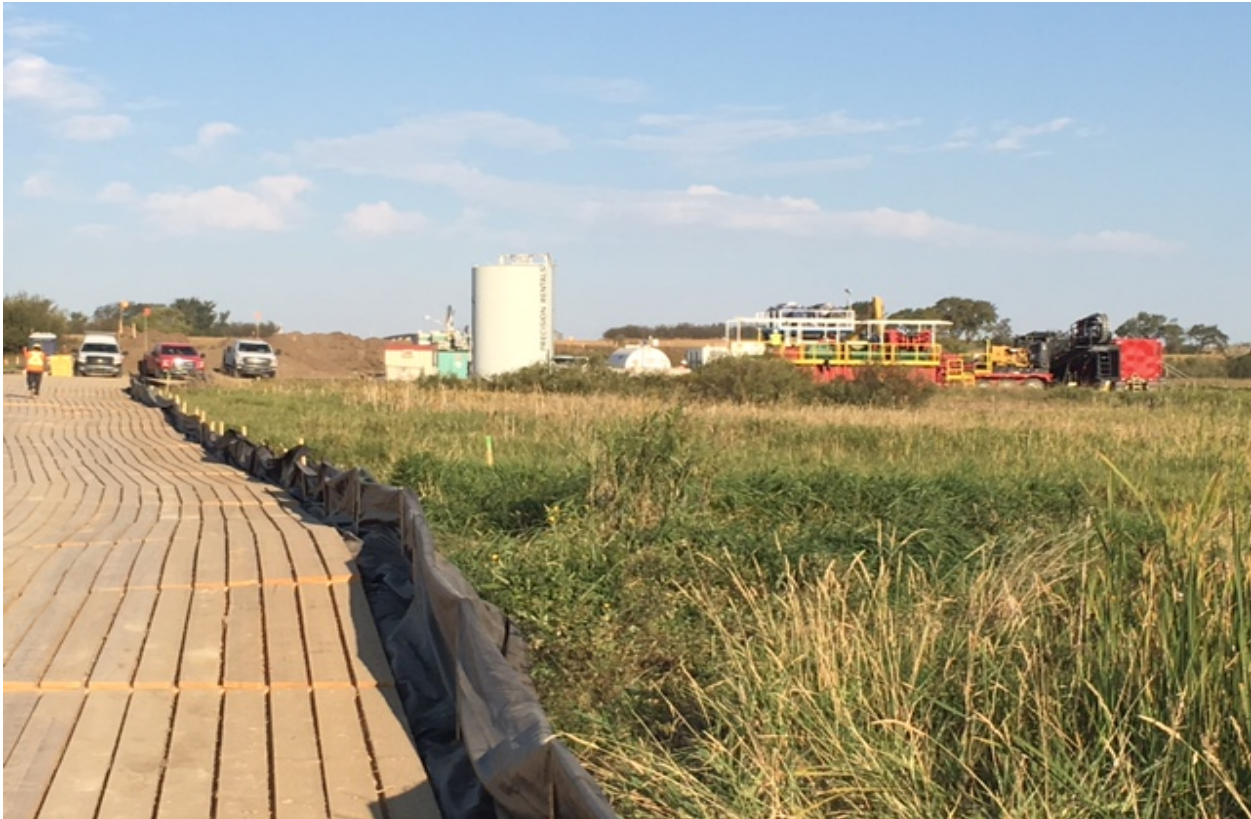
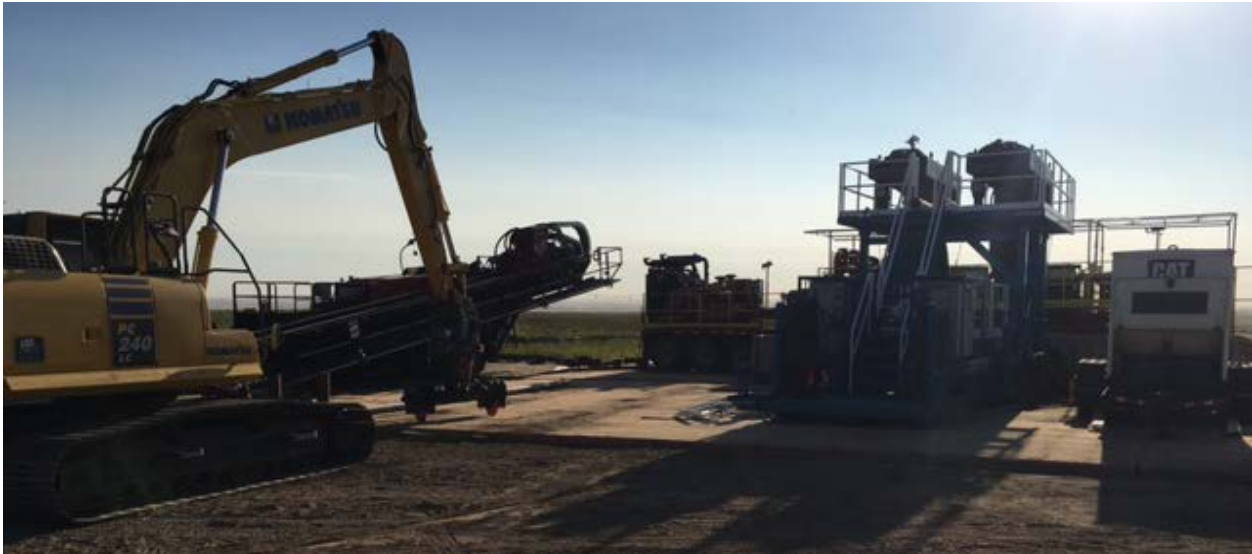
This week's construction started on Rd. 34 KP 330+778 WM1 canal, The pipeline crew completed building a ramp for wetland area and getting equipment ready for drilling underneath canal. The rig mats have been placed to the left of the wetland area and the drilling equipment is also on the other side of wetland. The pipeline crew will be Stripping top soil from wetland area to have workspace for when the pipe needs to be placed.

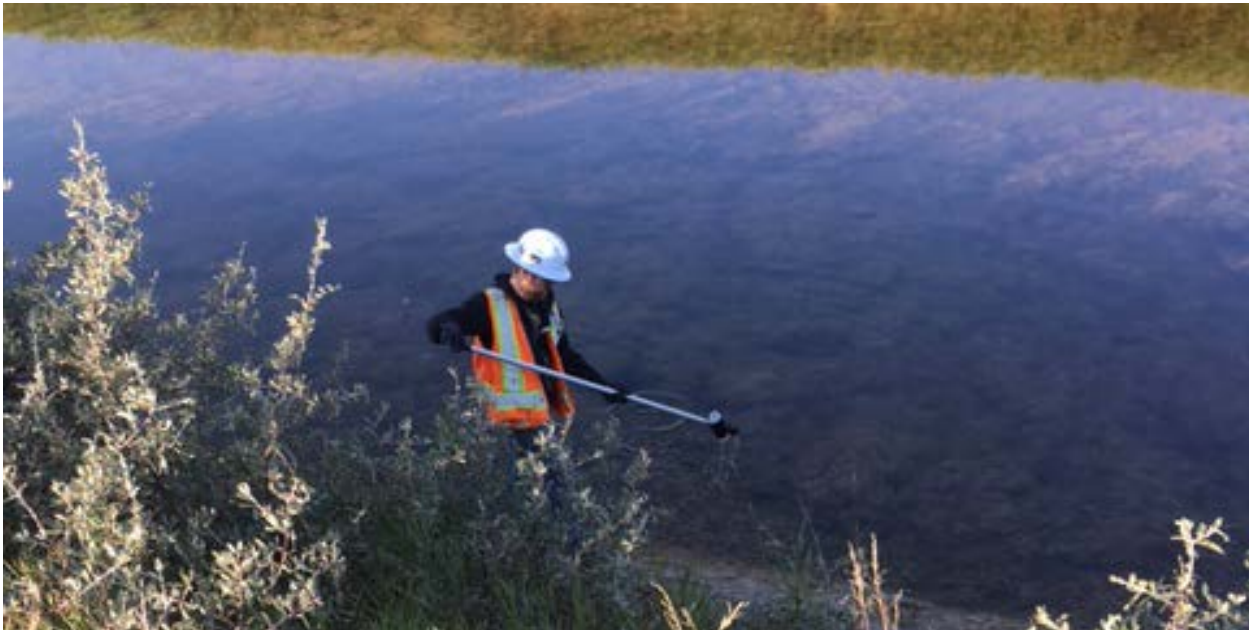
Water testing and water monitoring is taking place at this location, every 100m the pipeline crew have monitors downstream. This way they if there was to be an incident where drilling mud is released into the canal the crews would know right away and be able to respond. Water samples are collected every few hours and turbidity levels are documented.
