SGS MUSCOWPETUNG

ABORIGINAL CONSTRUCTION MONITORING

WEEKLY REPORT

FEBRUARY 18TH TO FEBRUARY 24TH, 2019

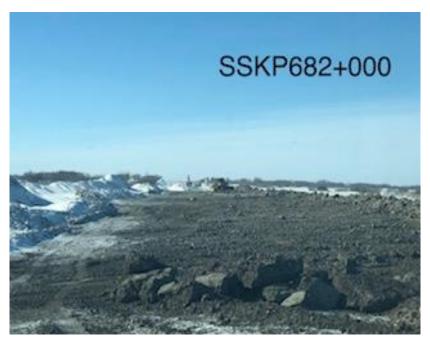
Machine clean up on the right of way

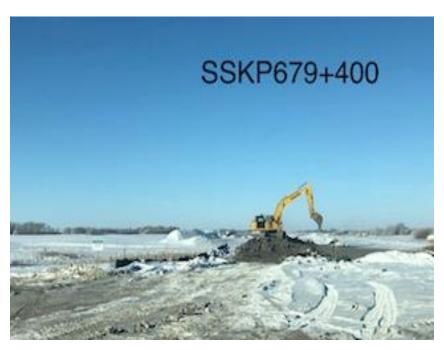
Wet Land crossing ramp removal SK646

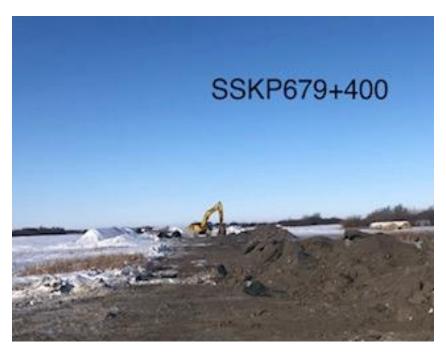
Wet land crossing SK642 ramp access removal

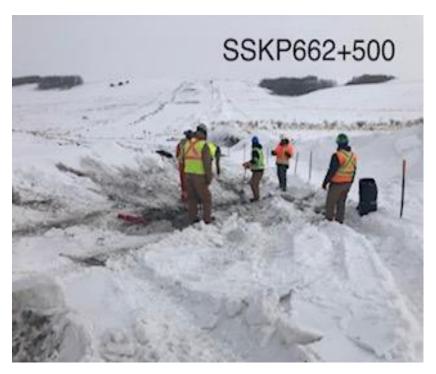
done for sediment control for spring mitigation. On Thursday crews also completed the silt

fence installation at water course crossing Vipond Creek SK WC72 SSKP662.52 and wet

land crossing SK584 SSKP662.39-SSKP662.6 crews used a skid steer with a ditch-witch

attachment to excavate a 6-inch trench line and the workers installed the silt fence on the

west slope of the area.

Silt fence installation at water crossing Vipond Creek SK WC72

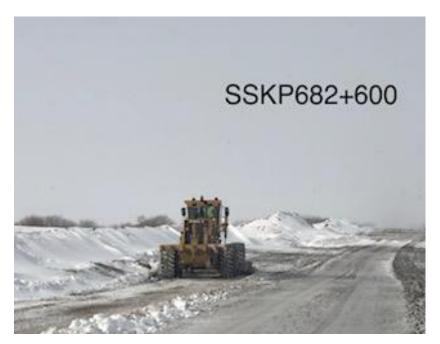
The end of the week, spread 5 machine clean was completed, and the only outstanding item

Machine clean up completed on Spread 5 - grading the right of way

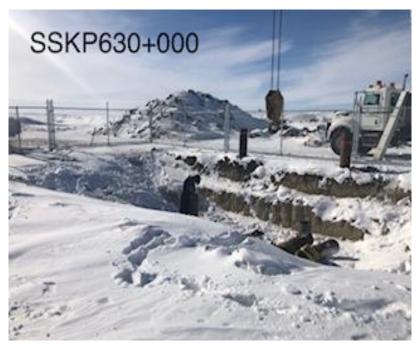
remaining is the MLBV16 valve site, 2 piles were welded in the pit and once that process

was done the welds were tested and approved. Backfill of this MLBV16 valve site will be

MLBV16 welding extension piles at the valve site

carried out the following week.
