SGS MUSCOWPETUNG

ABORIGINAL CONSTRUCTION MONITORING

WEEKLY REPORT

SPREAD 5

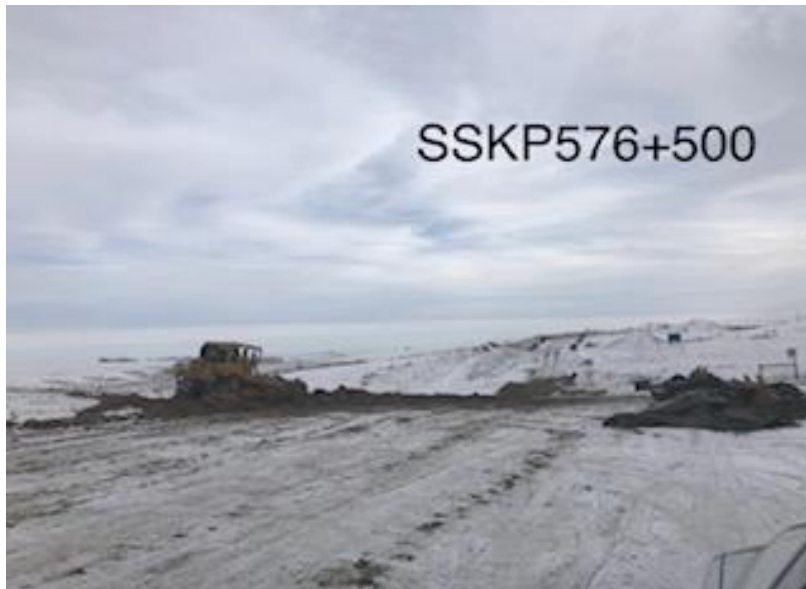
Building berm diversion west side of Kronau Creek SK WC63

Water Course Crossing Kronau Creek SK WC63 SSKP576.6 An excavator was building up the berm on the west side of the creek hillside an oiler was assisting the operator. The operator created a secondary berm for the spring runoff so it would not affect the water course crossing feature. An excavator along and crew members created a 6-inch trench on the west side at the toe of the slope and labourers put up a silt fence - the fence catches sediment that washes down slopes and keeps it from settling in waterways, typically helps short term effects of erosion, the removed dirt was reserved.

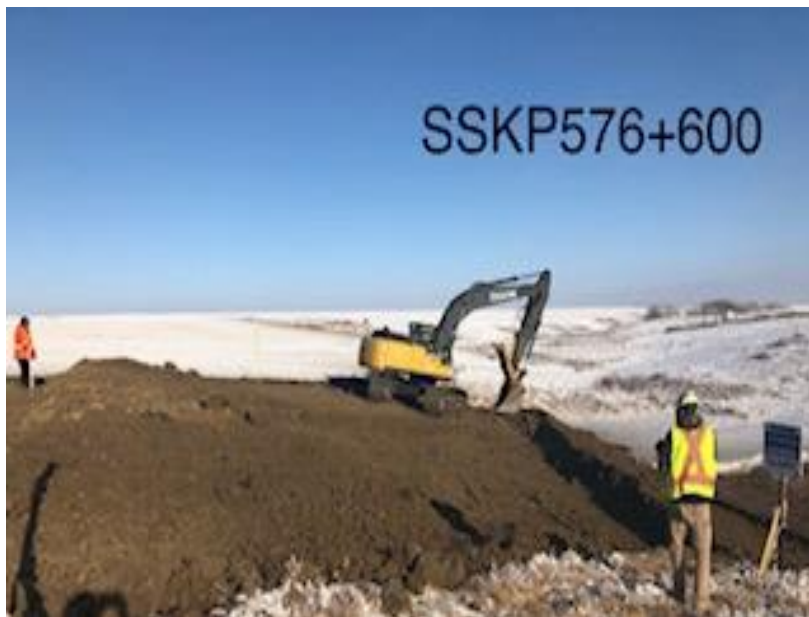
Secondary berm installed at Kronau Creek

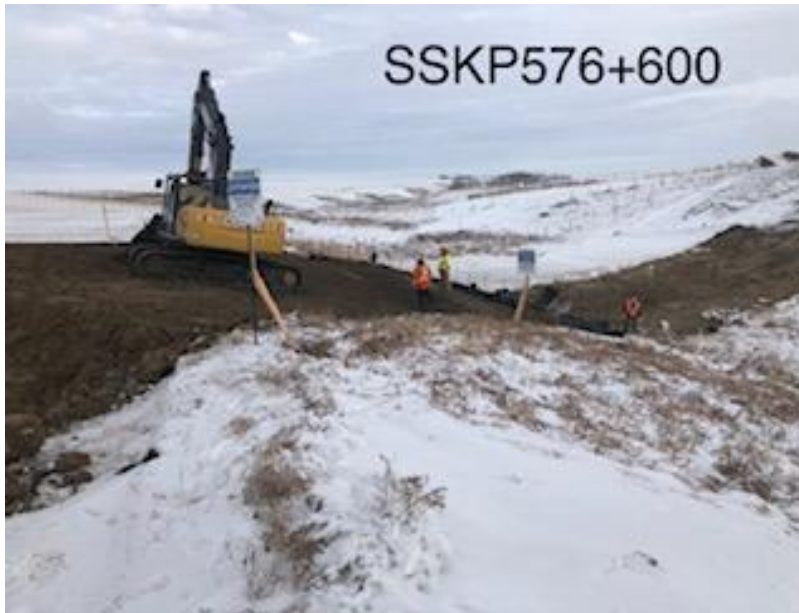
Berms completed West side of Kronau Creek

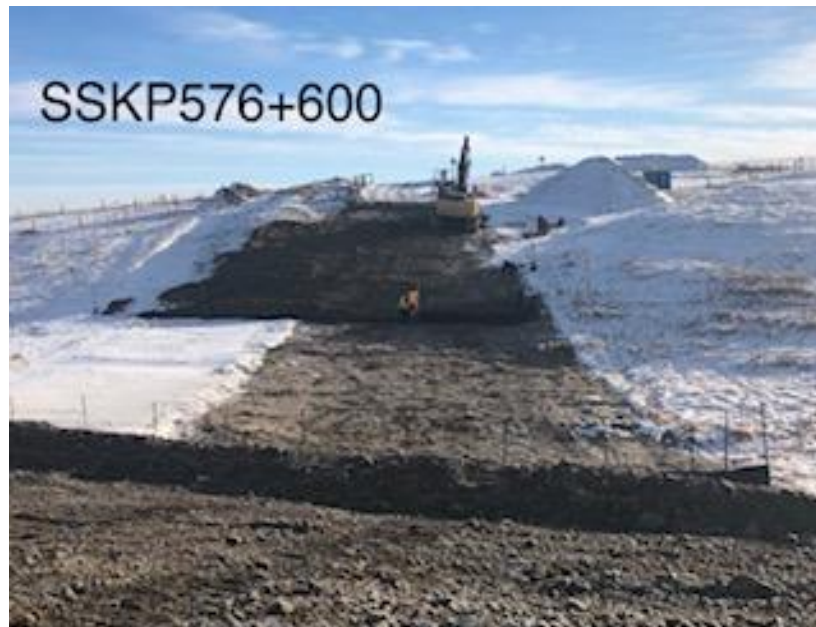
Banister work continues east side of Kronau Creek

Banister crews started working on the east side of the creek scraping the area that would be used as diversion berms and used the excavator to create a fence line which the labourers put up T-bars and silt fence on the bottom of the hill with the use of a spotter during this task. The operator continued to build the diversion berms closer to the top of the hill, Banister crew finished on the east side of the creek creating a diversion berm on the top of the east hillside top, Kronau Creek spring mitigation clean-up was completed on Friday. No concerns with the crews, they were great and did an excellent job!

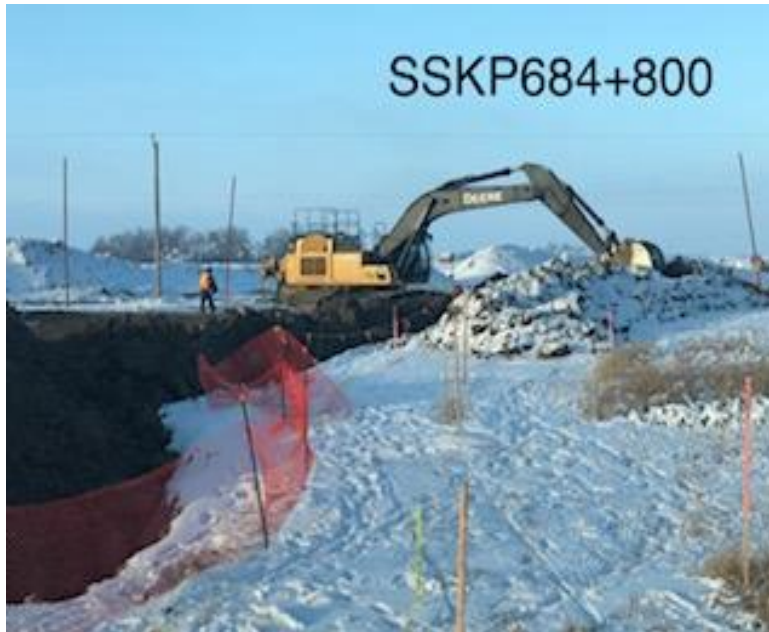
Backfill process completed on spread 5

The backfill process was completed on spread 5 Tuesday, SSKP684+830- Banister crews were on the west side of the road, backfilling the mainline ditch near overhead power lines- the operator was assisted by an oiler when he passed under the overhead power lines which were clearly visible as well as signs in the area. Once completed the backfilling in the mainline trench area and levelling the Right of Way, the equipment crossed over to the east side of the road - flaggers and signs were used to direct traffic in the area.

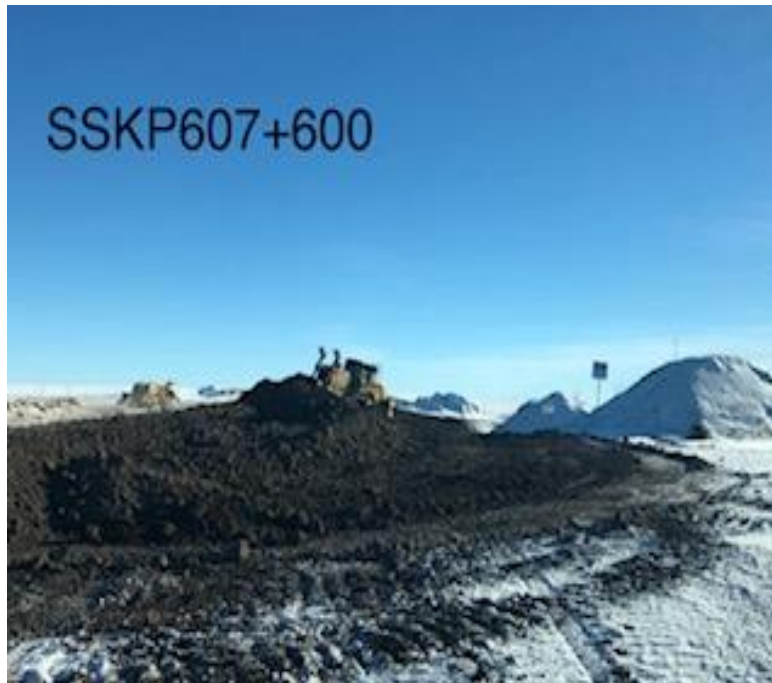
Clean up at Heritage Resource HER128

At end of the week, monitored clean up at SSKP607+000 Banister crews continued the clean up on the east side of the road passed the high voltage area, levelling the right of way going east through a Heritage Resource area HER128 SSKP607.21-SSKP607.45 & Wet land crossing SK472 SSKP606.75-SSKP607.46 another crew was clearing the right of way moving subsoil and levelling near Heritage Resource & TLU HER129 SSKP607.67-SSKP607.90 & Wet Land Crossing SK473 SSKP607.68-SSKP607.76 and up to wet land crossing SK474 which is located west side of SF42, will follow up in these areas before holidays!
