Line 5 Wisconsin Segment Relocation Project

Water Resources Application for Project Permits

EIR Attachment N

Stream Restoration Typical

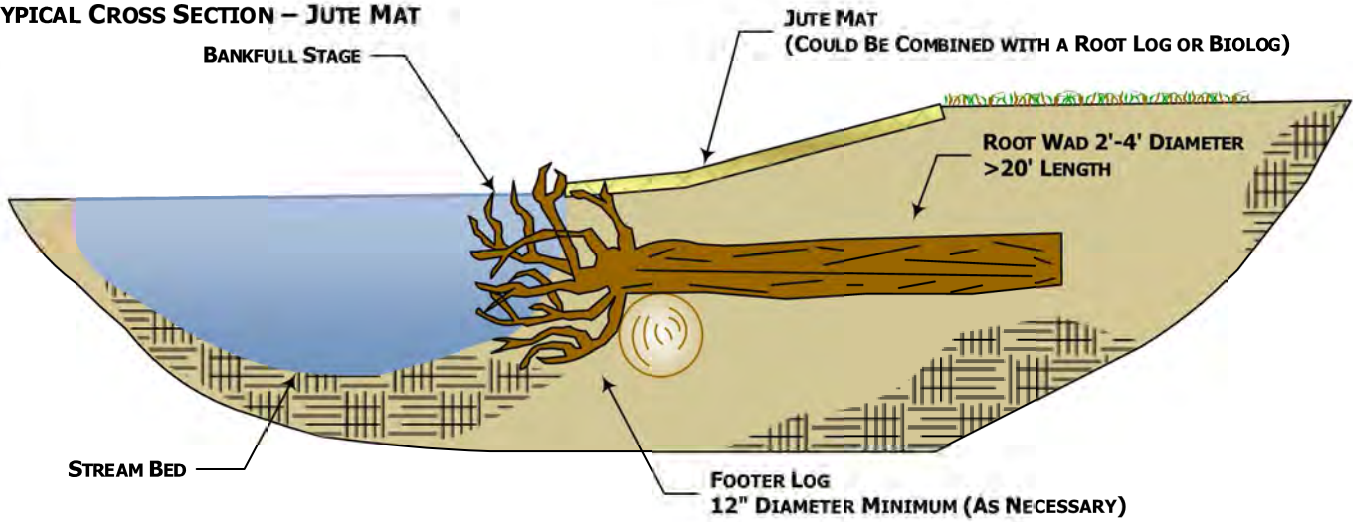
TYPICAL CROSS SECTION – JUTE MAT

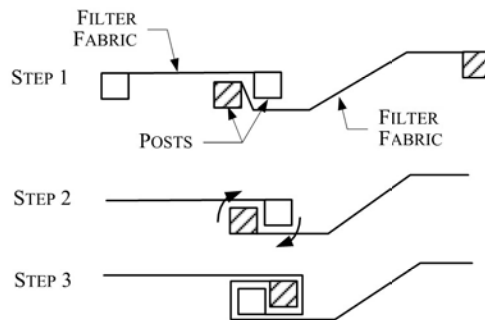
ATTACHING TWO SILT FENCES

1. PLACE THE END POST OF THE SECOND FENCE INSIDE THE END POST OF THE FIRST FENCE.
2. ROTATE BOTH POSTS AT LEAST 180 DEGREES IN A CLOCKWISE DIRECTION TO CREATE A TIGHT SEAL WITH THE FABRIC MATERIAL.
3. DRIVE BOTH POSTS A MINIMUM OF 18 INCHES IN THE GROUND AND BURY THE FLAP.
