**Line 5 Wisconsin Segment Relocation Project**

**Enbridge Responses to DNR Information Request Dated March 10, 2023**

**Attachment 2**

**Enbridge Line 5 Wisconsin Segment Relocation Project**  
**Responses to U.S. Army Corps of Engineers Data Request dated December 9, 2022**  
**Regulatory File # 2020-00260-WMS**

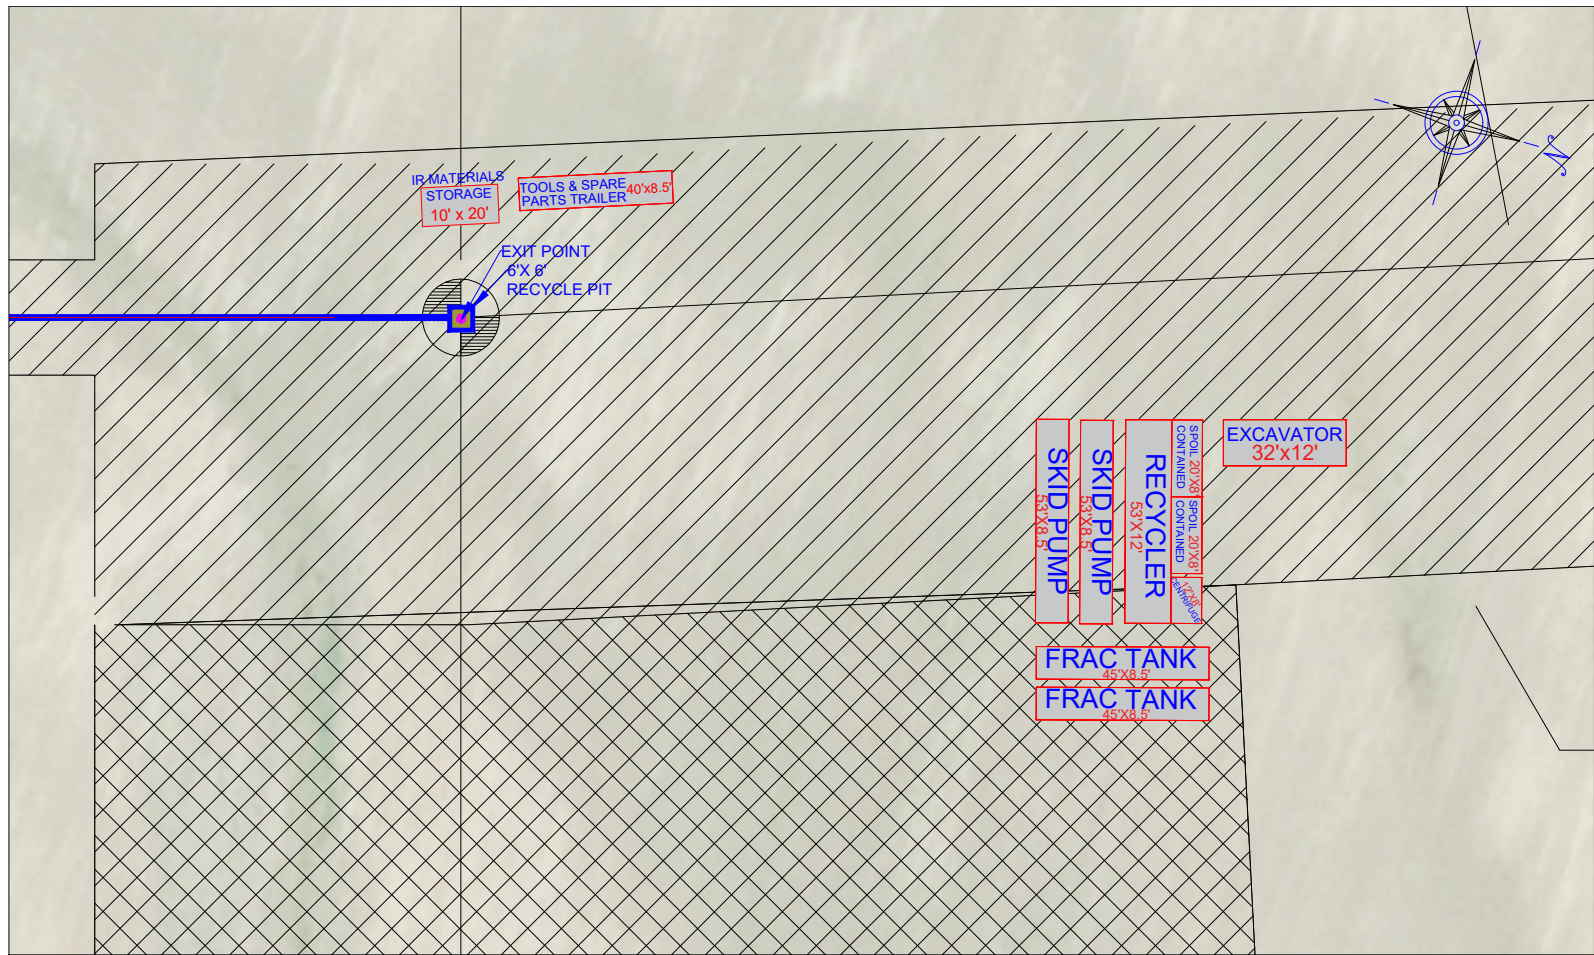
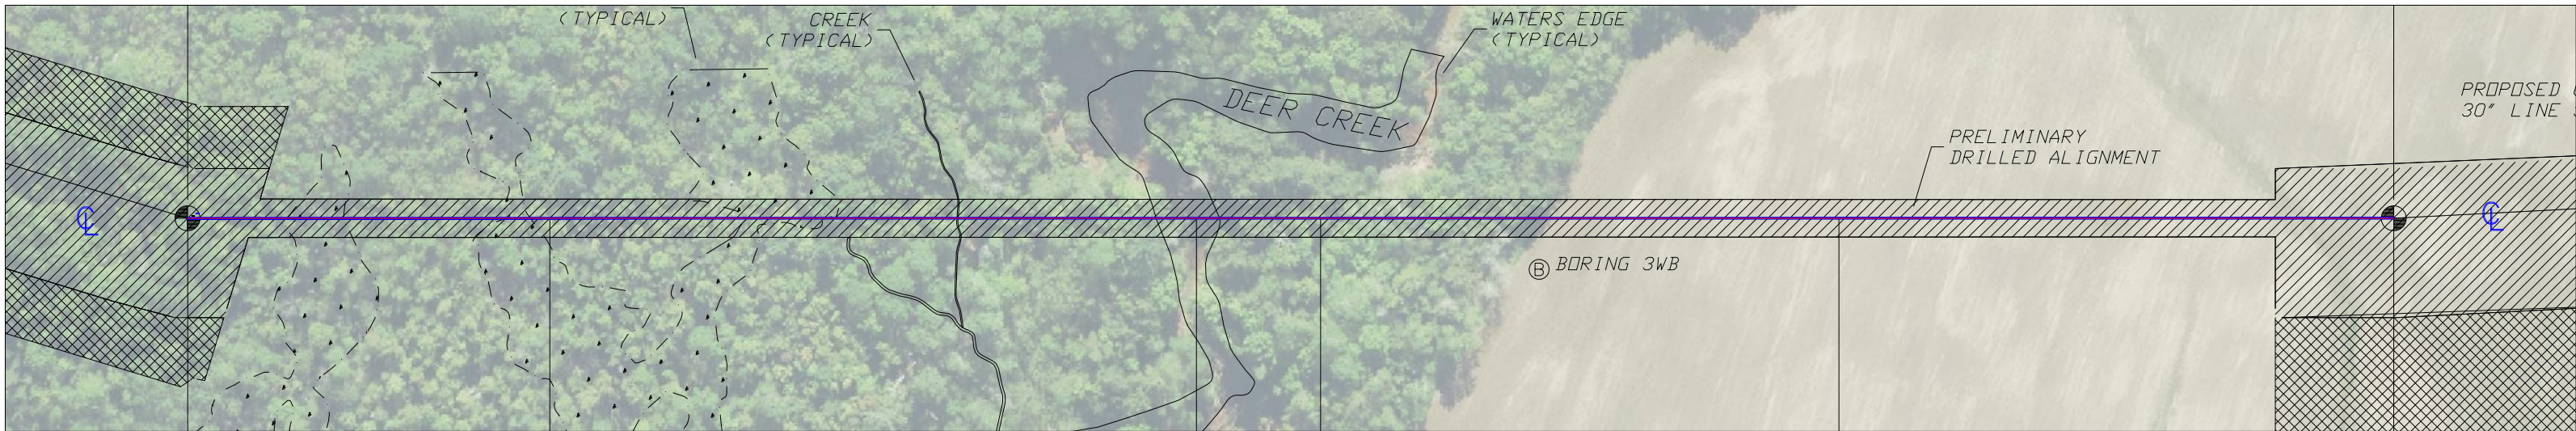
## EQUIPMENT AND CONTAINMENT SITE LAYOUT

1. EROSION CONTROL MEASURES TO BE IMPLEMENTED IN ACCORDANCE WITH EPP.
2. IN THE EVENT OF INADVERTENT RETURNS, CONSTRUCTION EFFORTS SHALL CEASE UNTIL PERMITTED BY ENBRIDGE.

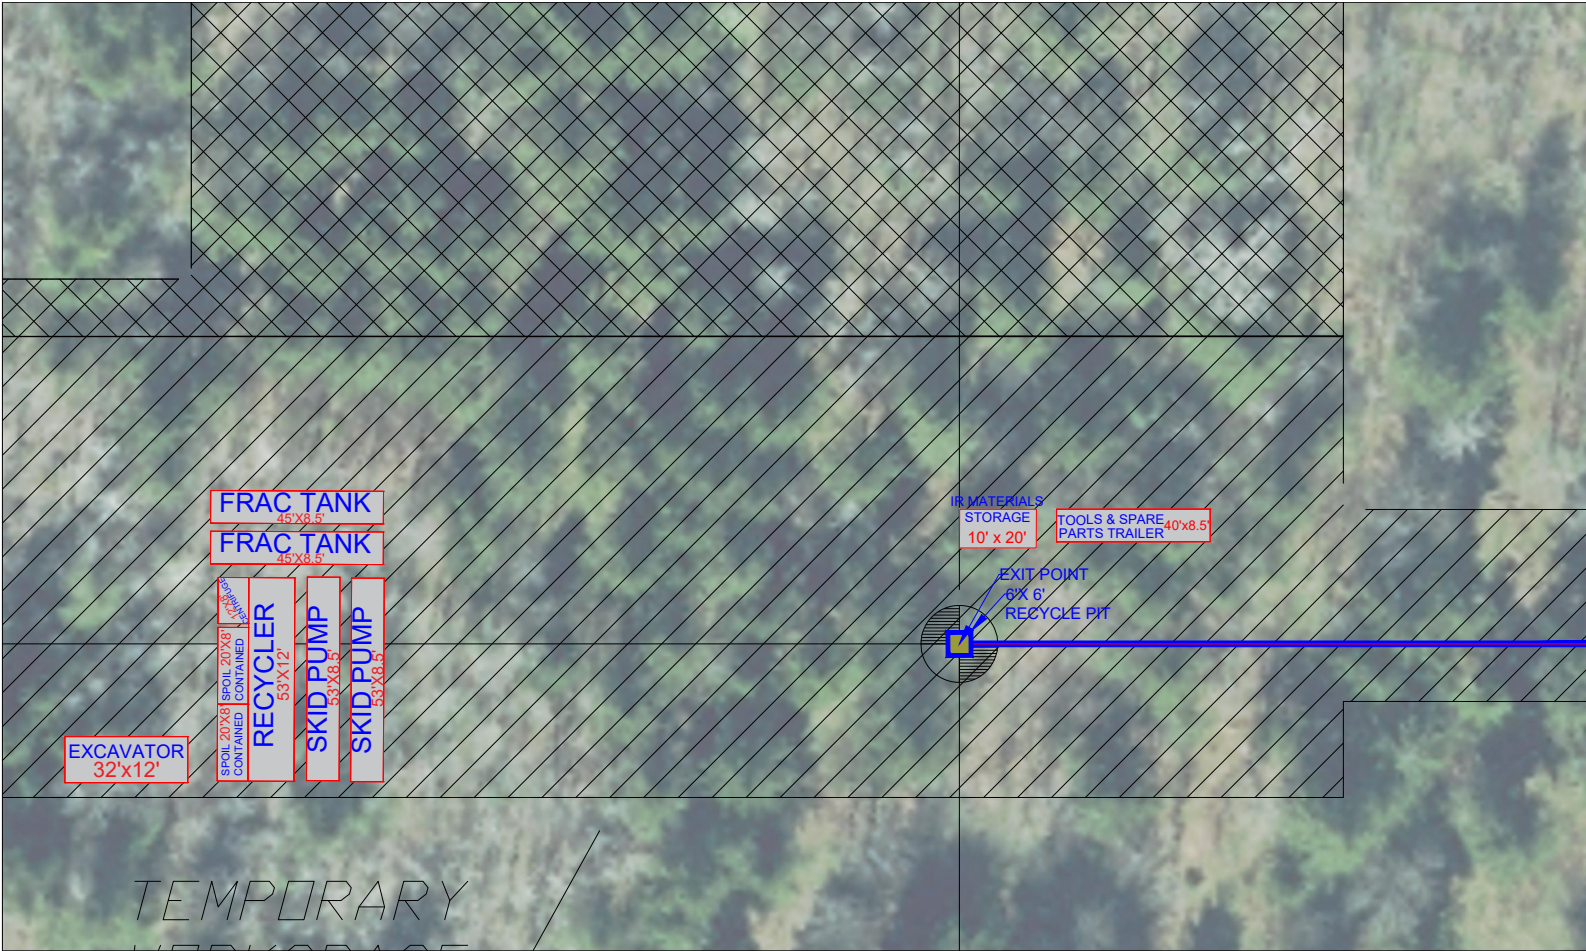
## EQUIPMENT AND CONTAINMENT SITE LAYOUT

PLAN  
SCALE: 1"=50'

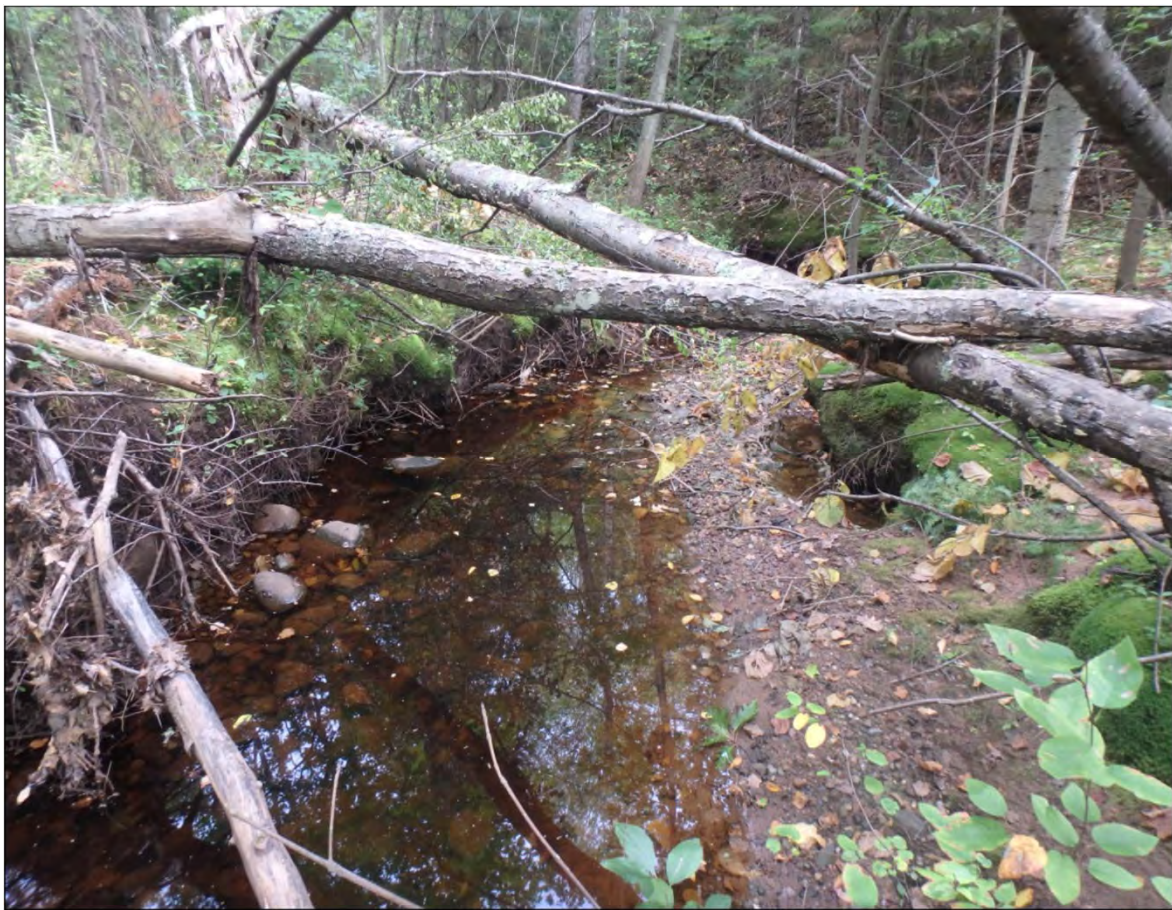
Sheet 1 of 13

Erosion and Sediment Control Plan  
Stream Crossing Profile Drawing  
Bay City Creek (sase006p)  
MP 0.6

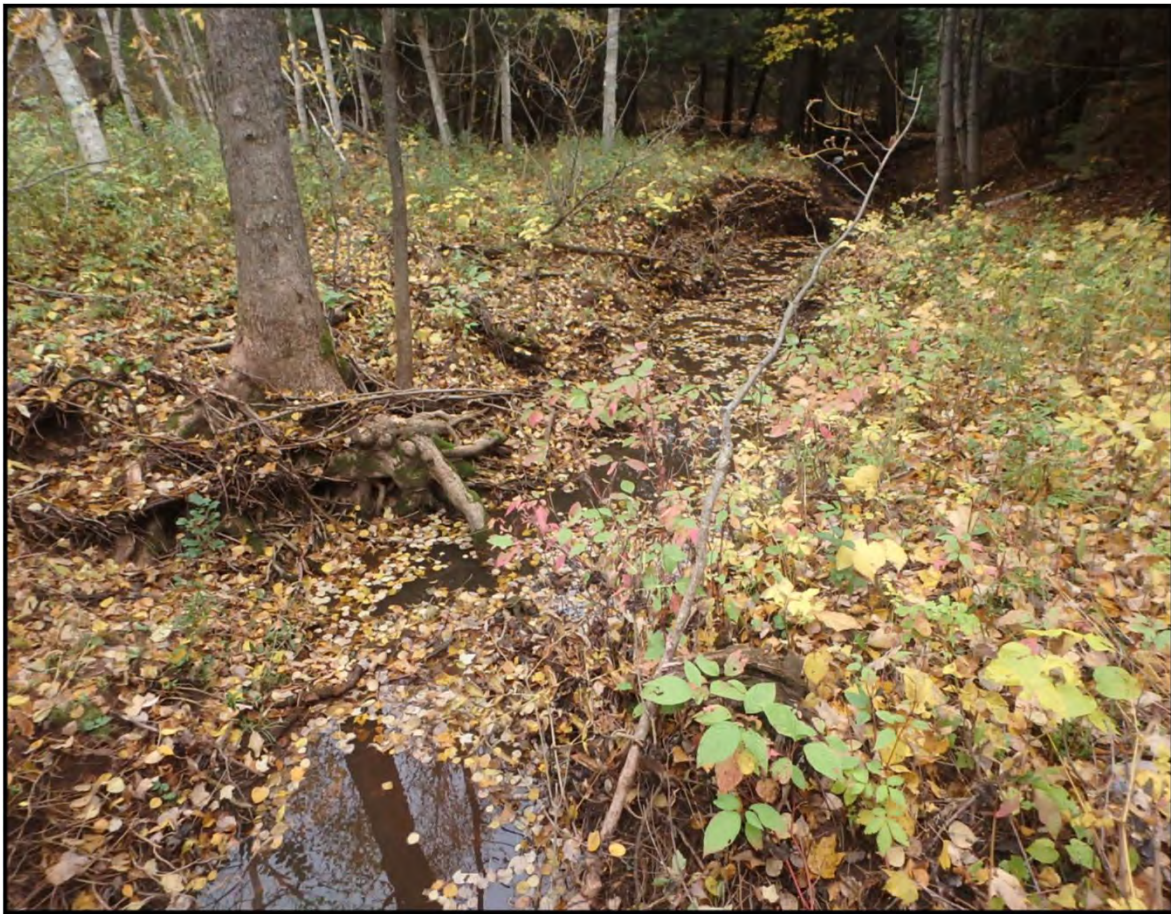
Sheet 2 of 13

Erosion and Sediment Control Plan  
Stream Crossing Profile Drawing  
Rock Creek (sasc041p)  
MP 5.1

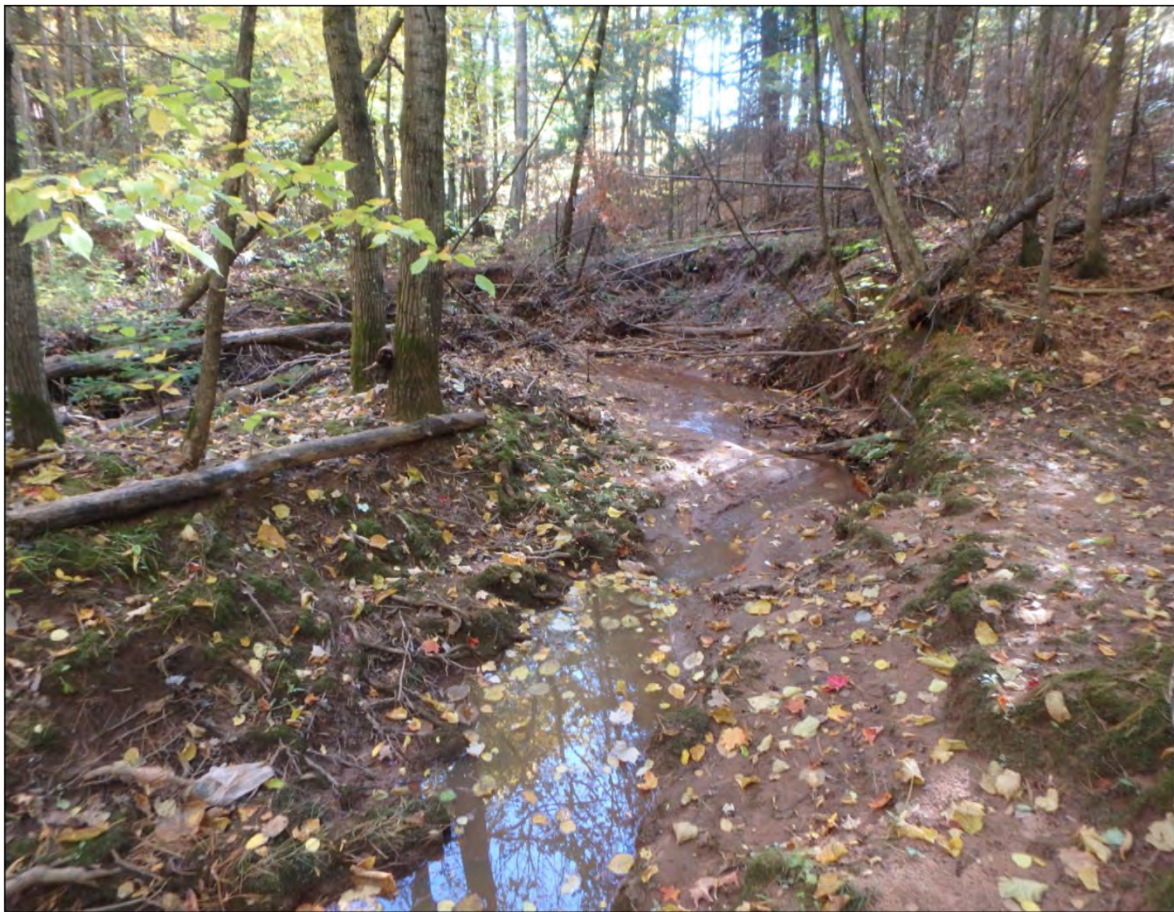
Sheet 3 of 13

Erosion and Sediment Control Plan  
Stream Crossing Profile Drawing  
UNT of Marengo River (sas011p)  
MP 8

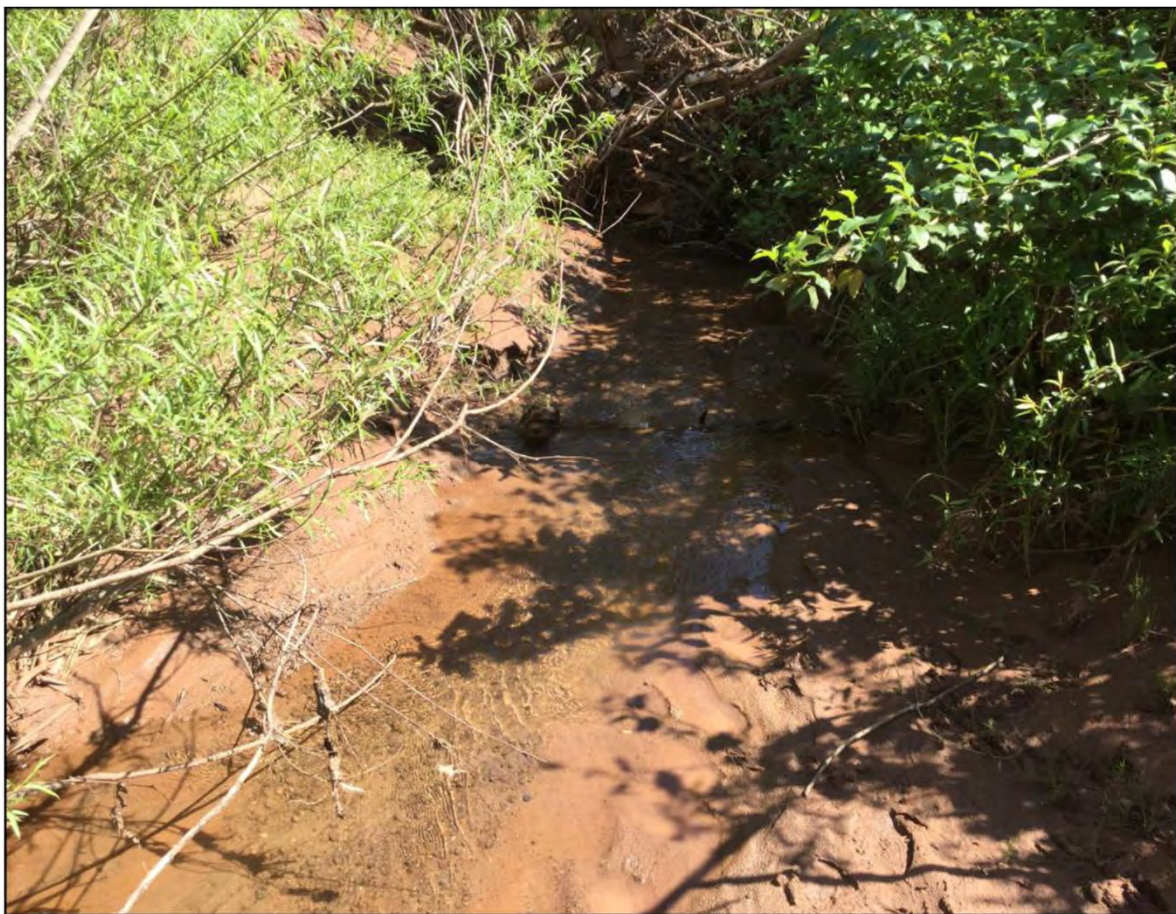
Sheet 4 of 13

Erosion and Sediment Control Plan  
Stream Crossing Profile Drawing  
UNT of Brunsweler River (sasc1006p)  
MP 14.7

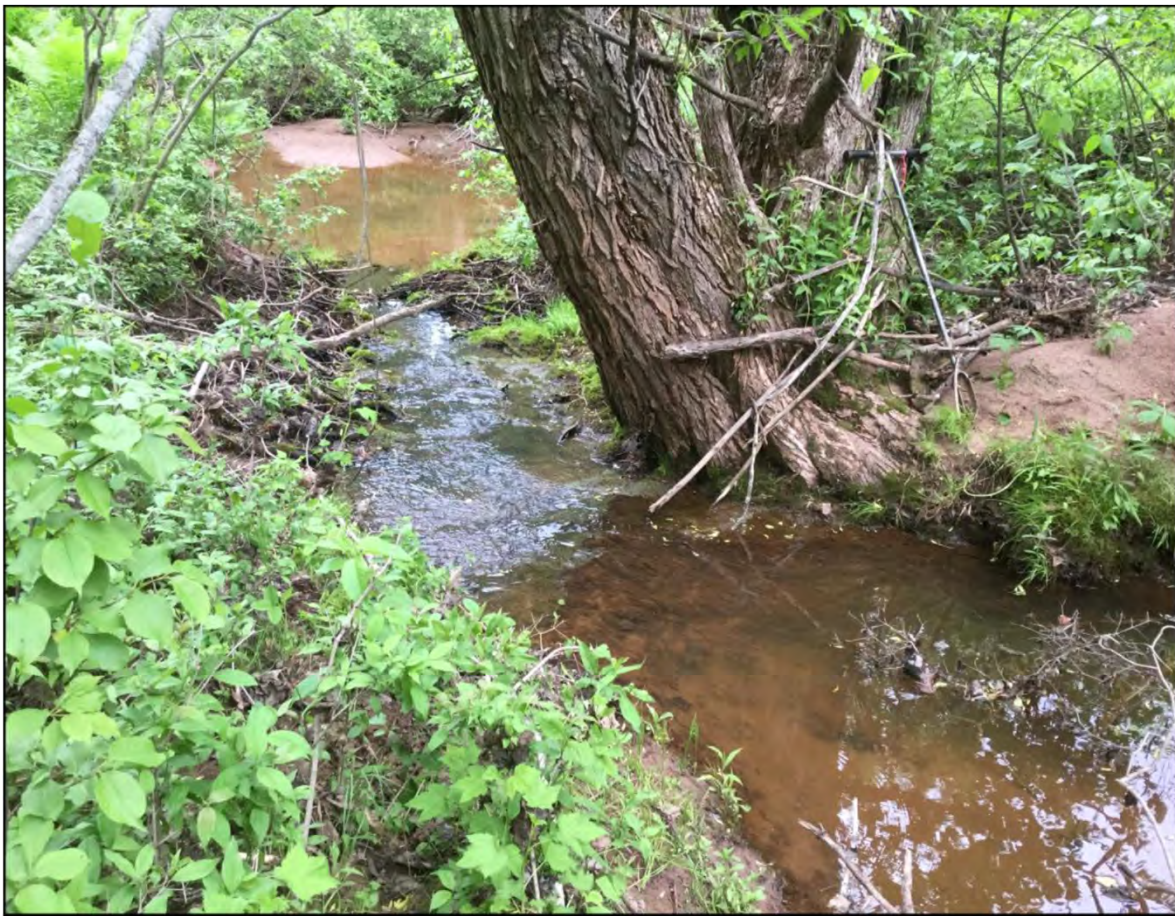
Sheet 5 of 13

Erosion and Sediment Control Plan  
Stream Crossing Profile Drawing  
UNT of Trout Brook (sasc1003p\_x1)  
MP 15.9

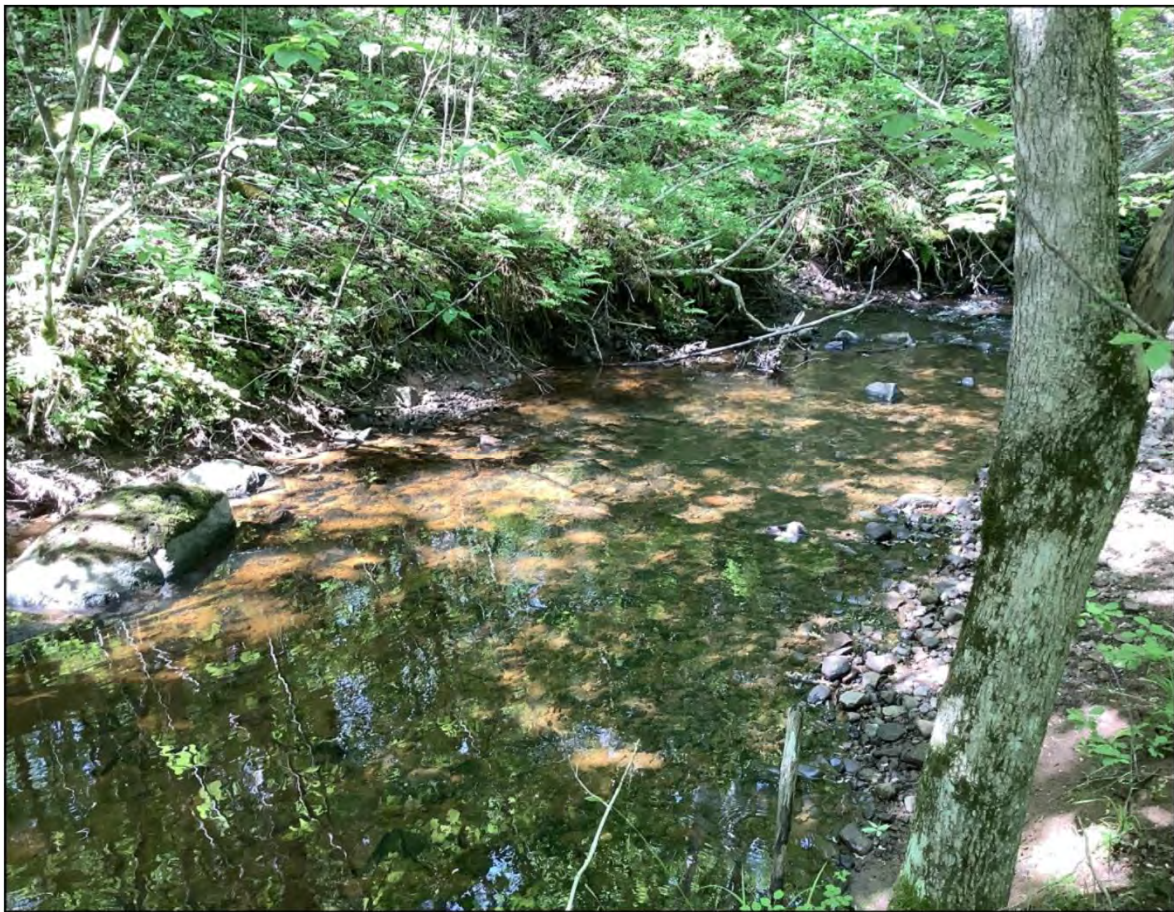
Sheet 6 of 13

Erosion and Sediment Control Plan  
Stream Crossing Profile Drawing  
UNT of Silver Creek (sasd1015p)  
MP 19.8

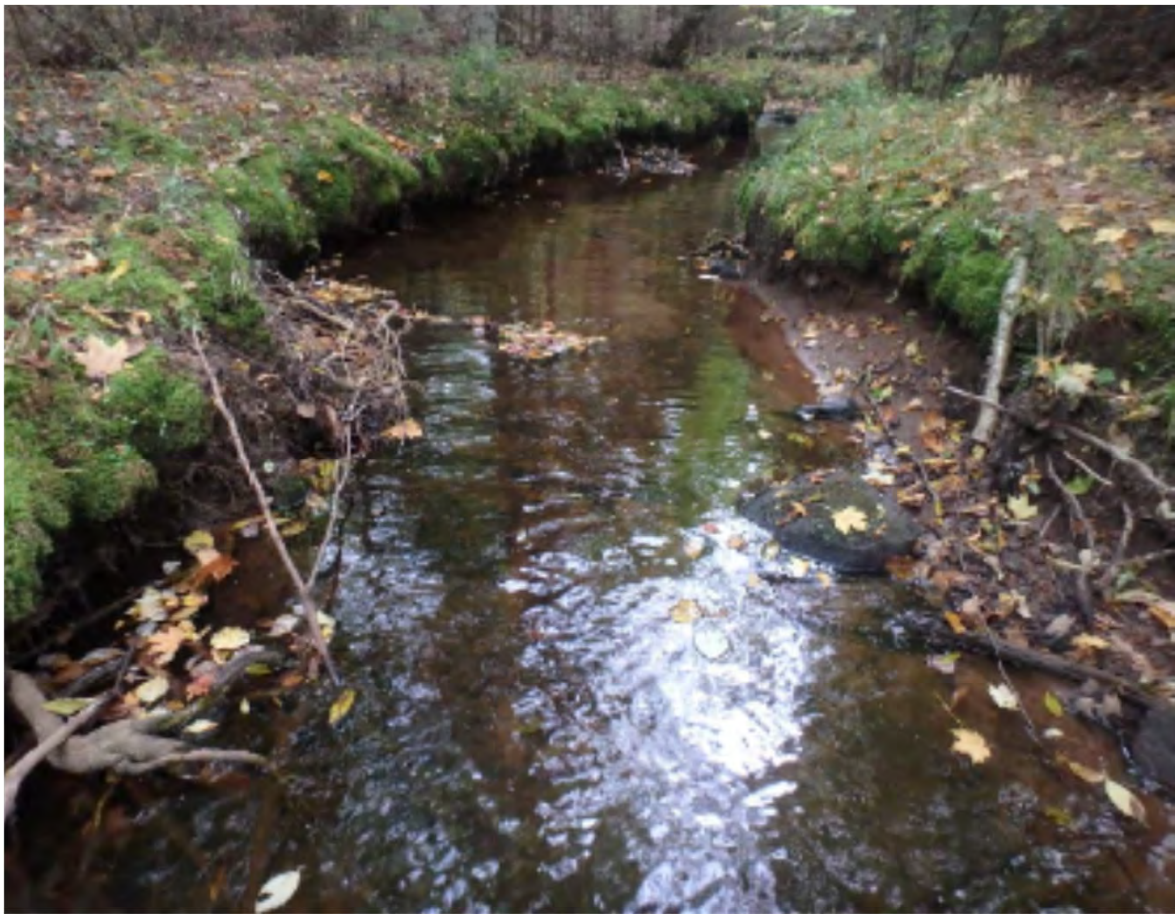
Sheet 7 of 13

Erosion and Sediment Control Plan  
Stream Crossing Profile Drawing  
UNT of Silver Creek (sase005p\_x2)  
MP 20.6

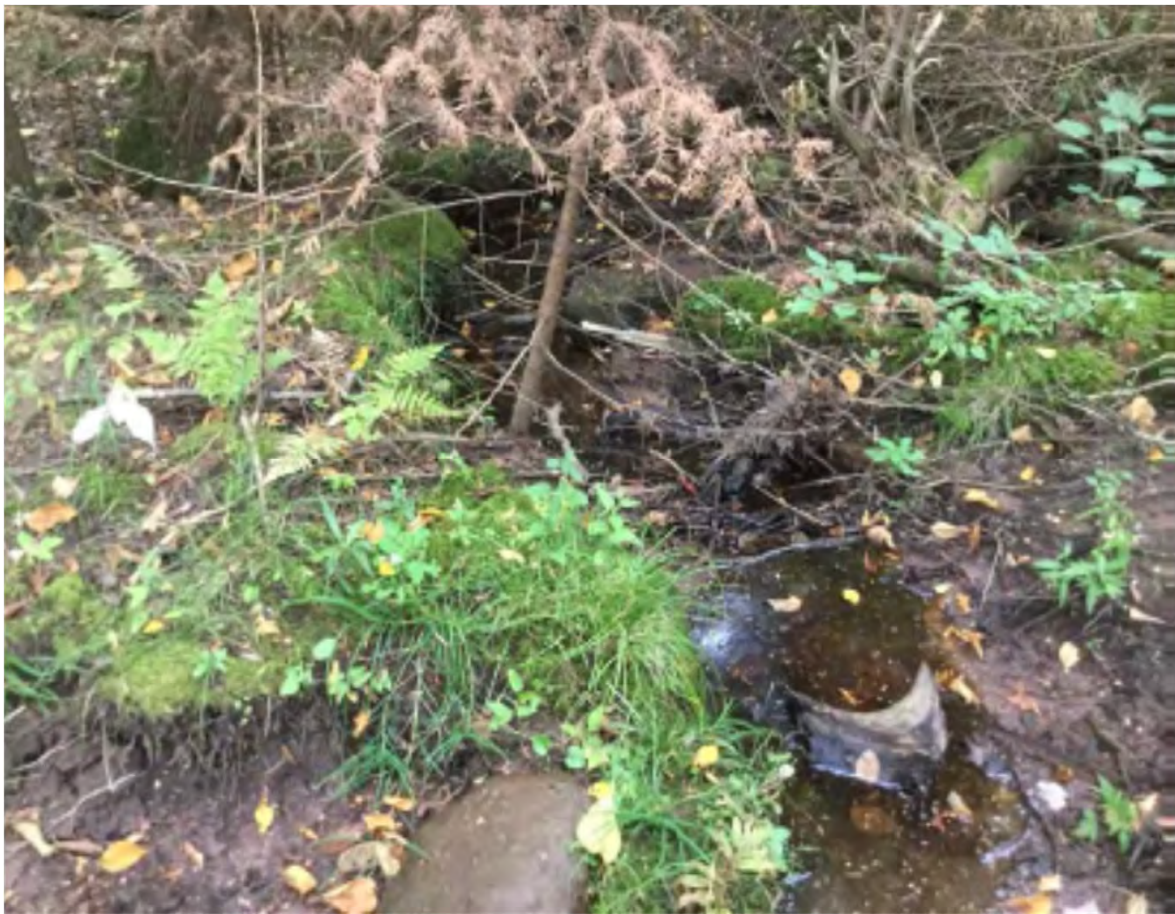
Sheet 8 of 13

Erosion and Sediment Control Plan  
Stream Crossing Profile Drawing  
UNT of Silver Creek (sasv004p)  
MP 21.3

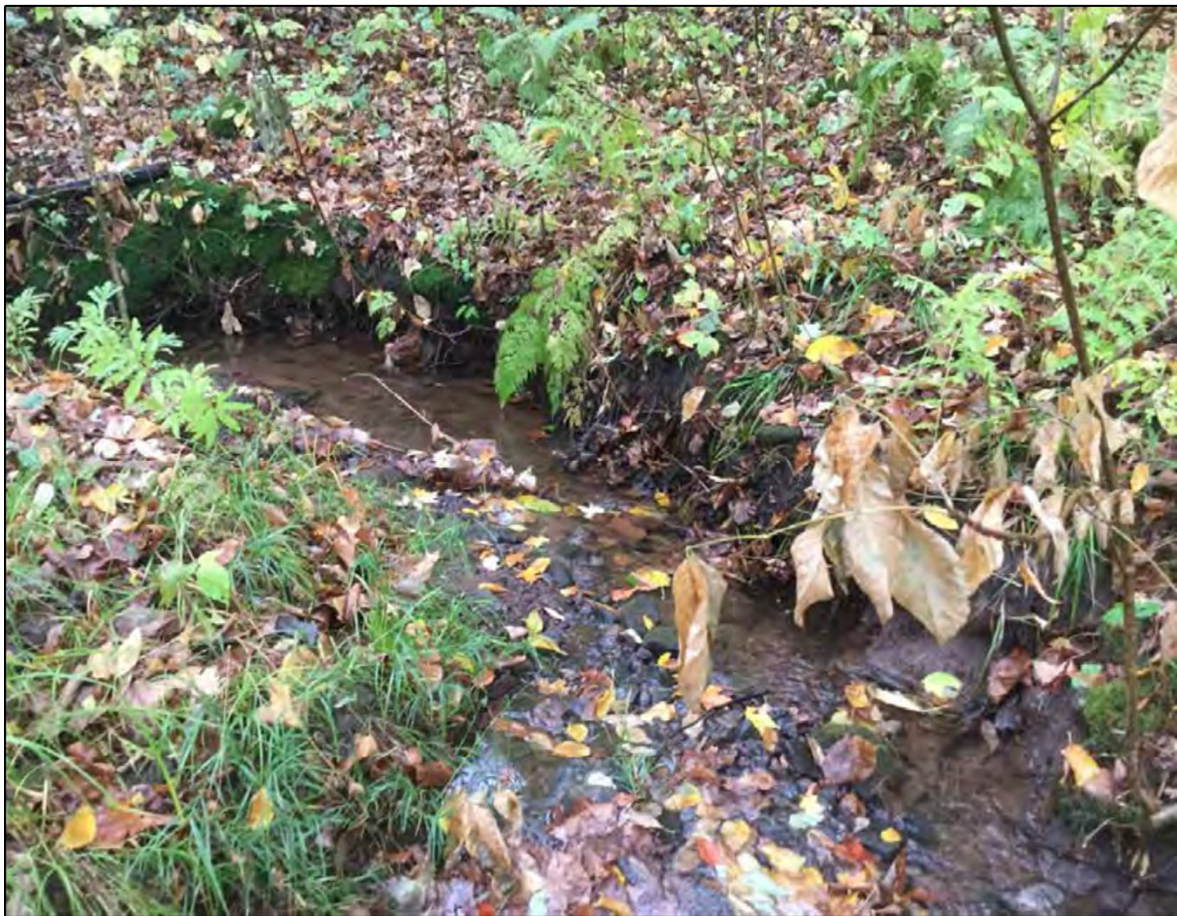
Sheet 9 of 13

Erosion and Sediment Control Plan  
Stream Crossing Profile Drawing  
UNT of Krause Creek (sasv020p)  
MP 22

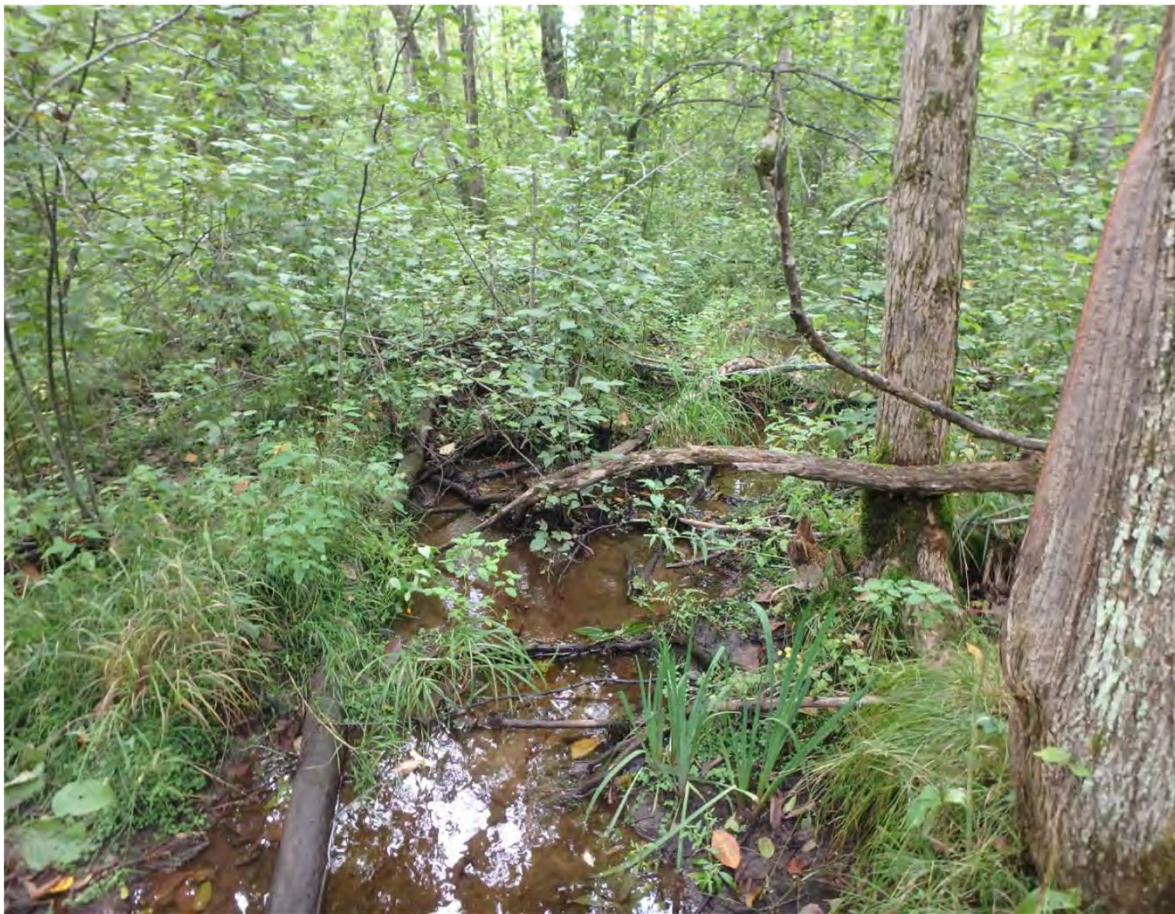
Sheet 10 of 13

Erosion and Sediment Control Plan  
Stream Crossing Profile Drawing  
UNT of Bad River (sasa008p)  
MP 23.8

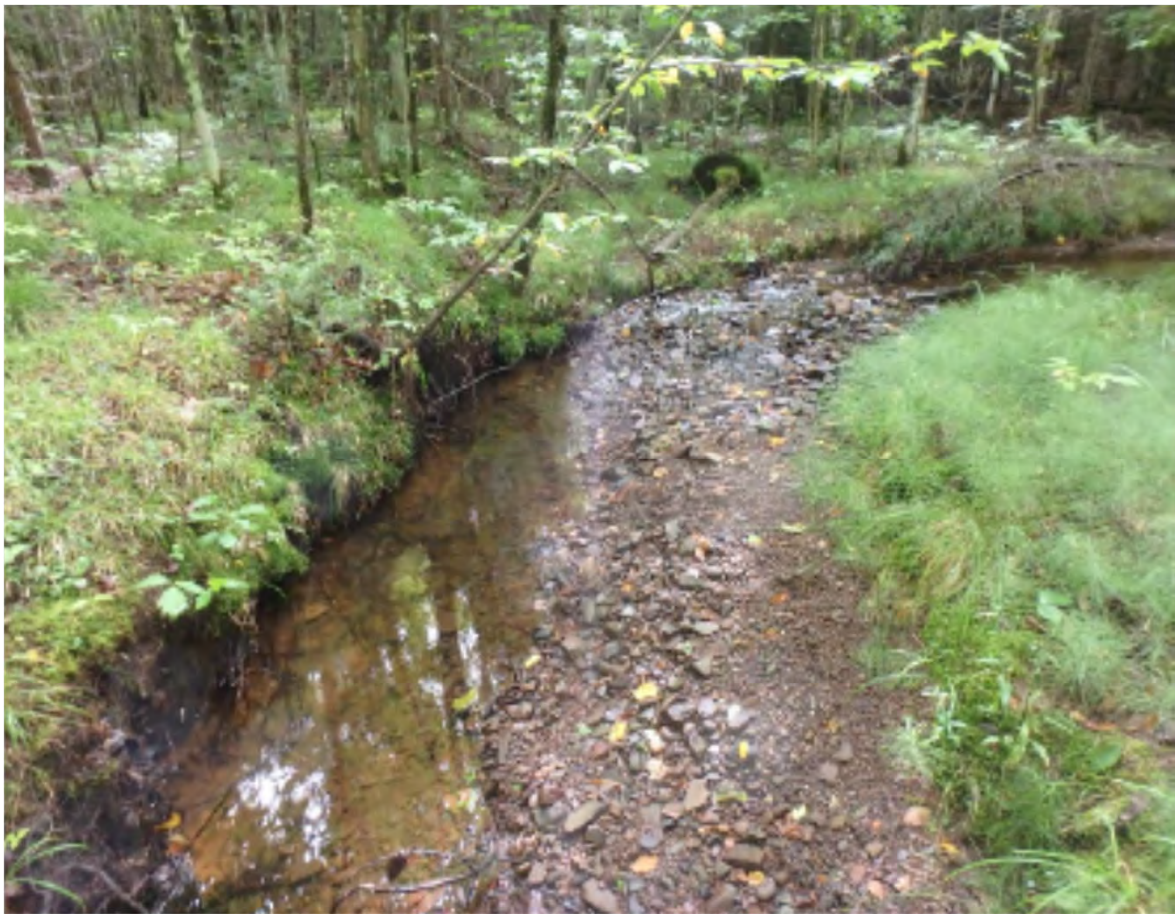
Sheet 11 of 13

Erosion and Sediment Control Plan  
Stream Crossing Profile Drawing  
UNT of Gehrman Creek (sasa004p)  
MP 28.3

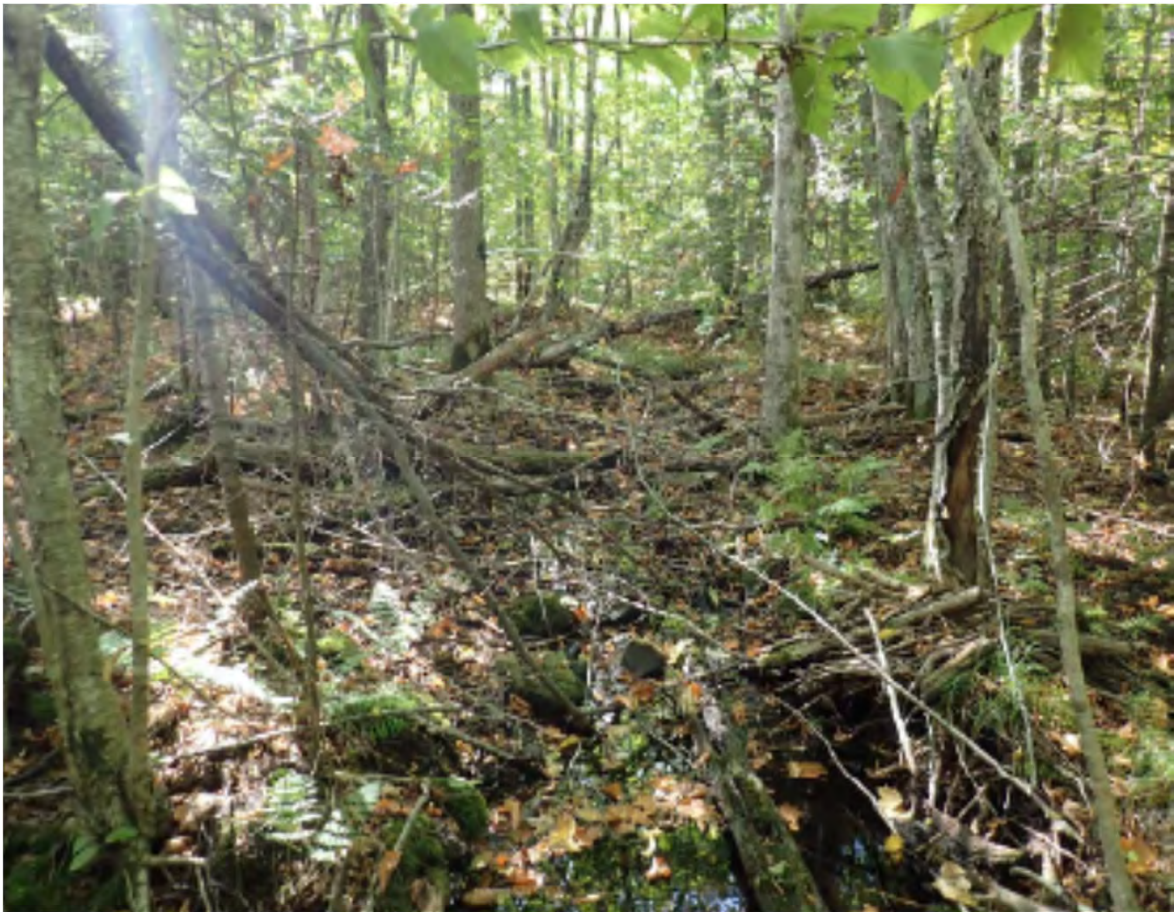
Sheet 12 of 13

Erosion and Sediment Control Plan  
Stream Crossing Profile Drawing  
UNT of Feldcher Creek (sirb010p)  
MP 30.6

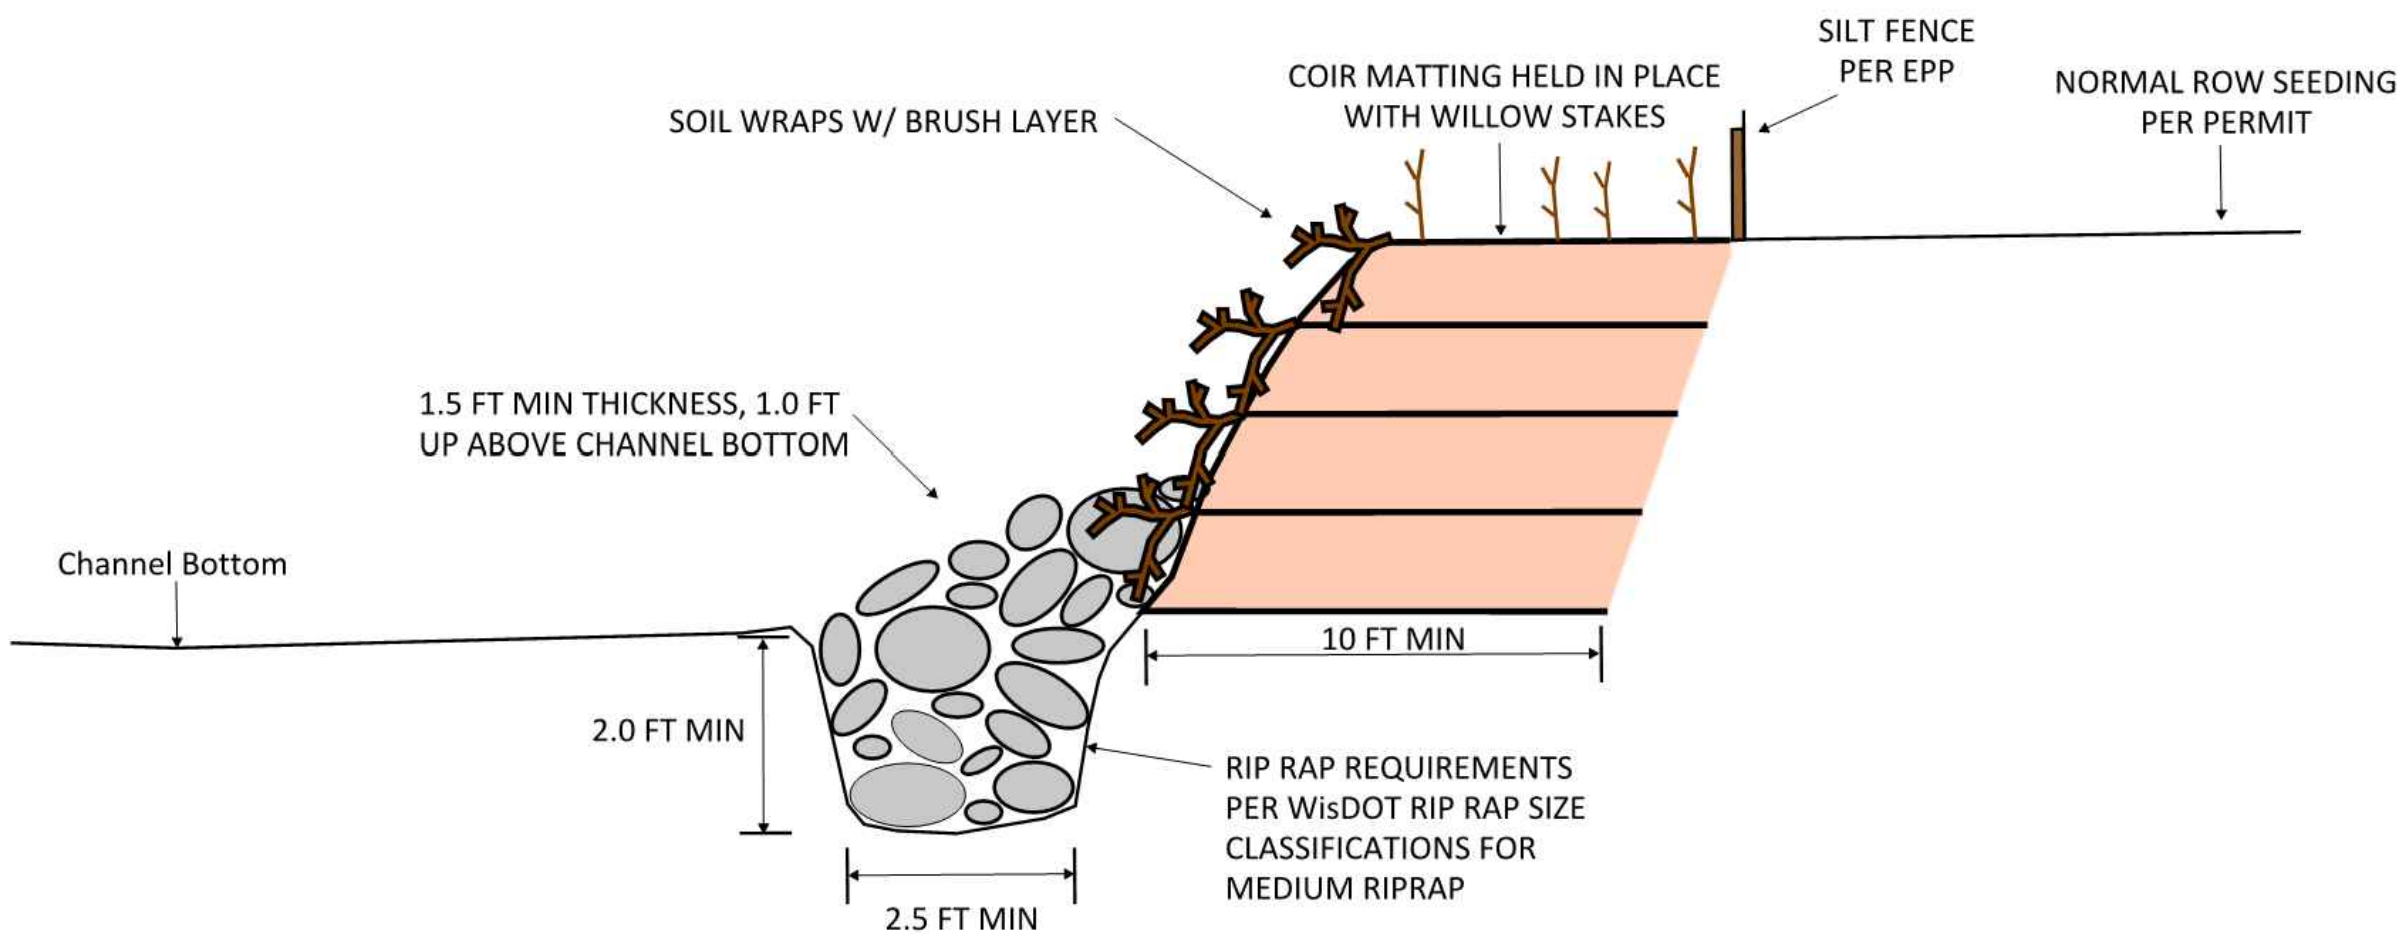
TYPICAL SIDE VIEW OF SOIL WRAPS W/ BRUSH LAYER & RIP RAP TOE
