**Line 5 Wisconsin Segment Relocation Project**

**Enbridge Responses to DNR Information Request Dated March 10, 2023**

**Attachment 2**

**Enbridge Line 5 Wisconsin Segment Relocation Project**  
**Responses to U.S. Army Corps of Engineers Data Request dated December 9, 2022**  
**Regulatory File # 2020-00260-WMS**

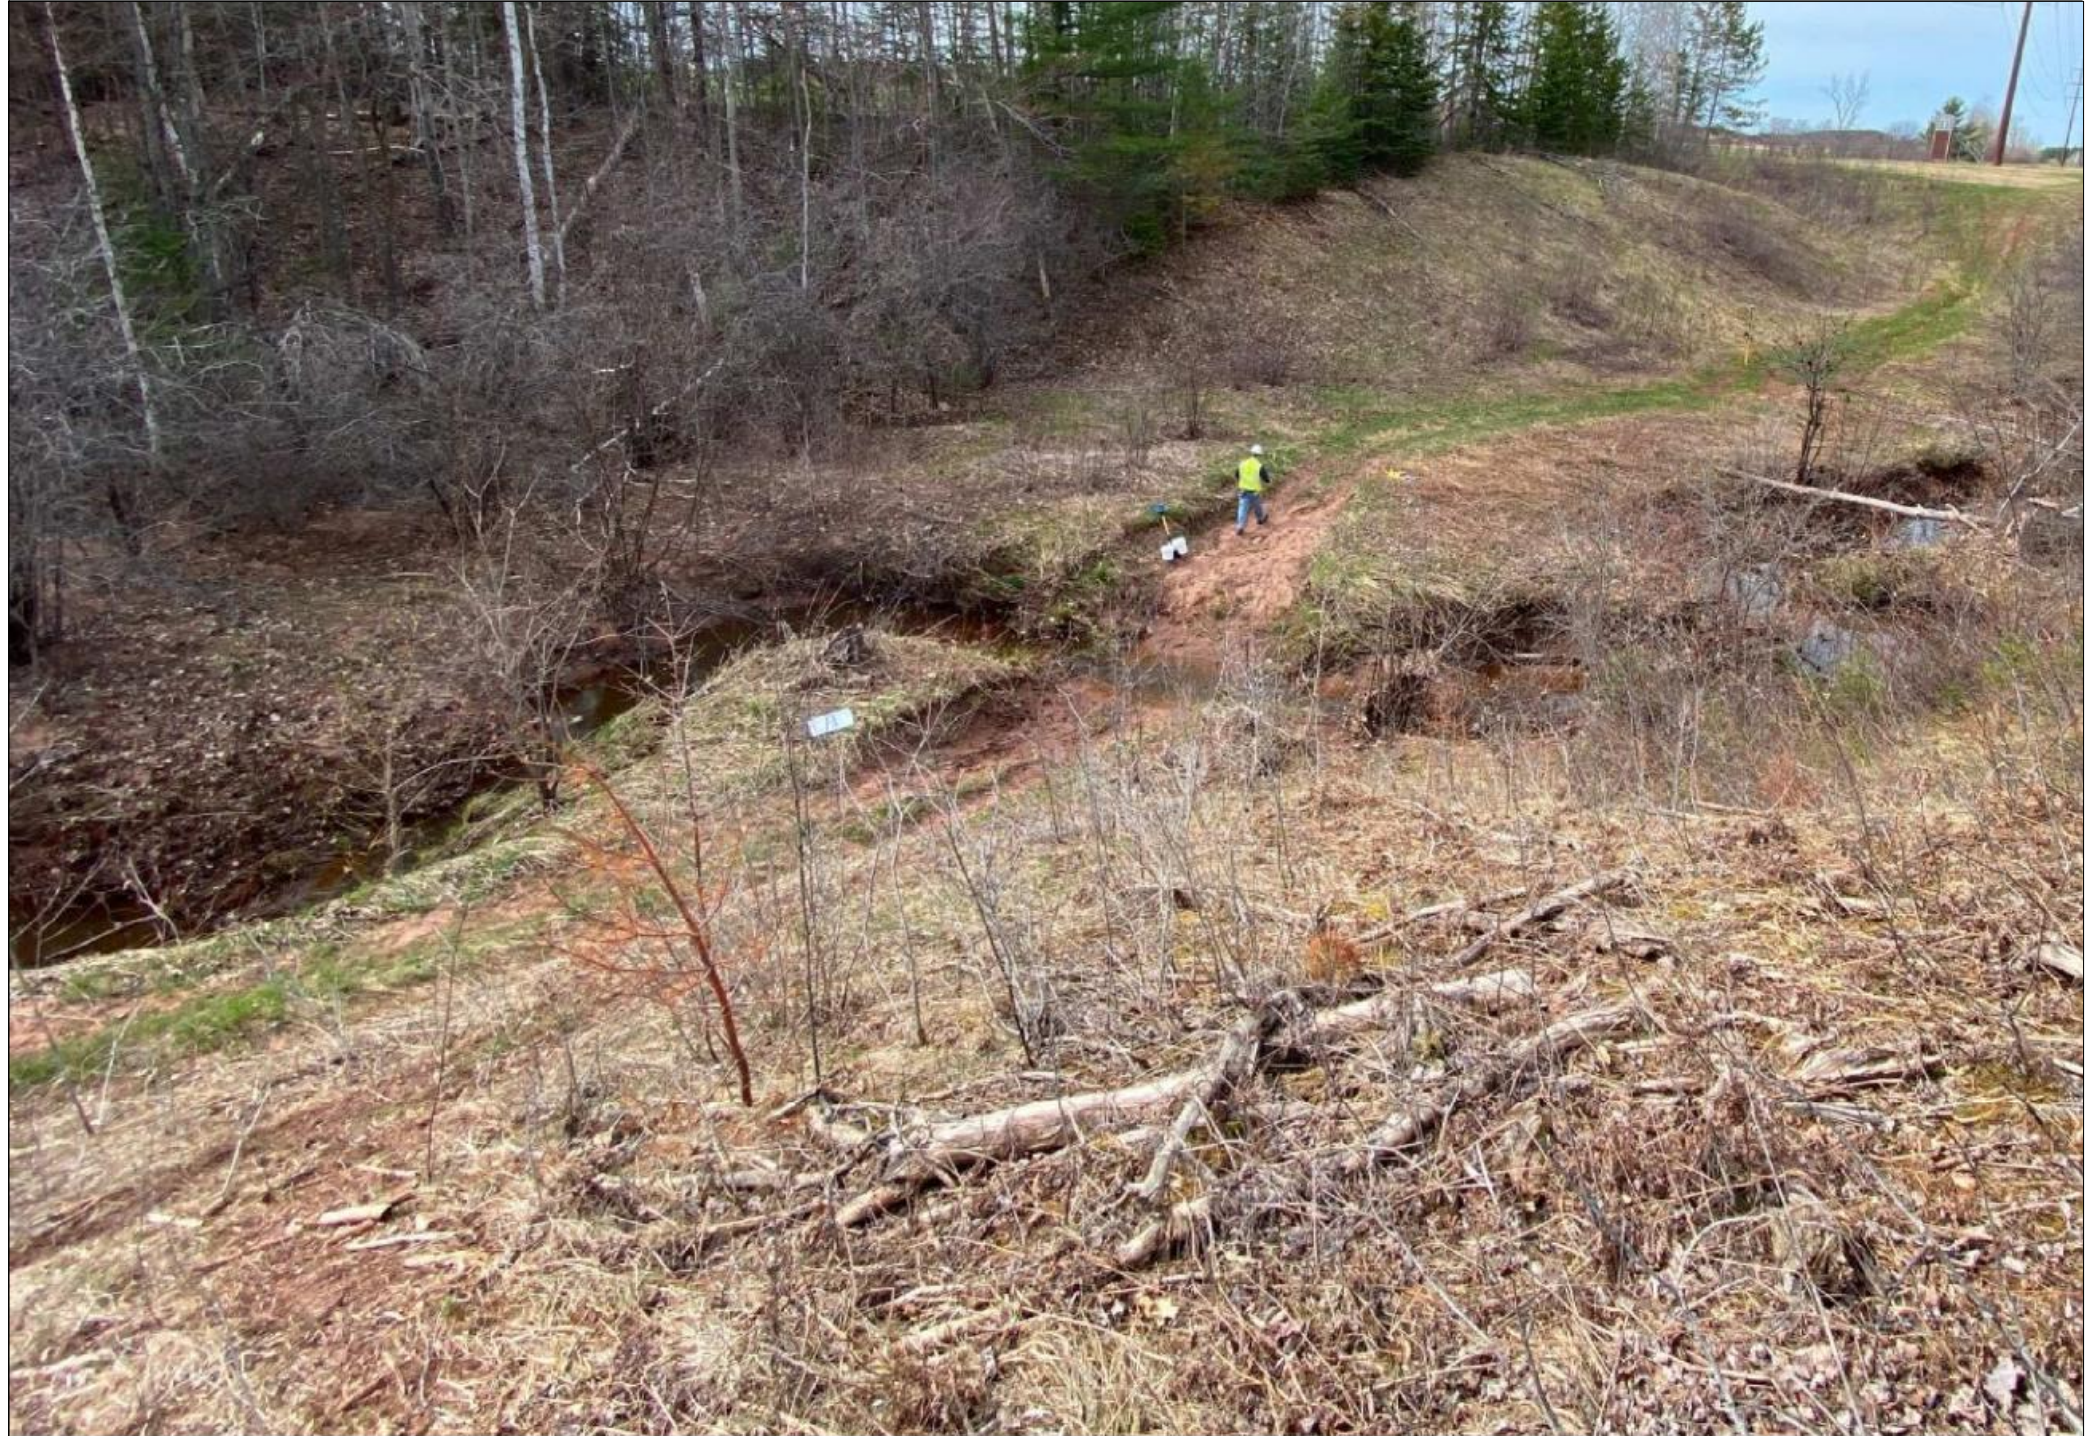
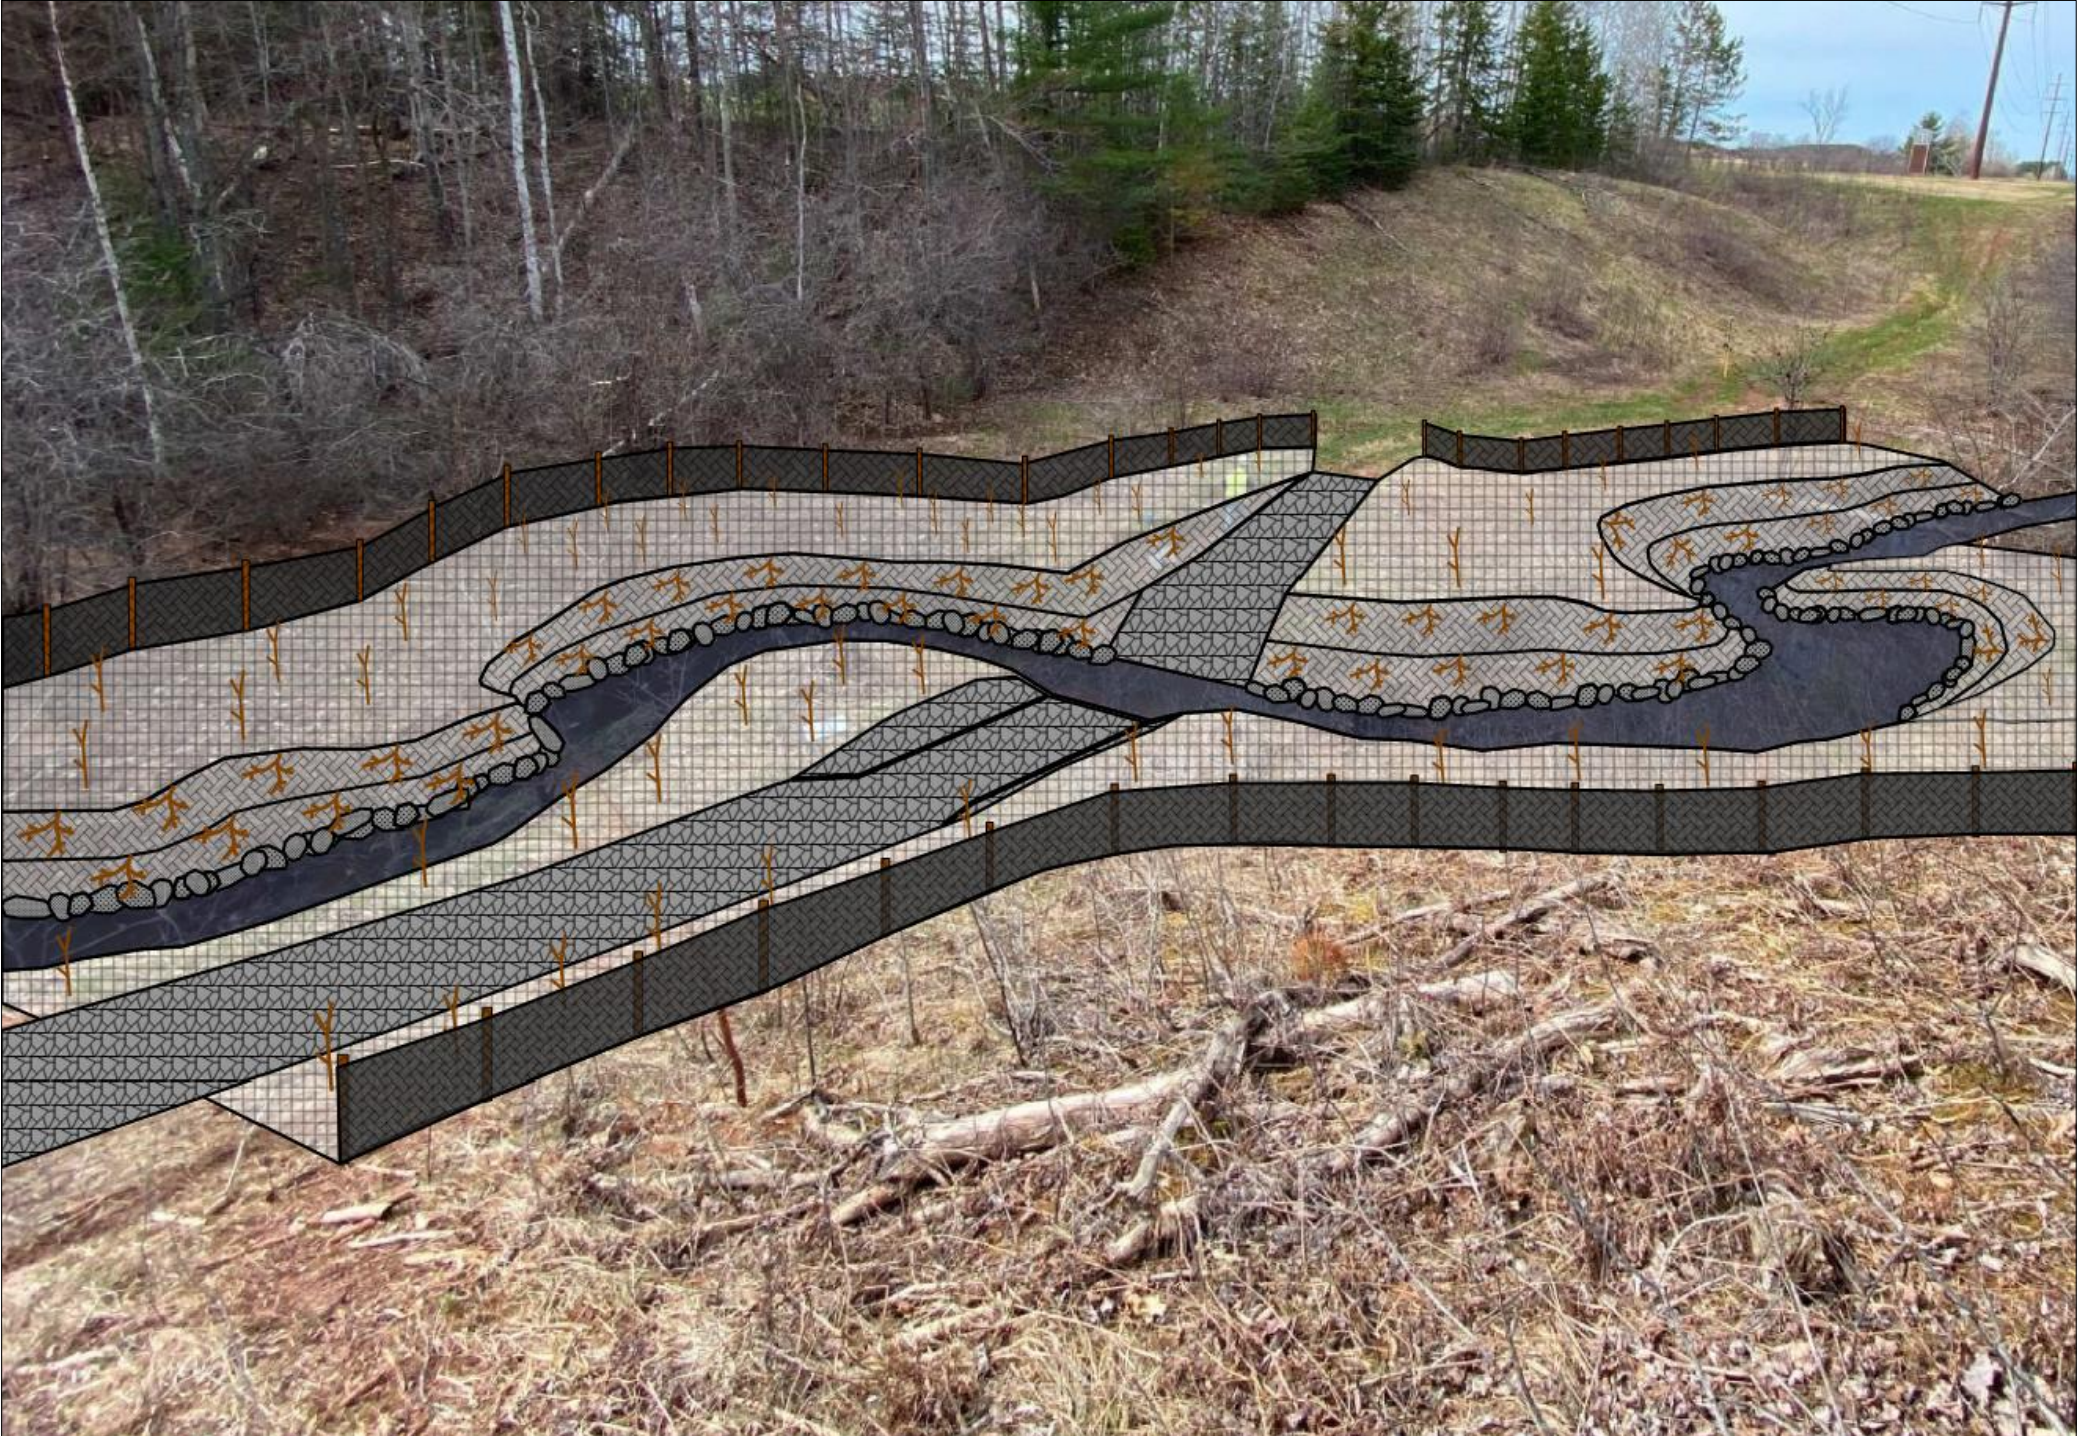
DOWNSTREAM RIGHT, EXISTING CHANNEL (NORTH BANK BACKGROUND, SOUTH BANK FOREGROUND)

DOWNSTREAM RIGHT, PROPOSED CONCEPT (NORTH BANK BACKGROUND, SOUTH BANK FOREGROUND)

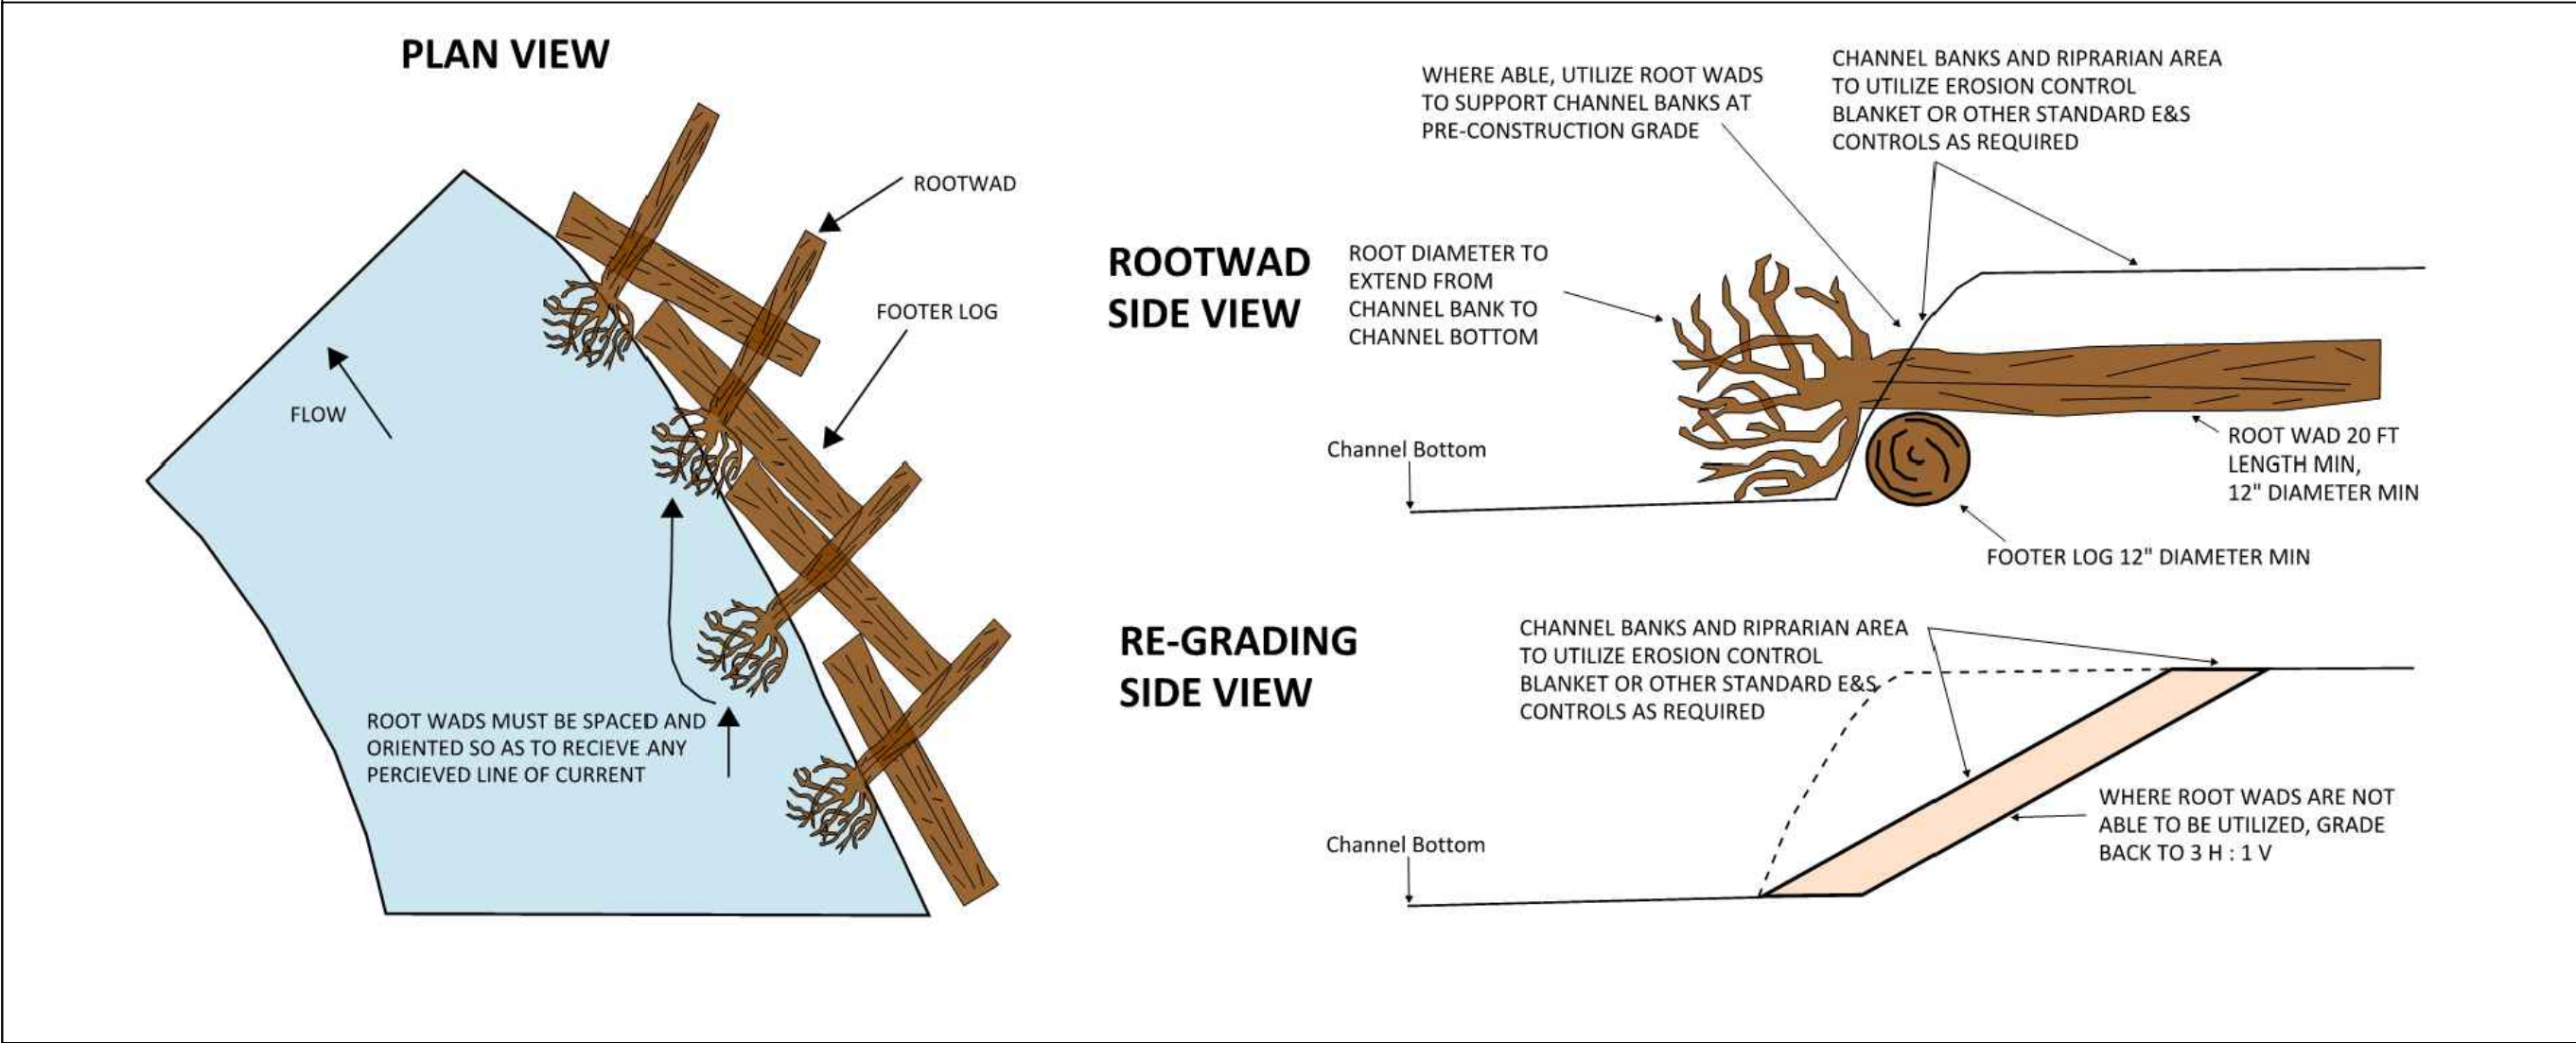
TYPICAL PLAN AND SIDE VIEW OF ROOTWADS AND RE-GRADE

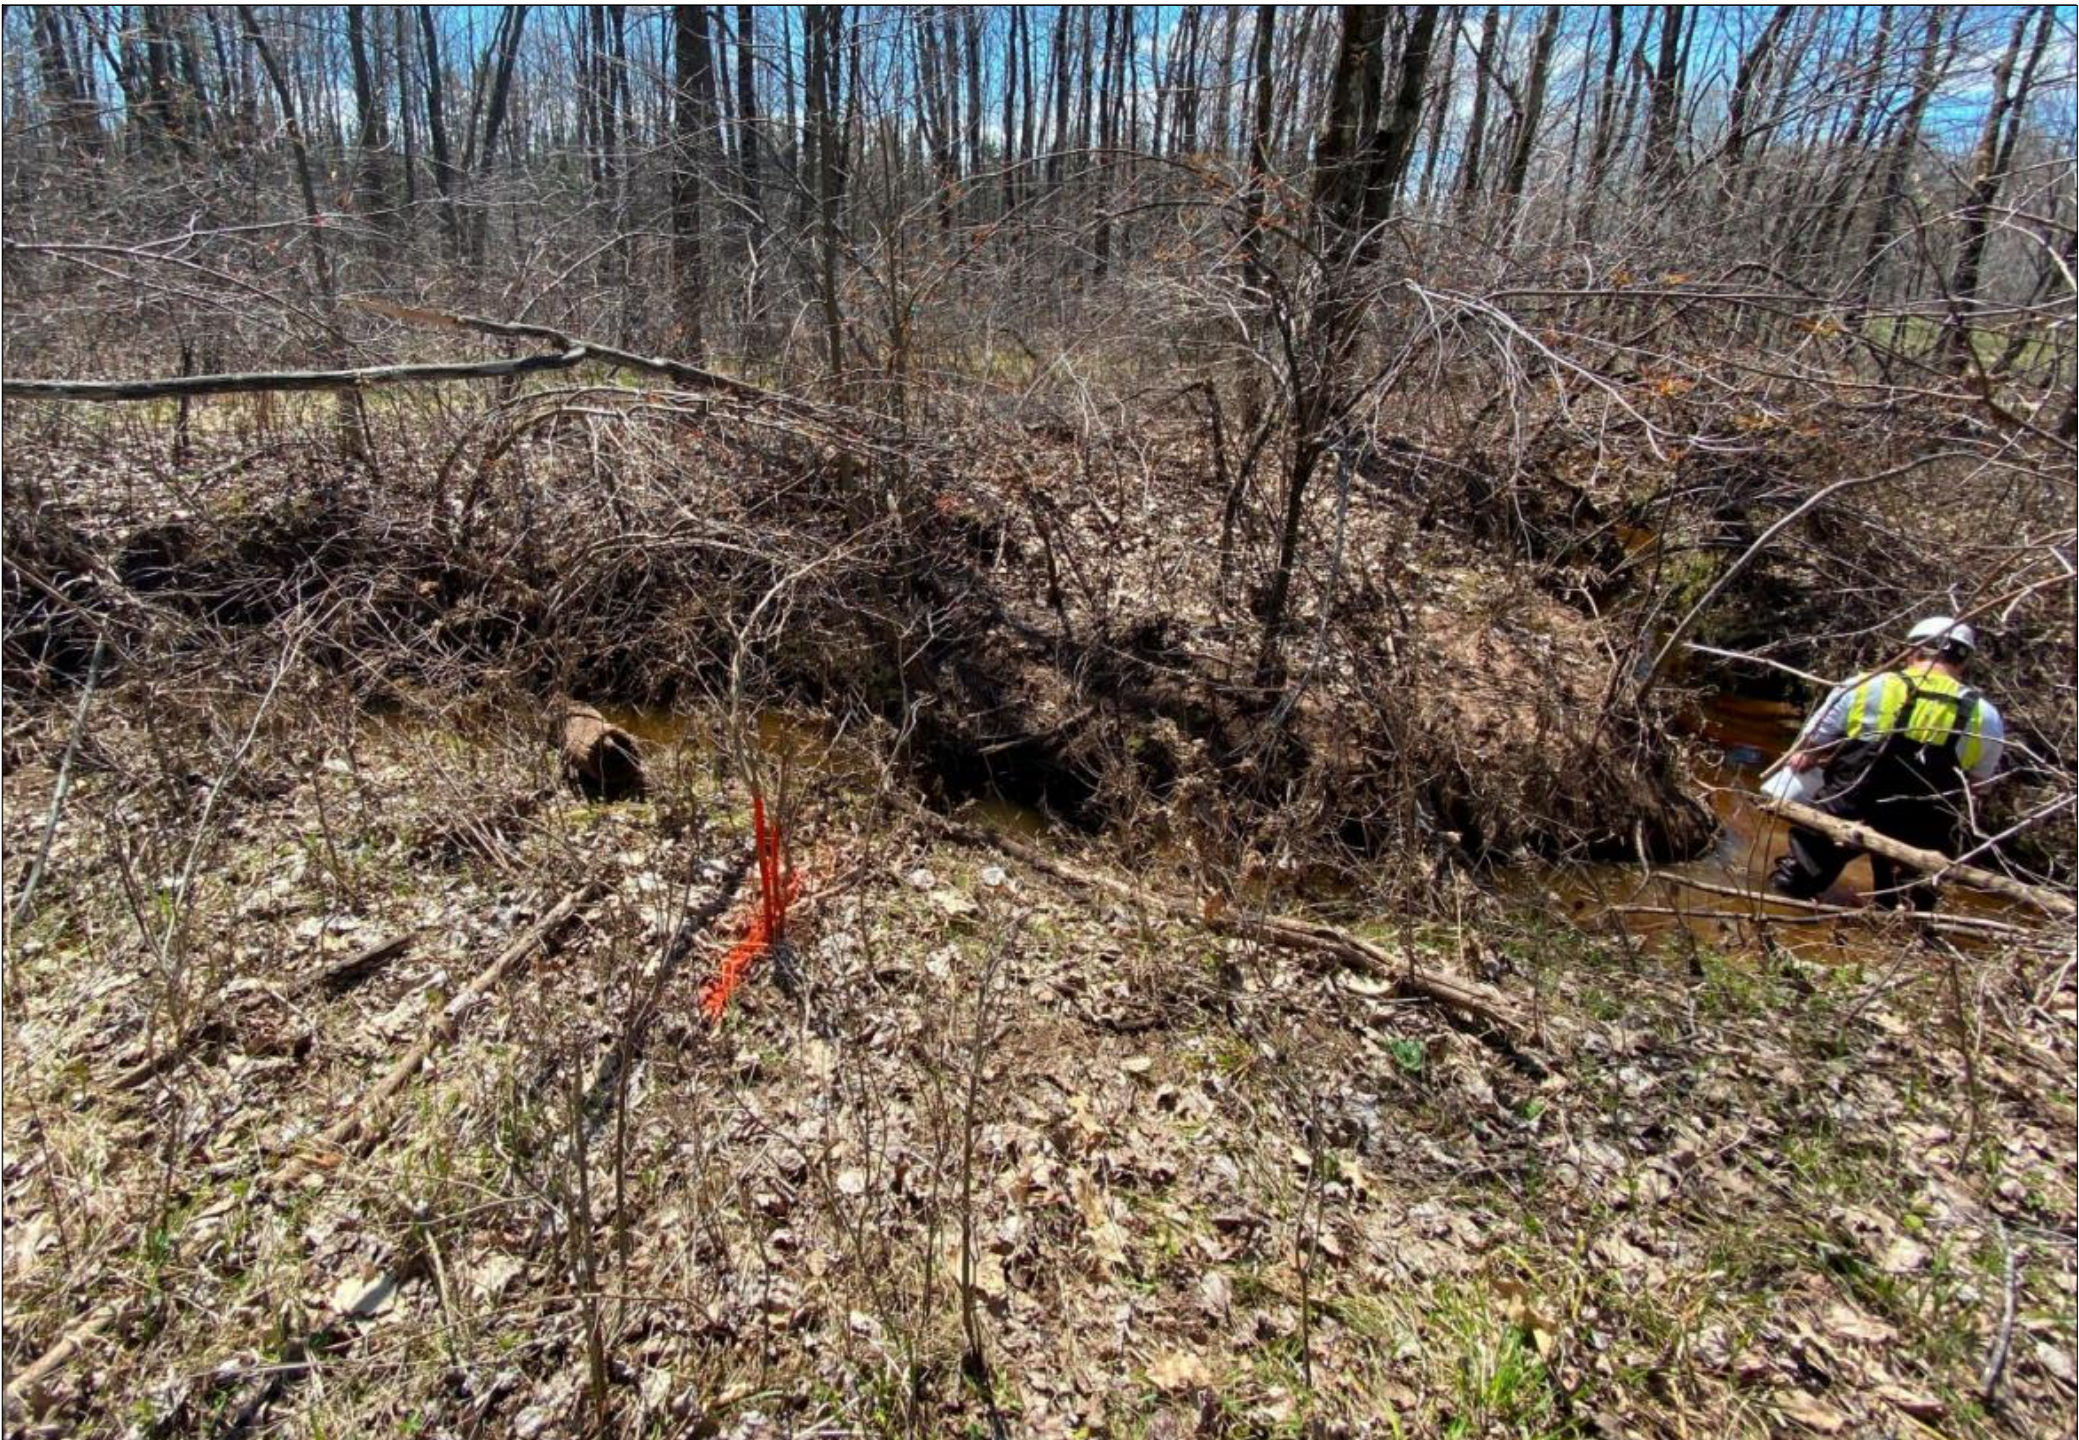
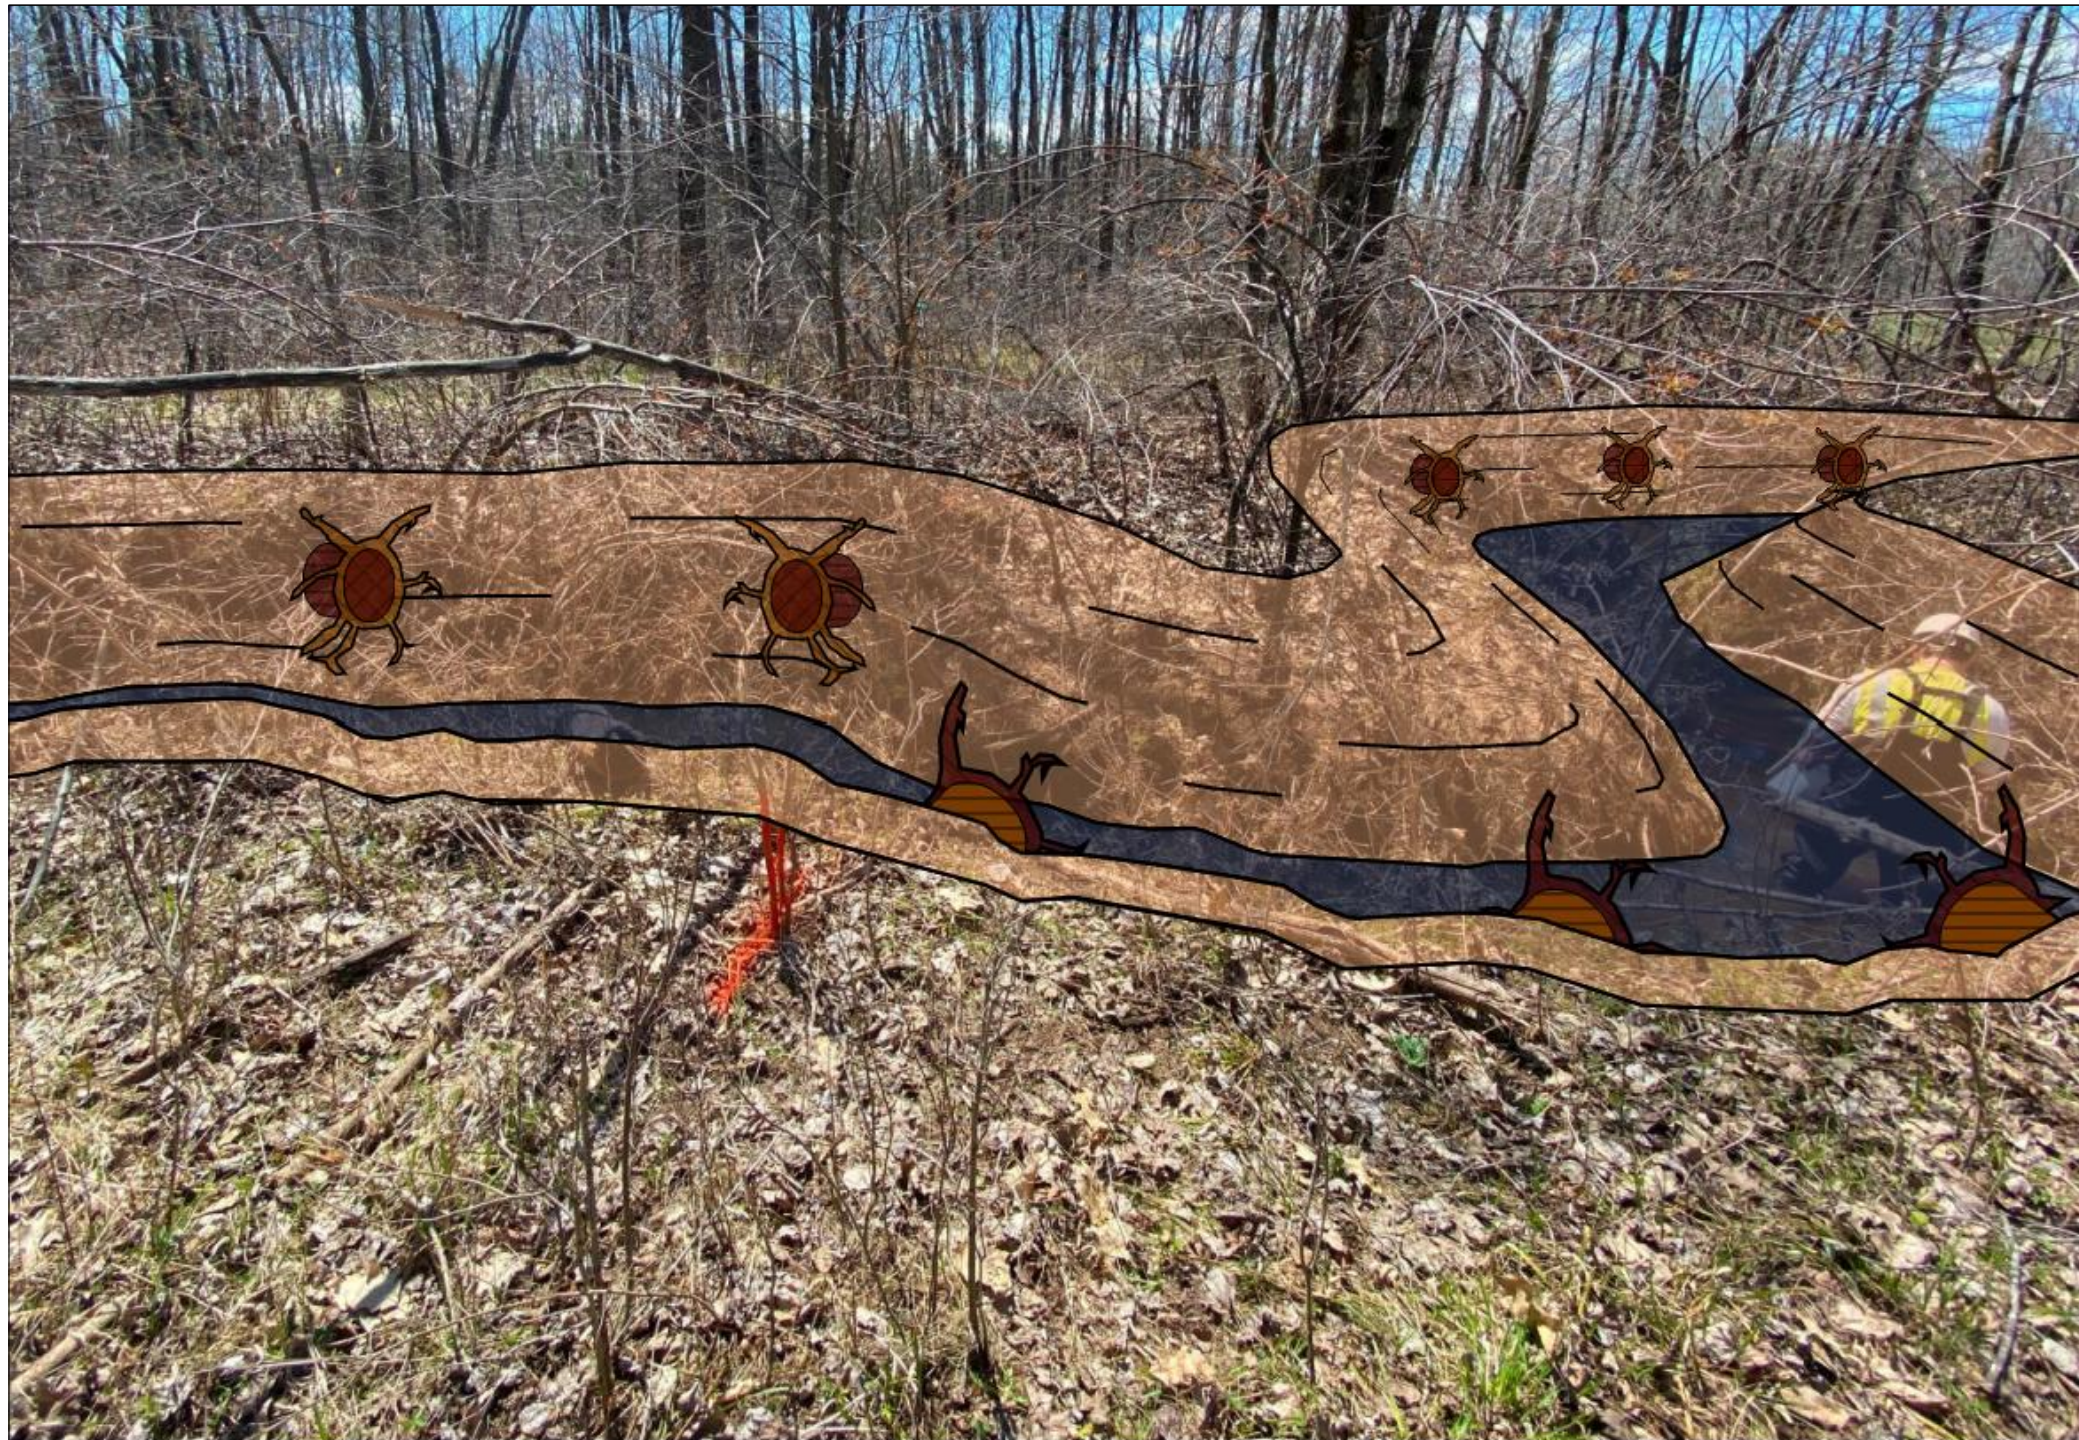
DOWNSTREAM LEFT, EXISTING CHANNEL (NORTH BANK FOREGROUND, SOUTH BANK BACKGROUND)

DOWNSTREAM LEFT, PROPOSED CONCEPT (NORTH BANK FOREGROUND, SOUTH BANK BACKGROUND)

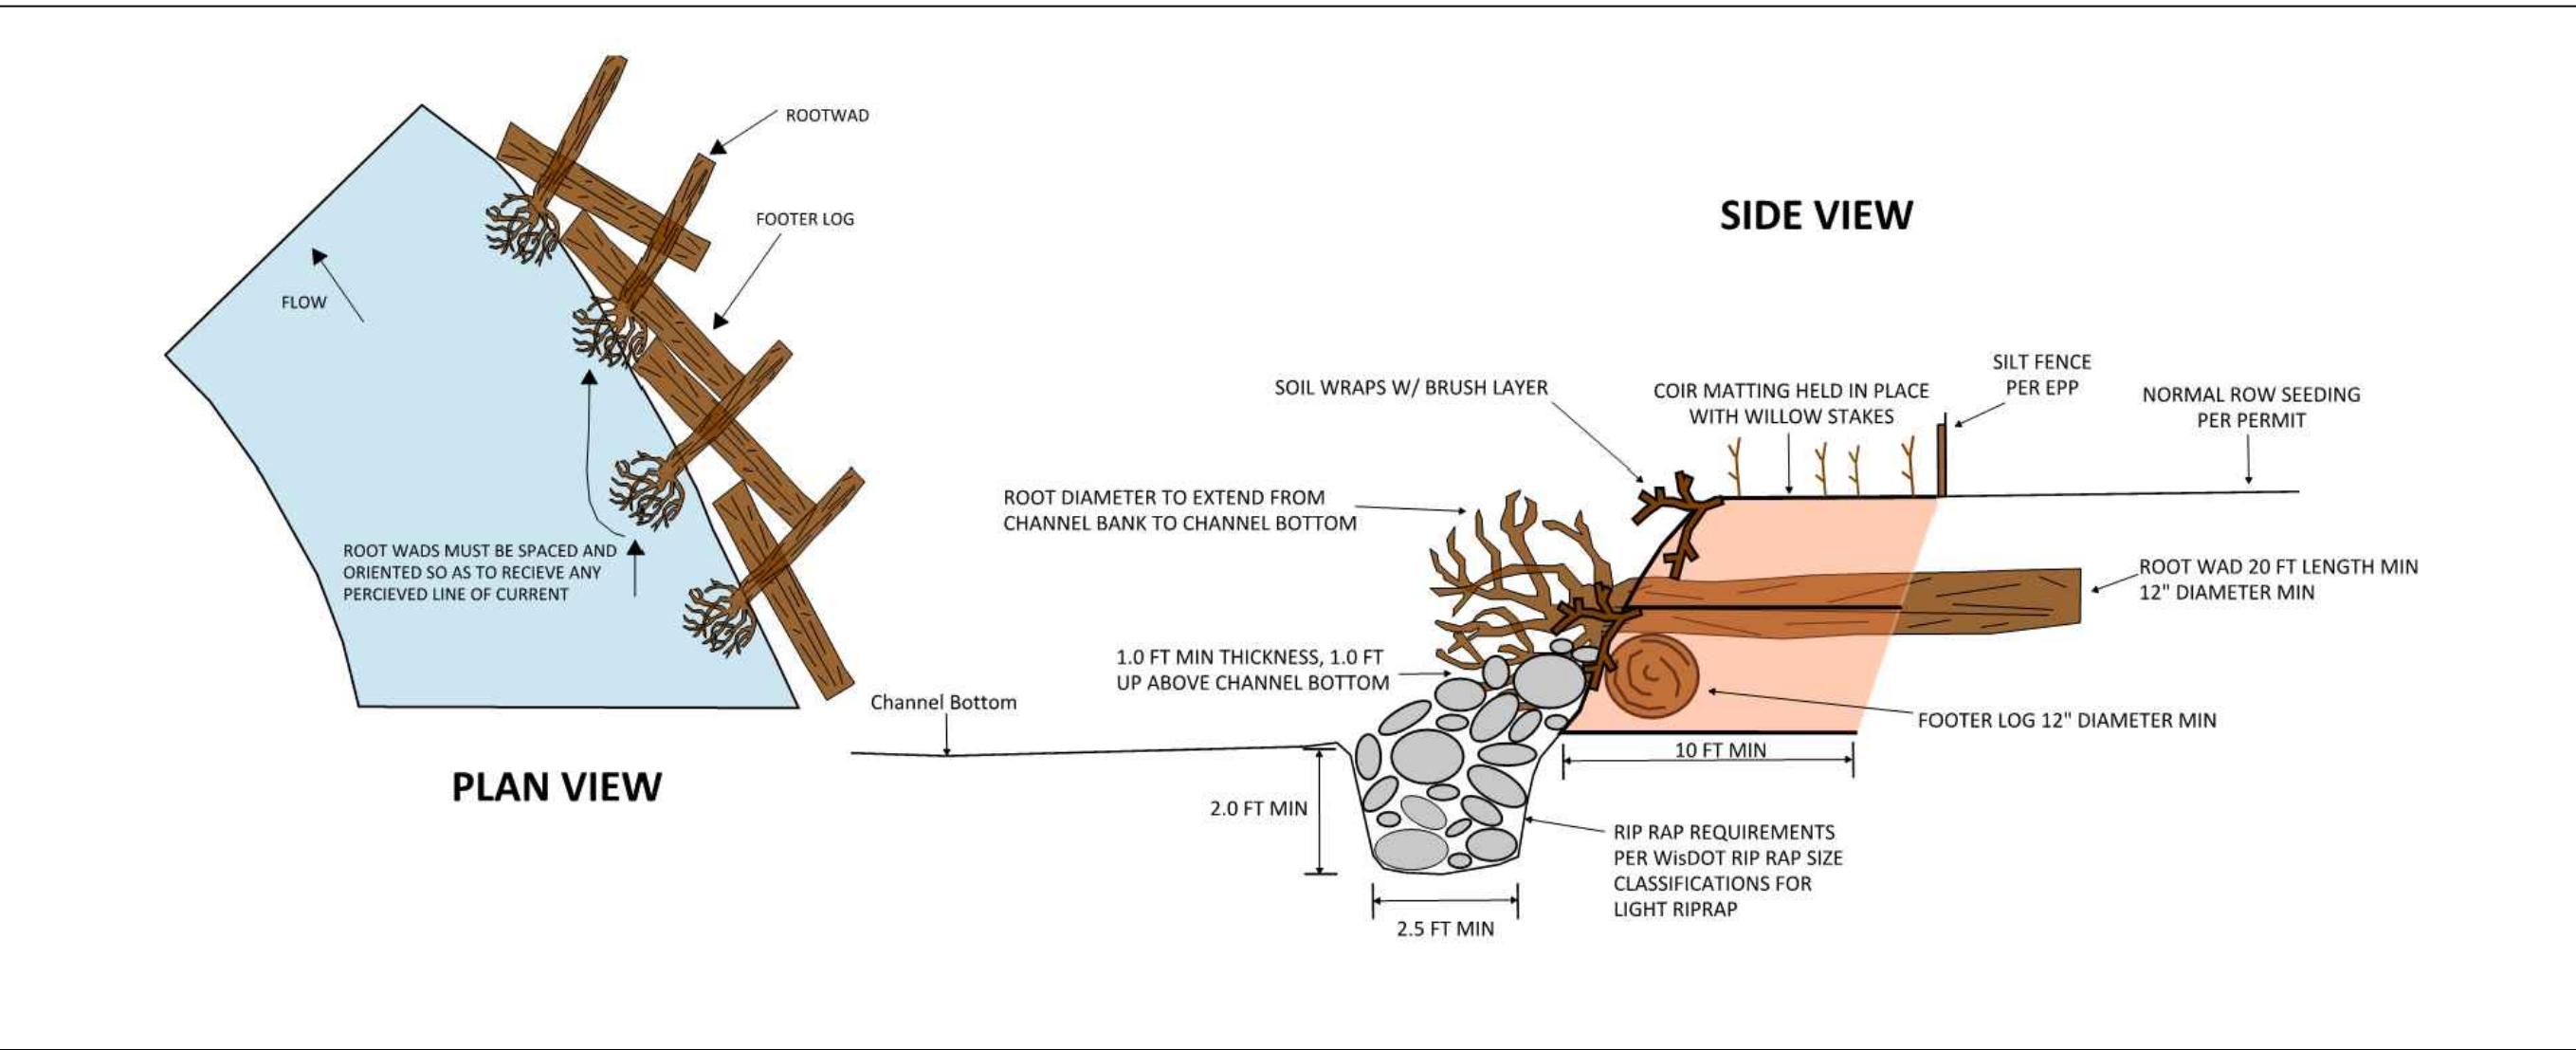
TYPICAL PLAN AND SIDE VIEW OF ROOTWADS, SOIL WRAPS W/ BRUSH LAYER, AND STONE TOE
