**Line 5 Wisconsin Segment Relocation Project**

**Enbridge Responses to DNR Information Request Dated March 10, 2023**

**Attachment 2**

**Enbridge Line 5 Wisconsin Segment Relocation Project**  
**Responses to U.S. Army Corps of Engineers Data Request dated December 9, 2022**  
**Regulatory File # 2020-00260-WMS**

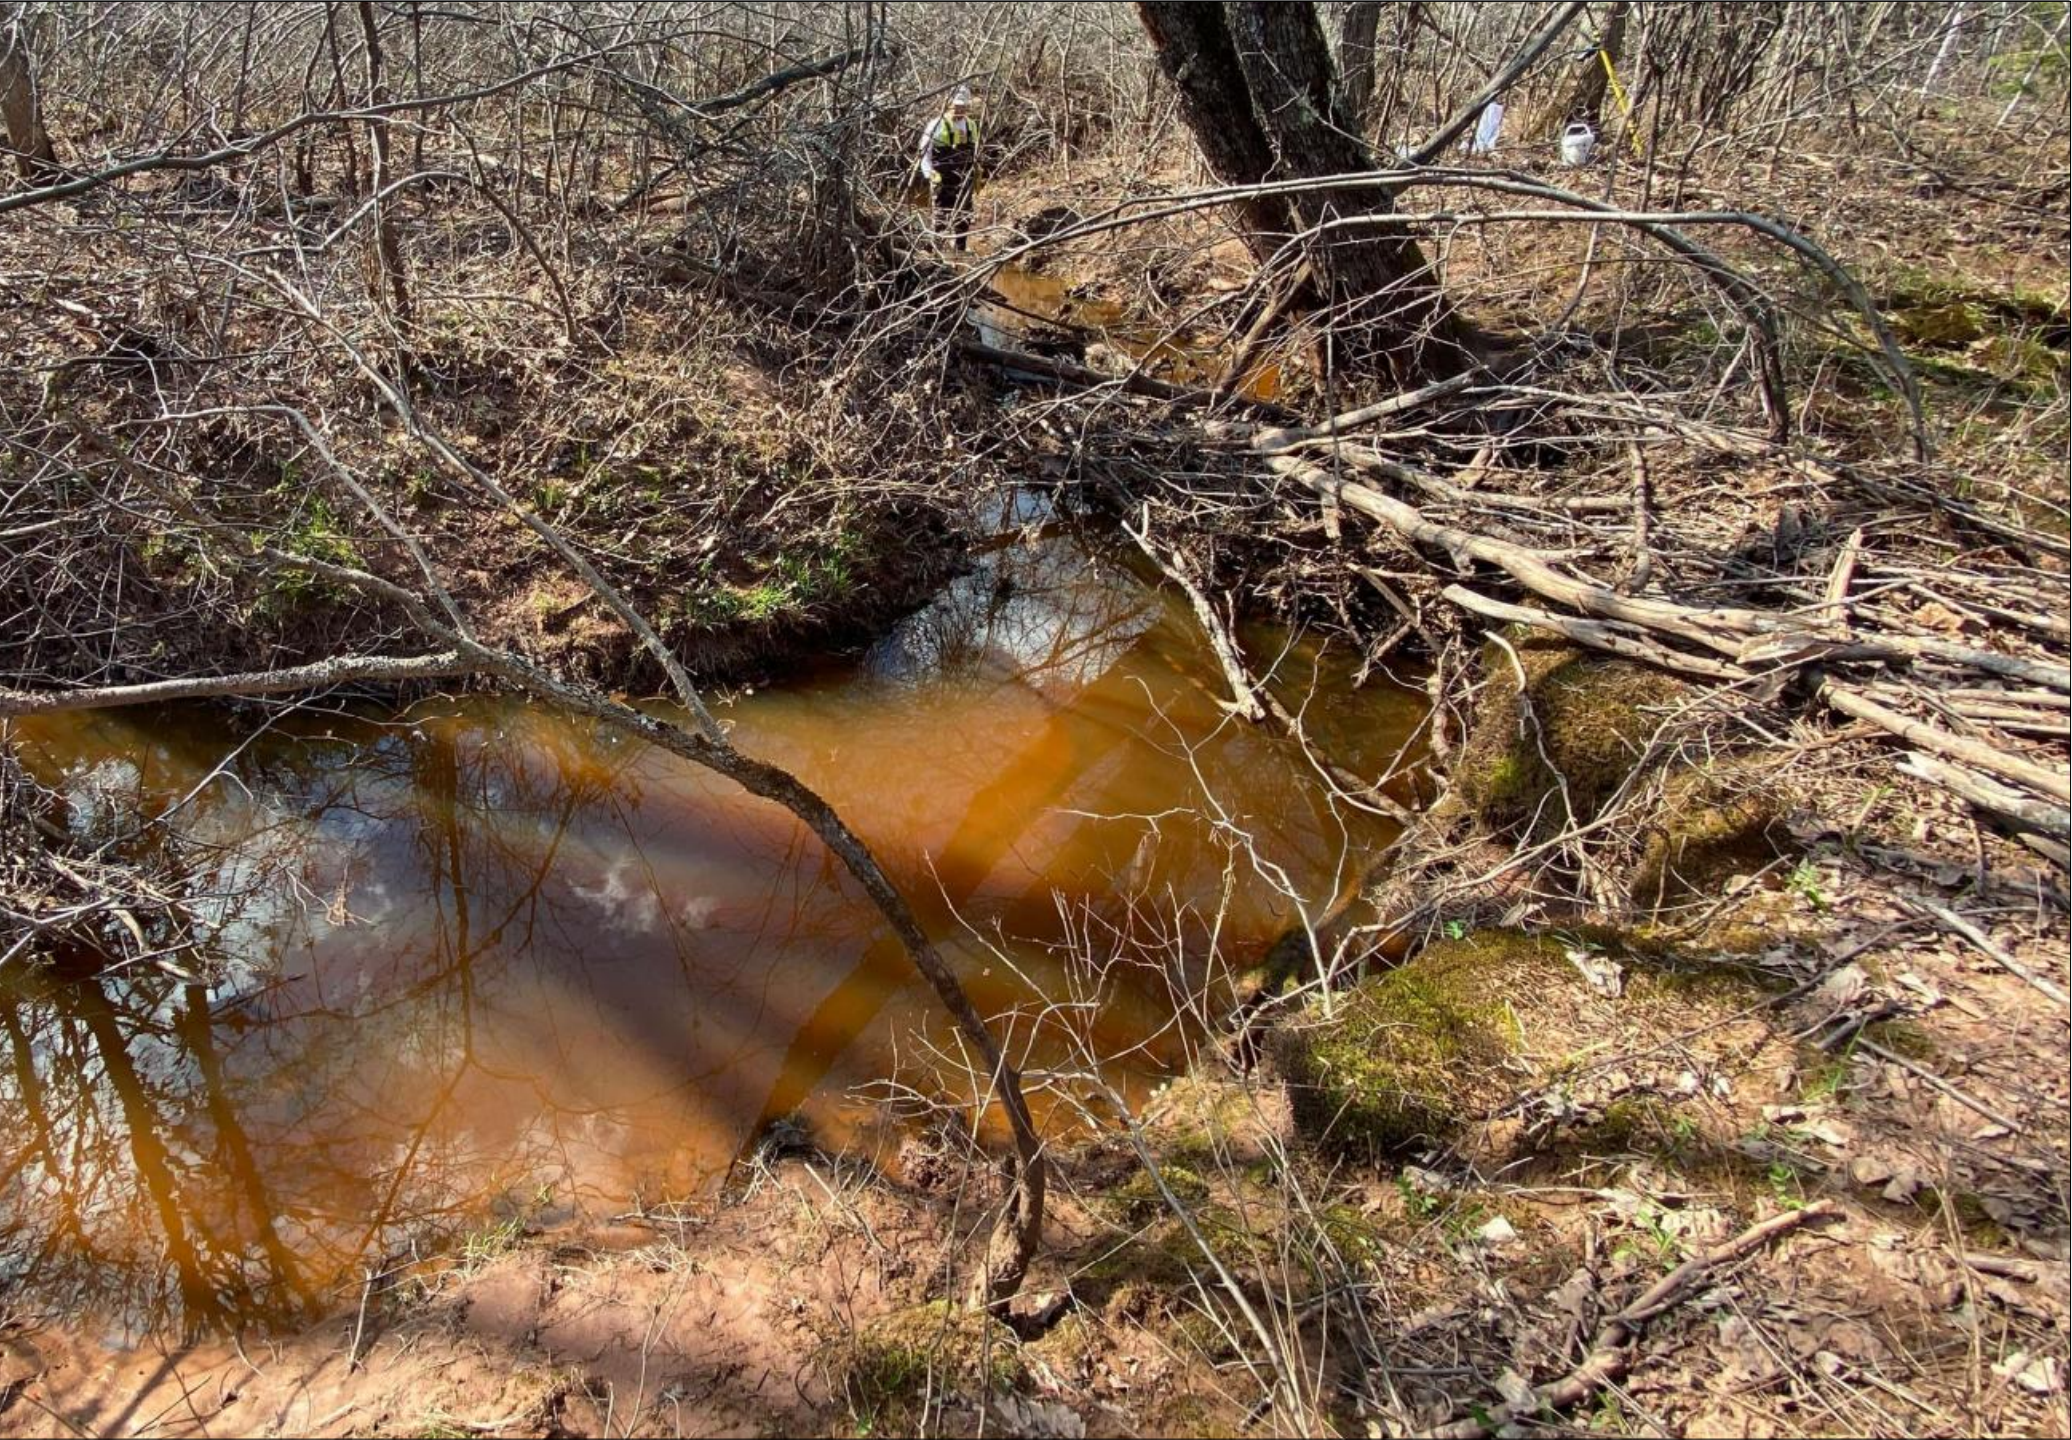
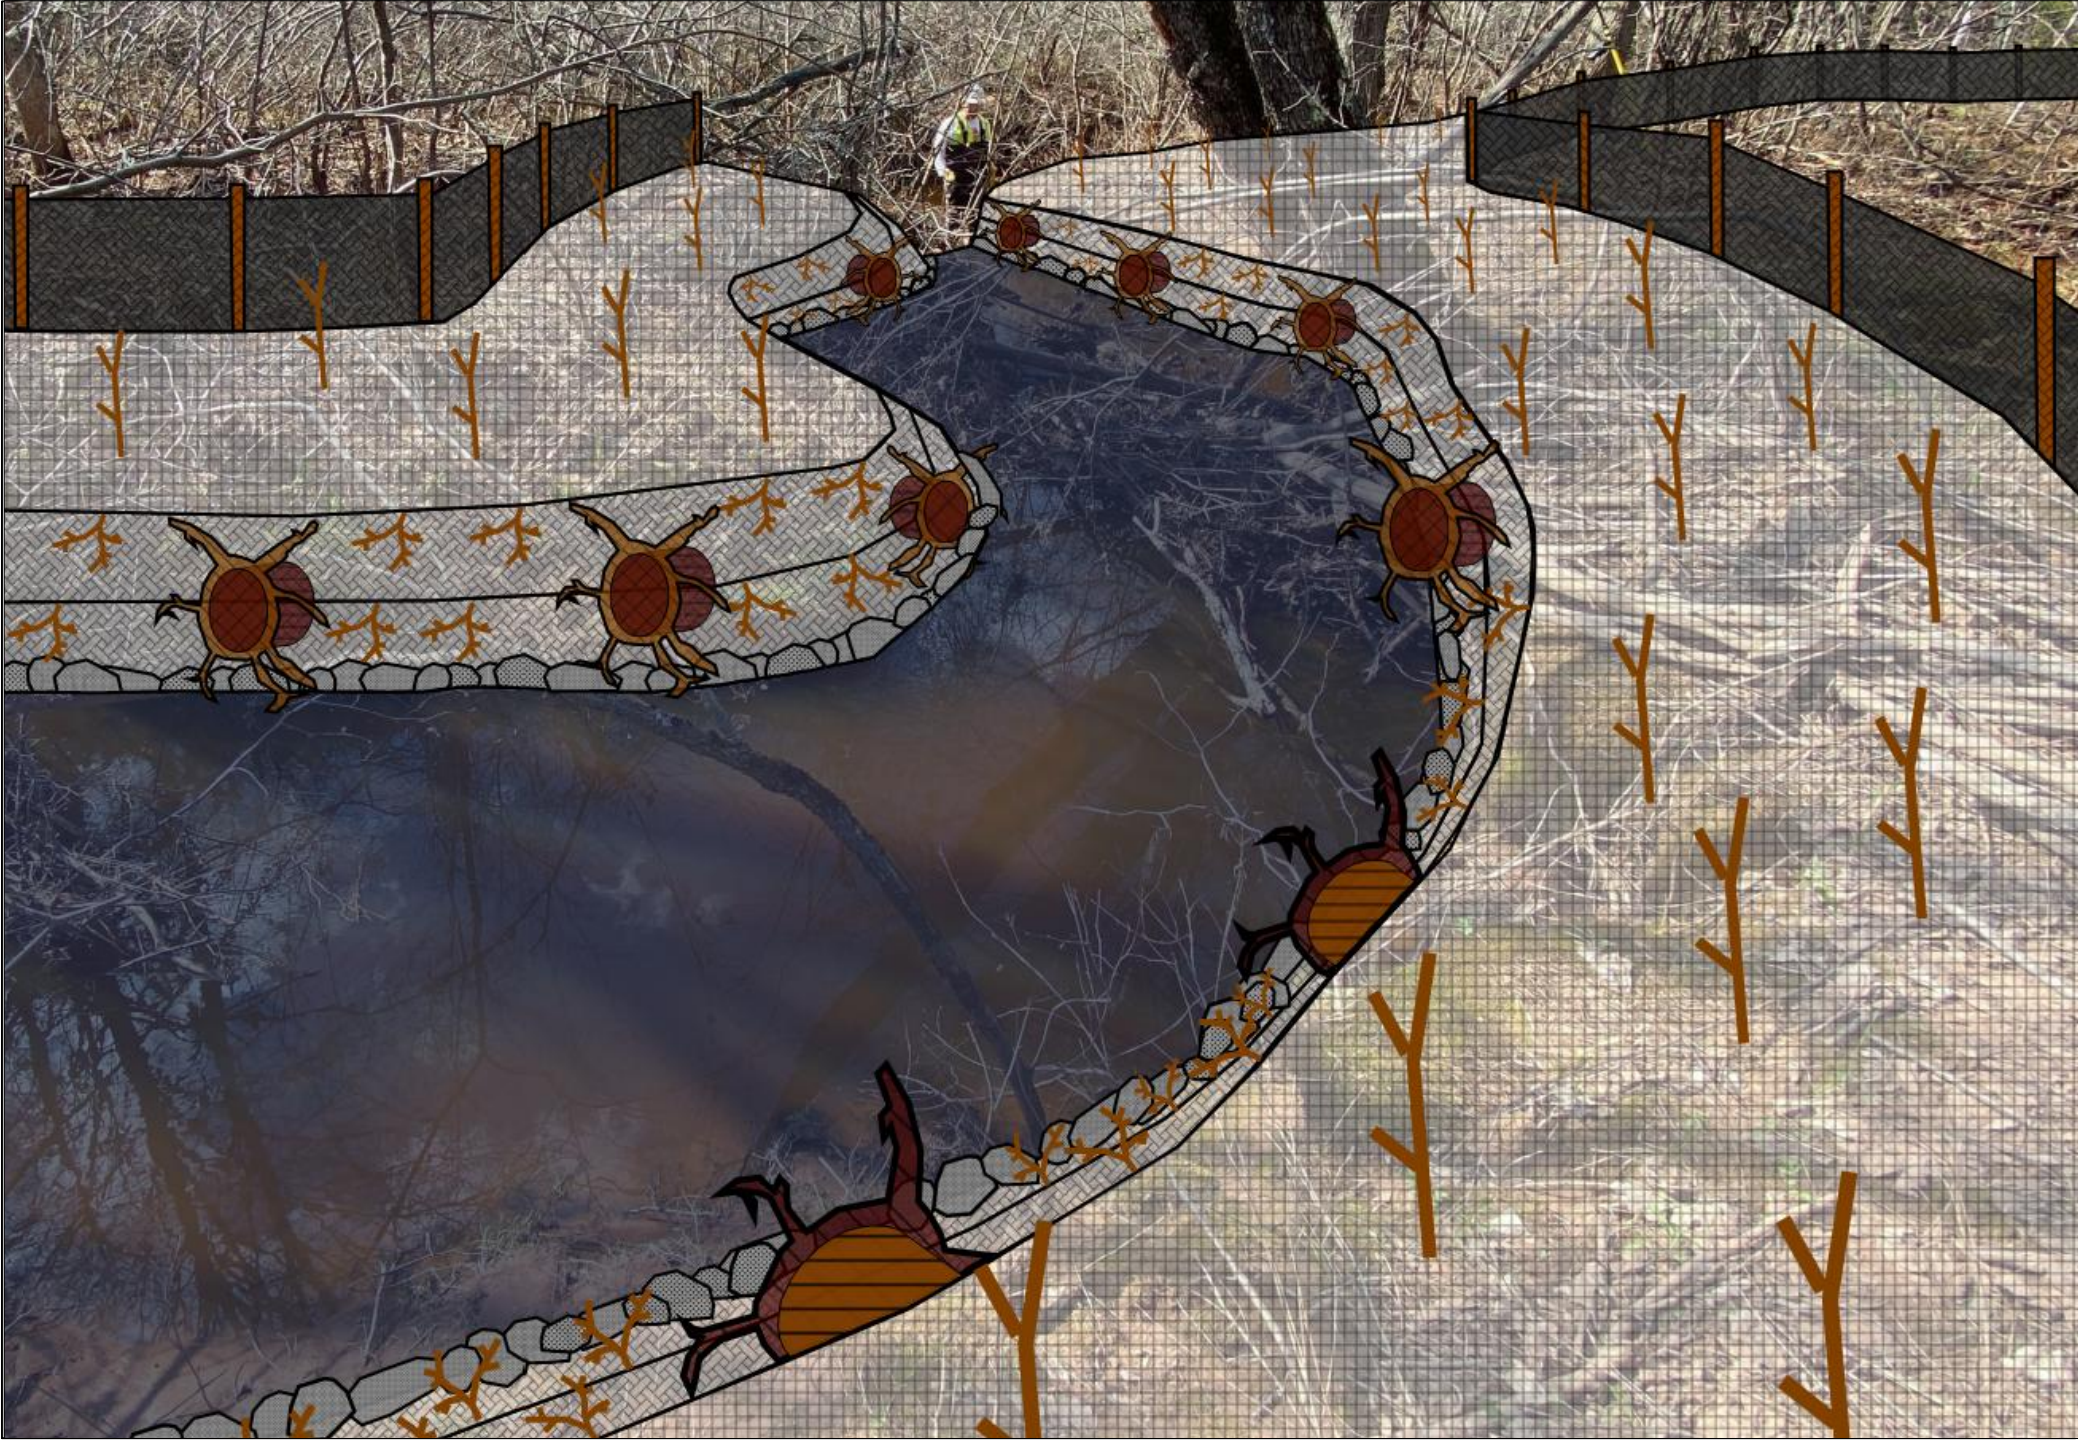
FACING DOWNSTREAM, EXISTING CHANNEL (NORTH BANK LEFT, SOUTH BANK RIGHT)

FACING DOWNSTREAM, PROPOSED CONCEPT (NORTH BANK LEFT, SOUTH BANK RIGHT)

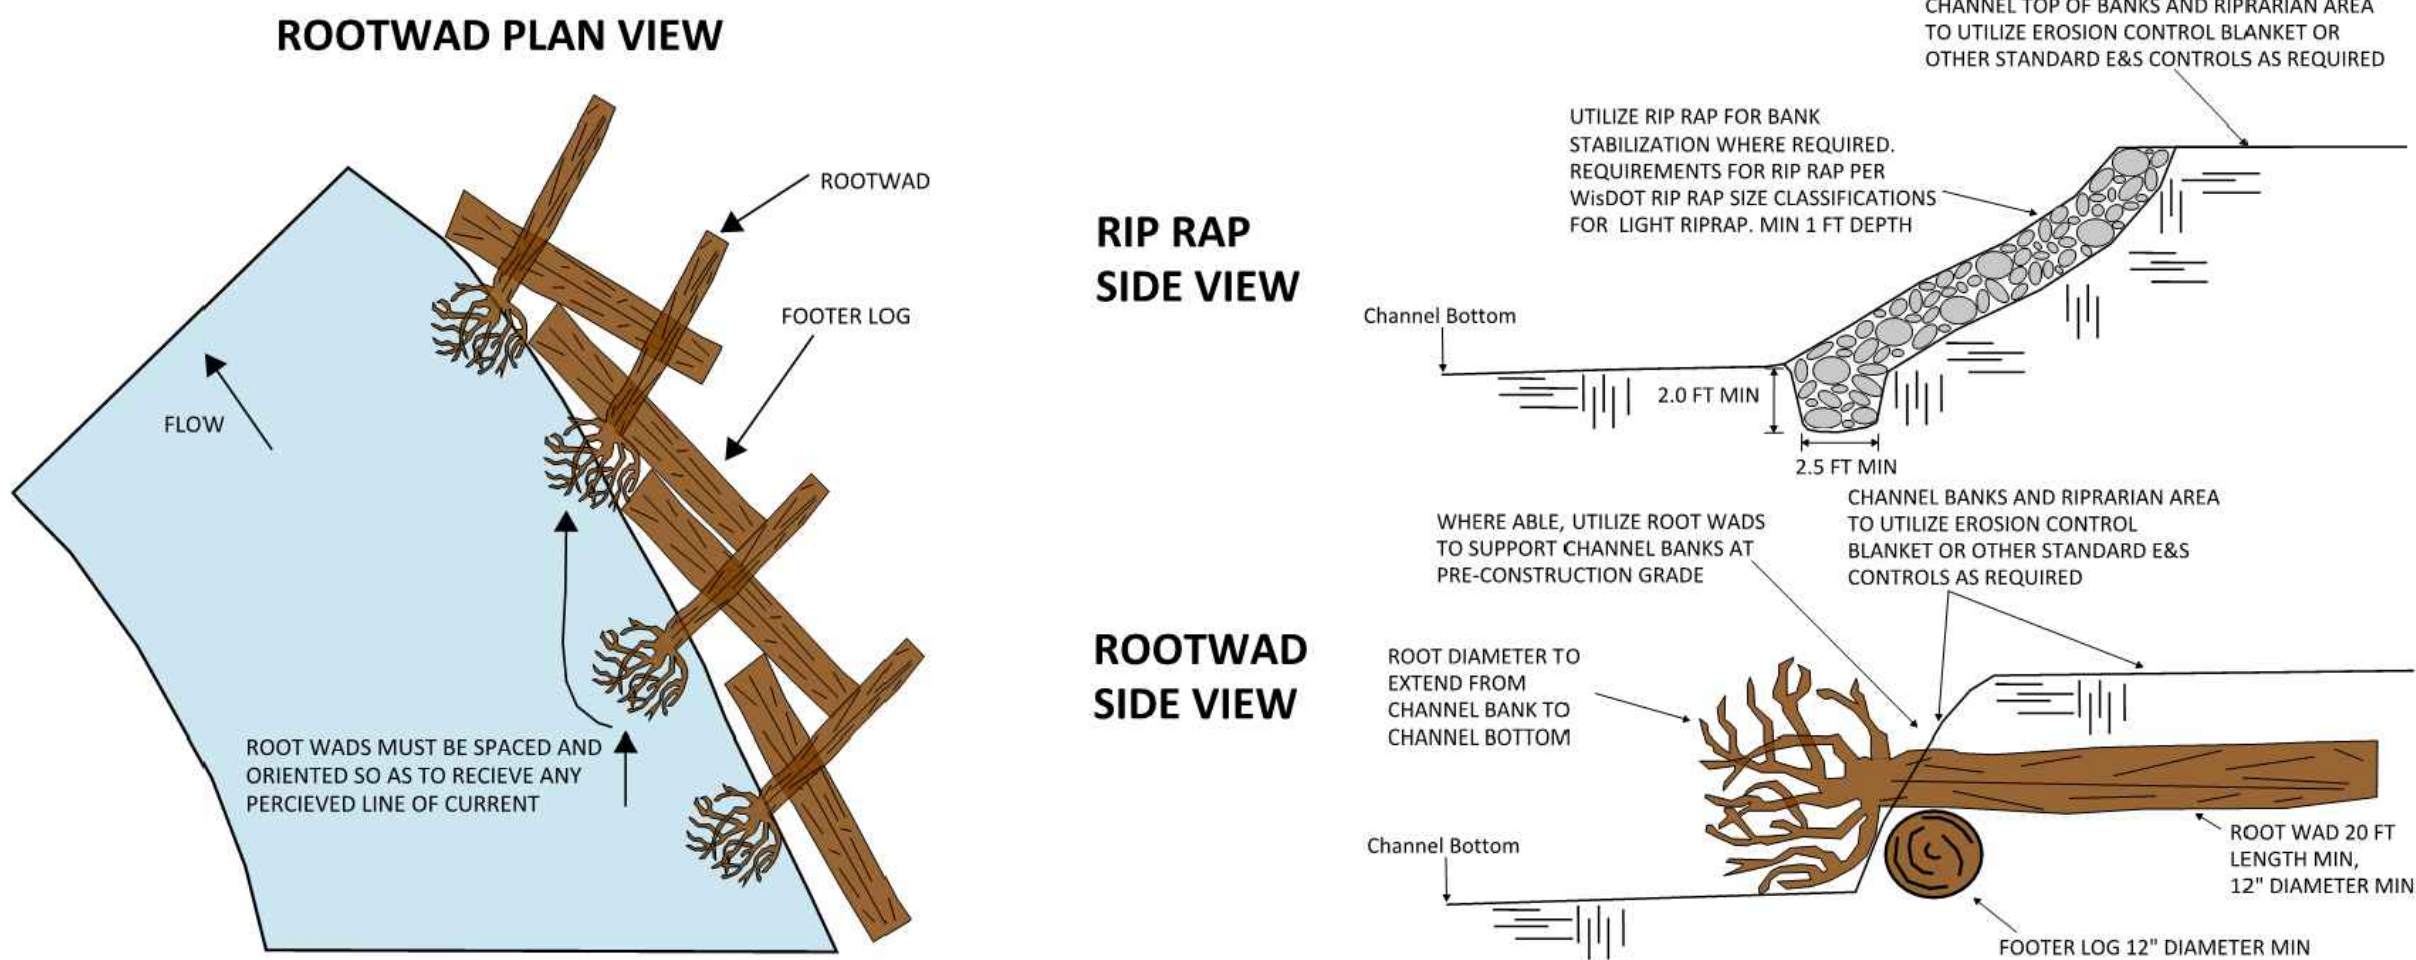
TYPICAL PLAN AND SIDE VIEW OF ROOTWADS AND RIP RAP

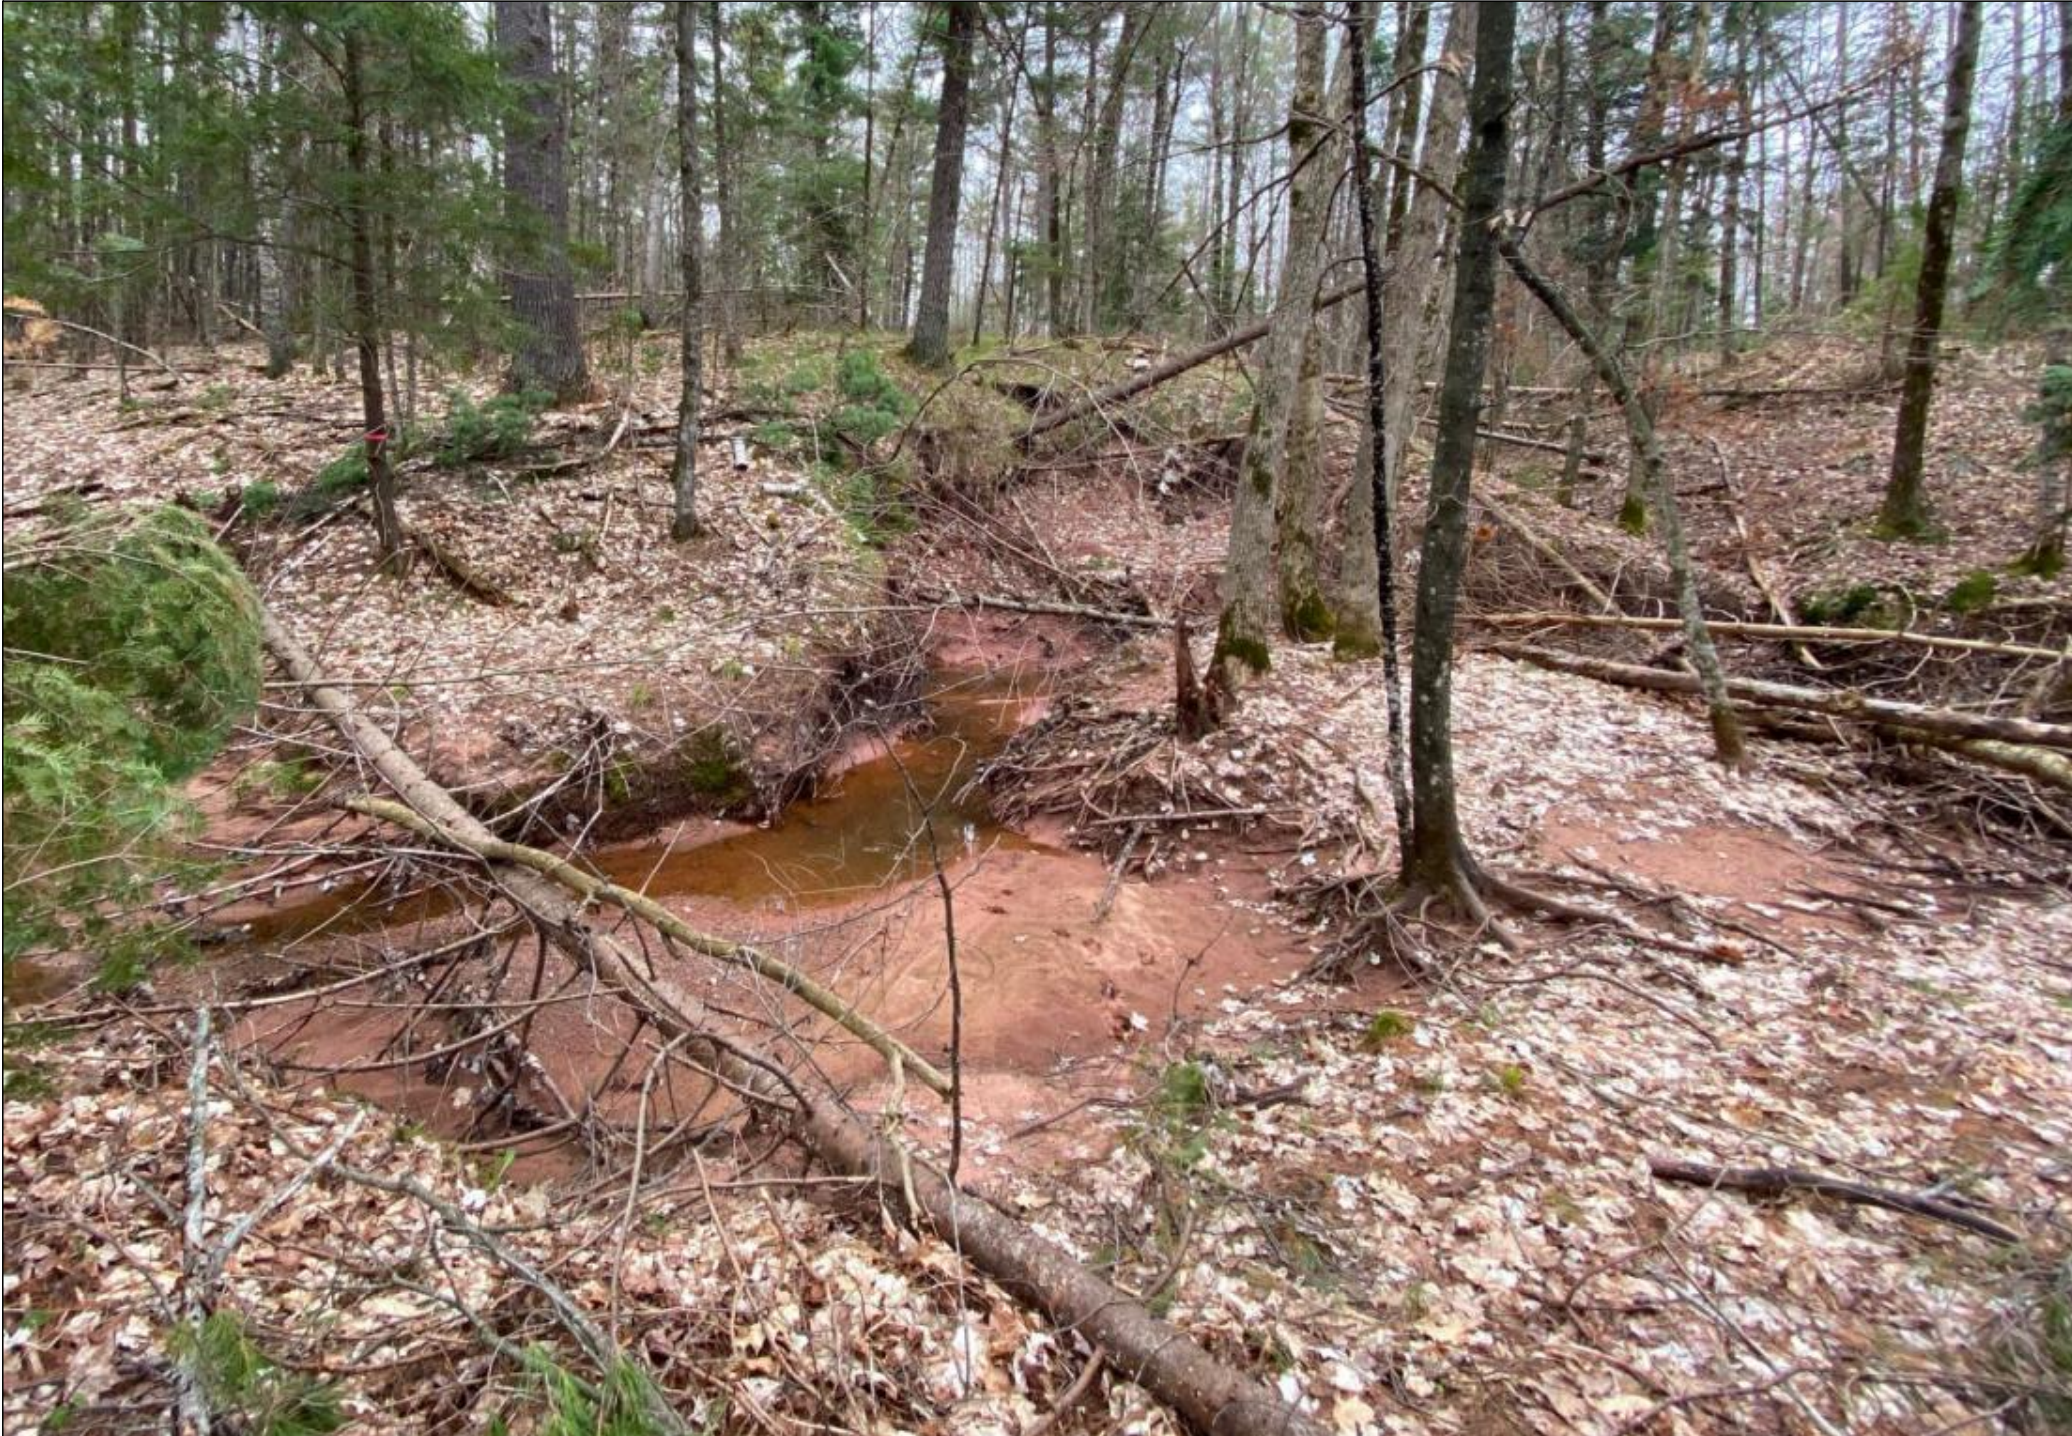
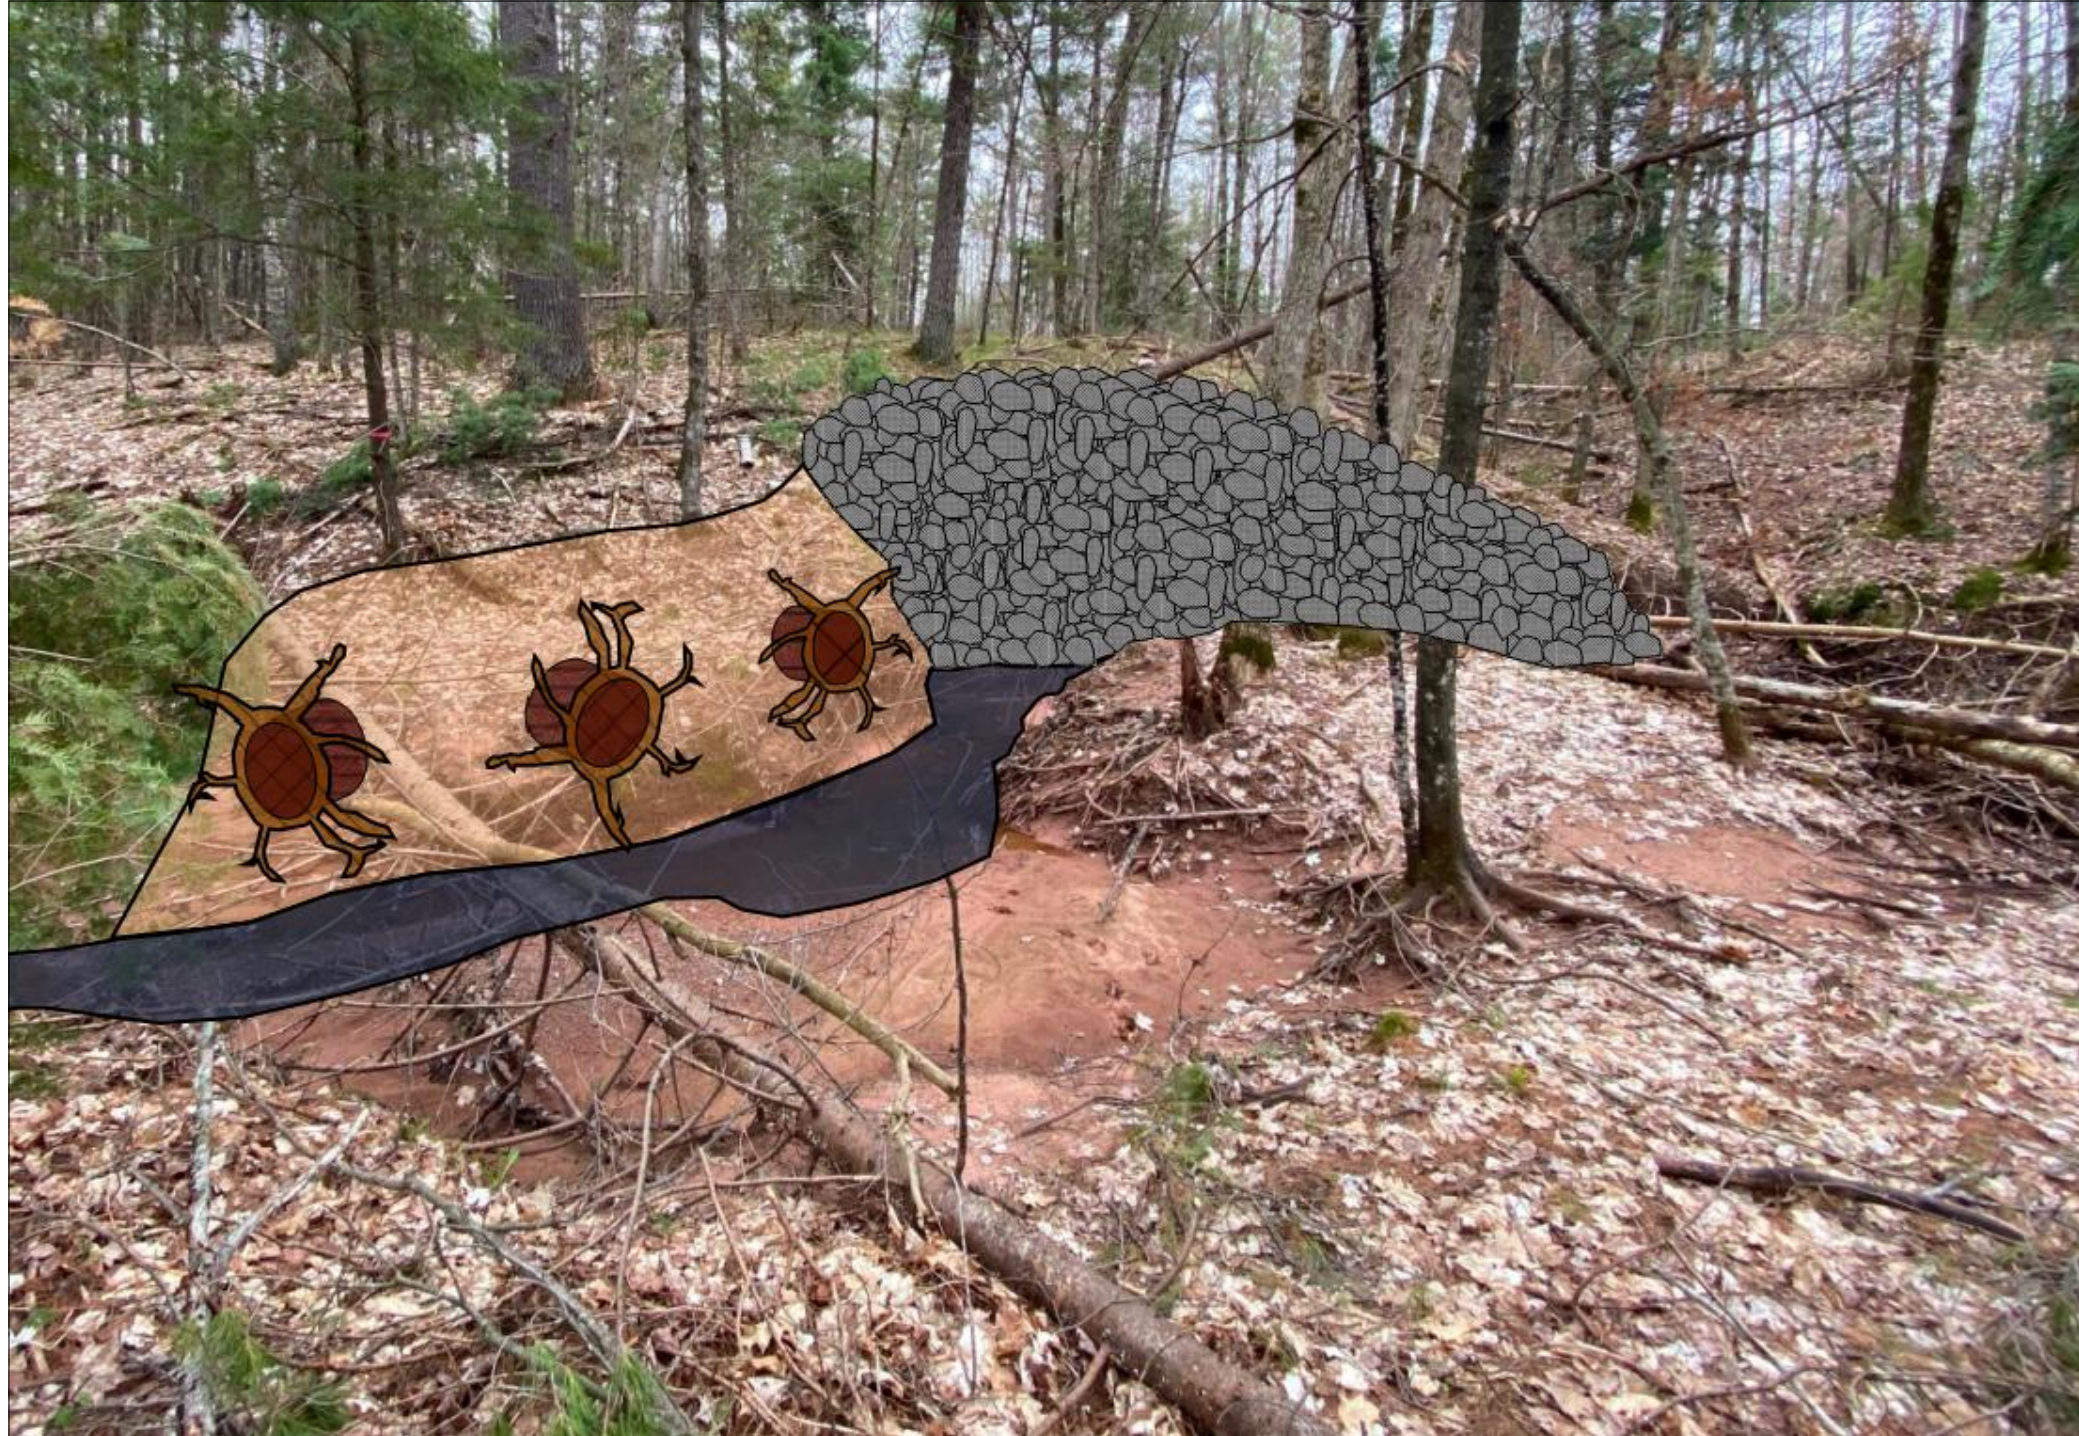
DOWNSTREAM RIGHT, EXISTING CHANNEL (NORTH BANK FOREGROUND, SOUTH BANK BACKGROUND)

DOWNSTREAM RIGHT, PROPOSED CONCEPT (NORTH BANK FOREGROUND, SOUTH BANK BACKGROUND)

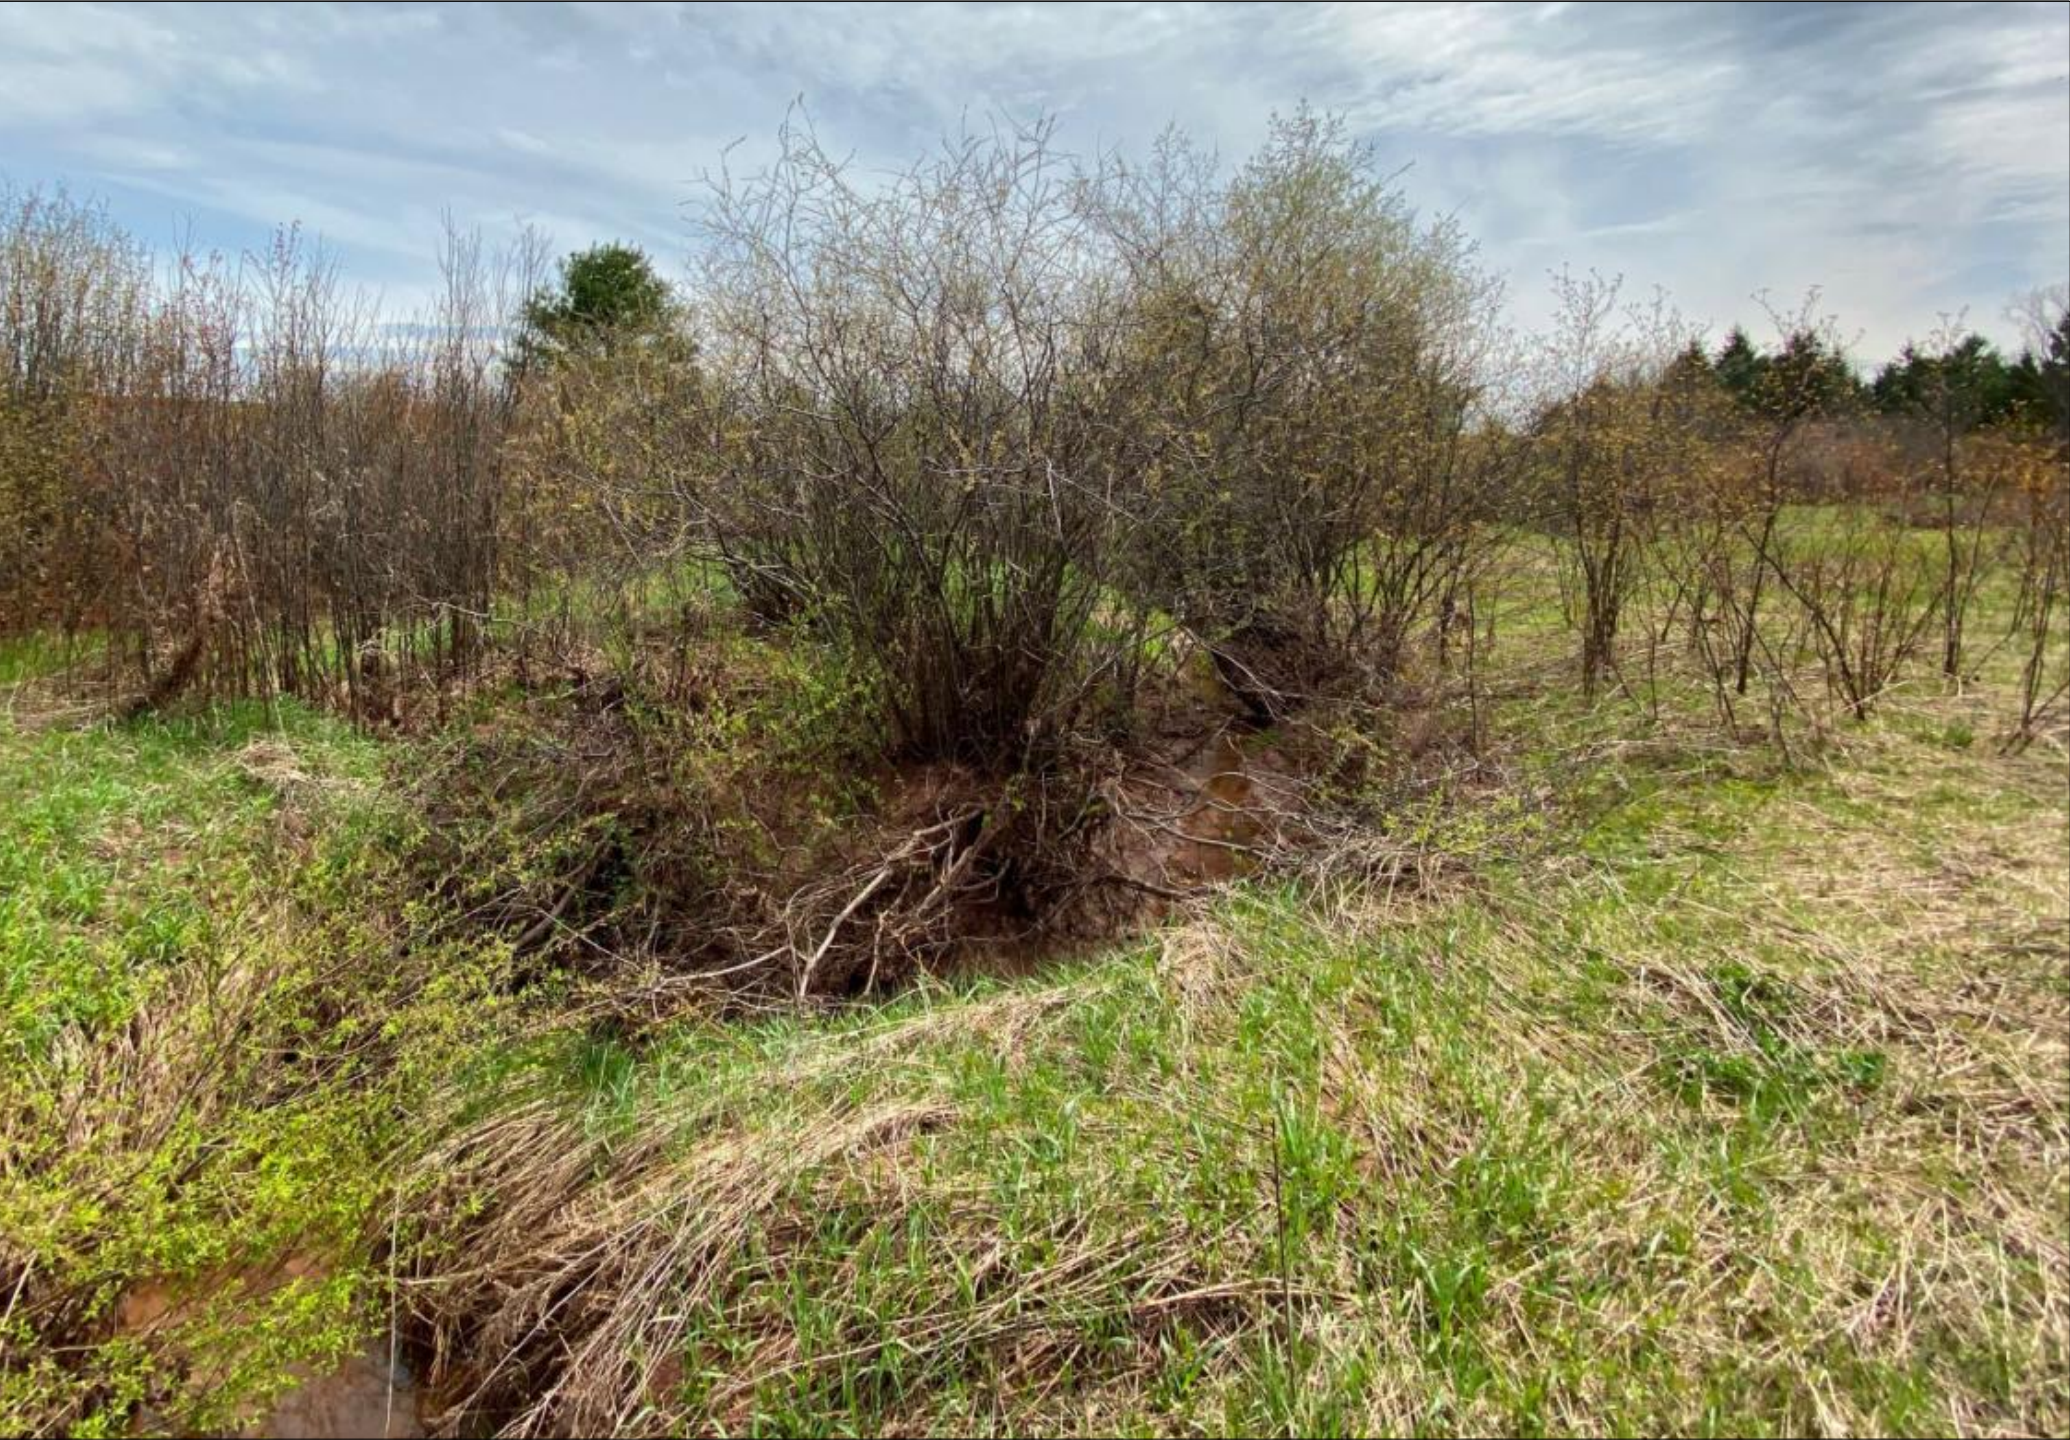
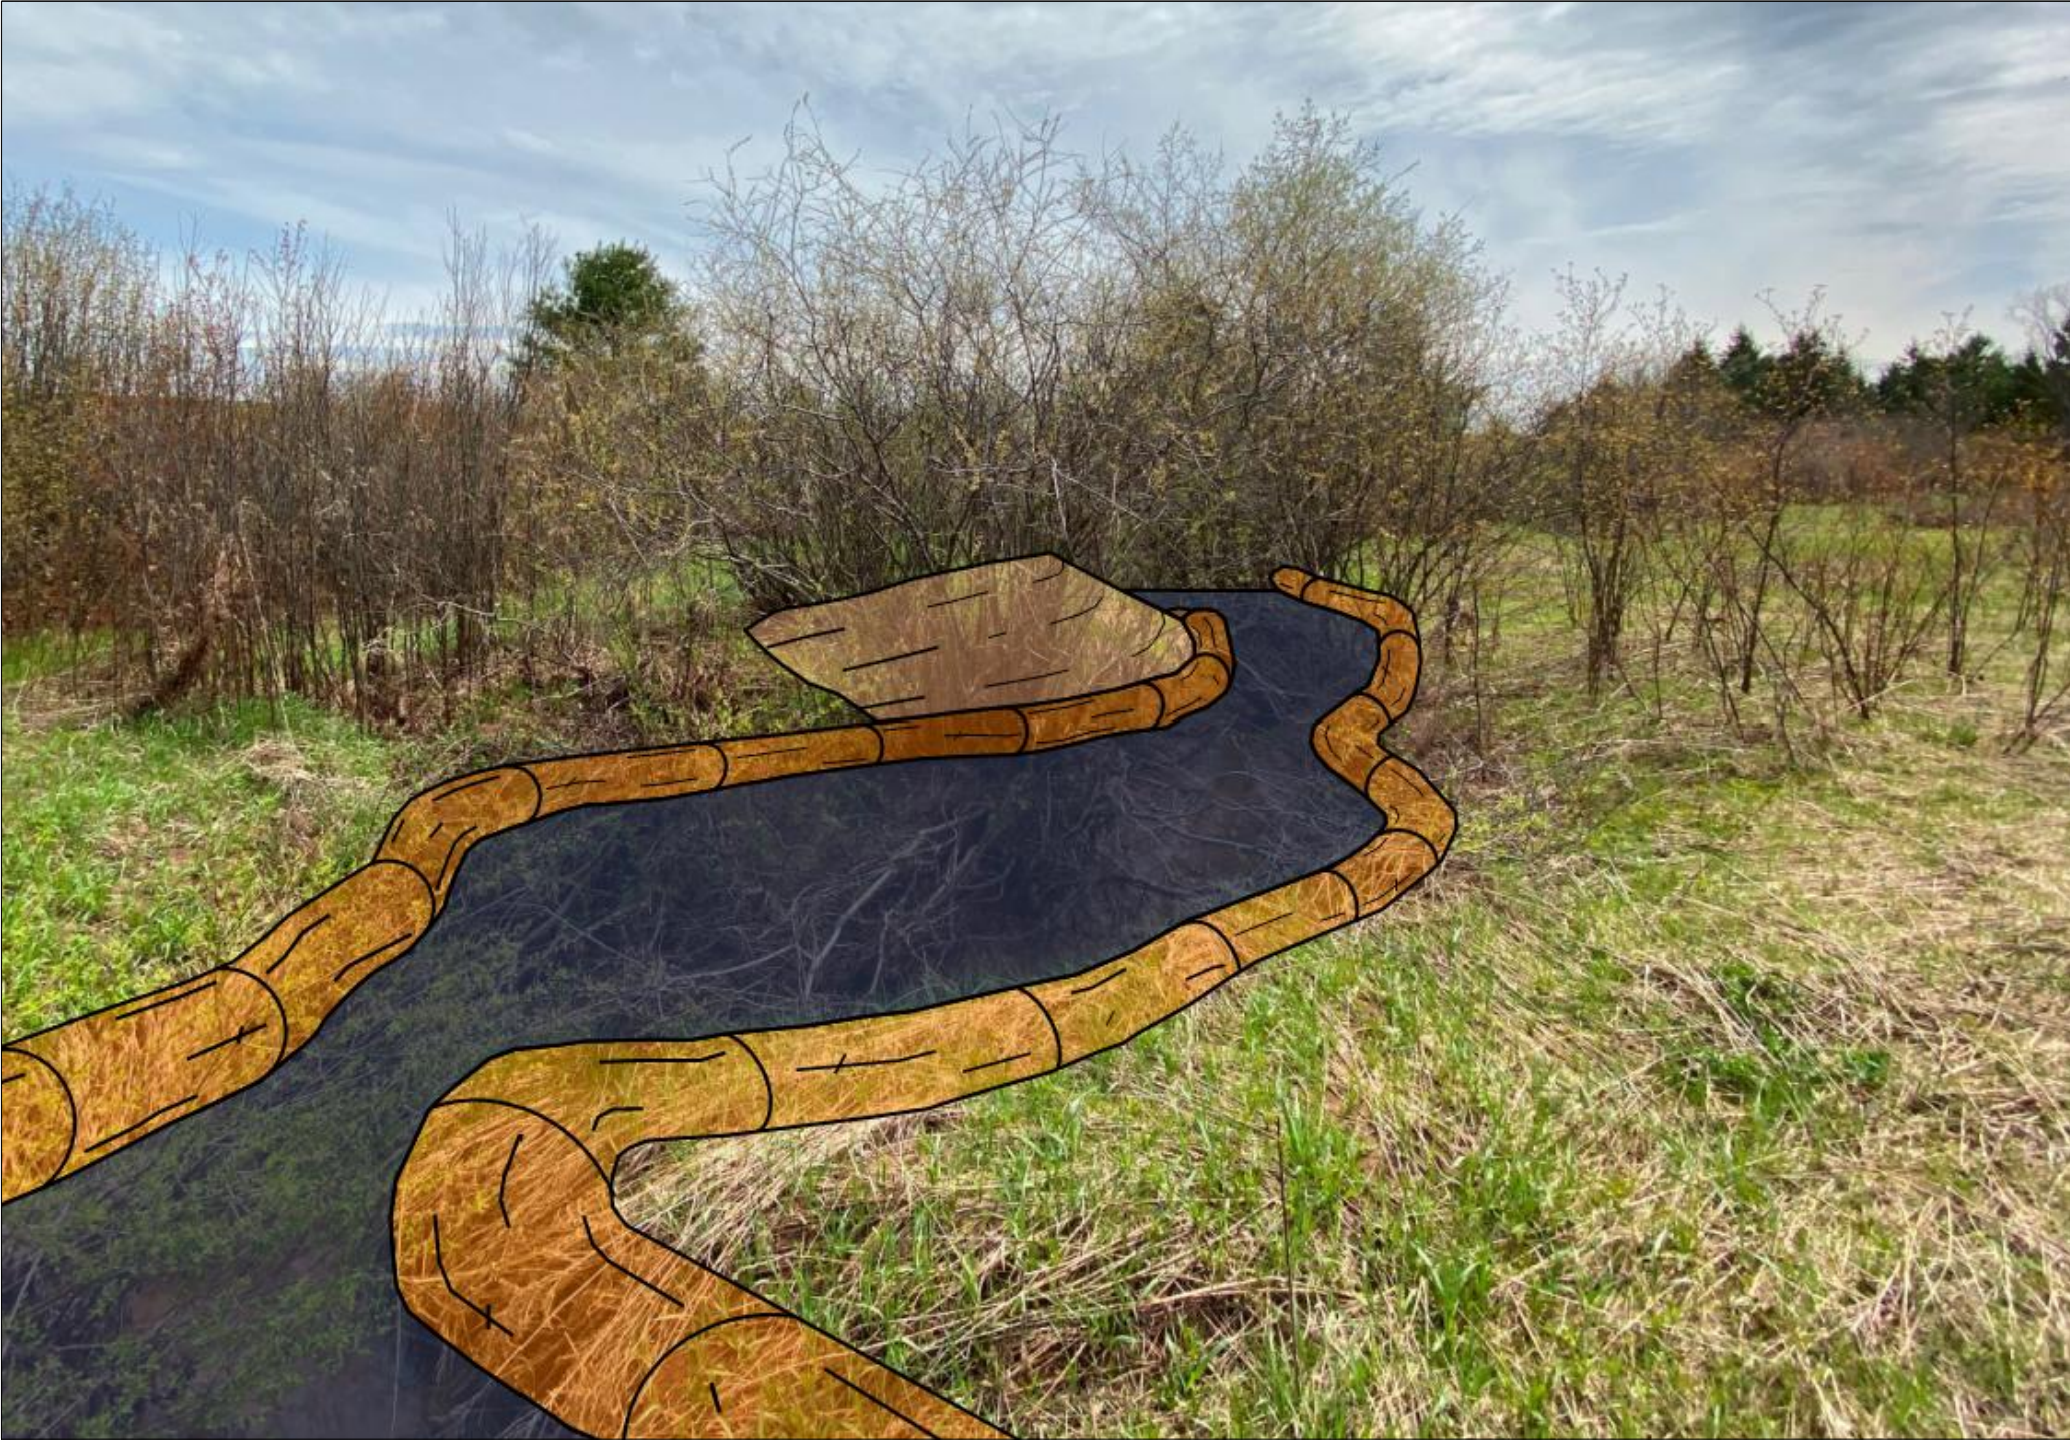
FACING UPSTREAM, EXISTING CHANNEL (EAST BANK LEFT, WEST BANK RIGHT)

FACING UPSTREAM, PROPOSED CONCEPT (EAST BANK LEFT, WEST BANK RIGHT)

- BANKS TO BE RE-GRADED AS NEEDED
- BIOLOG

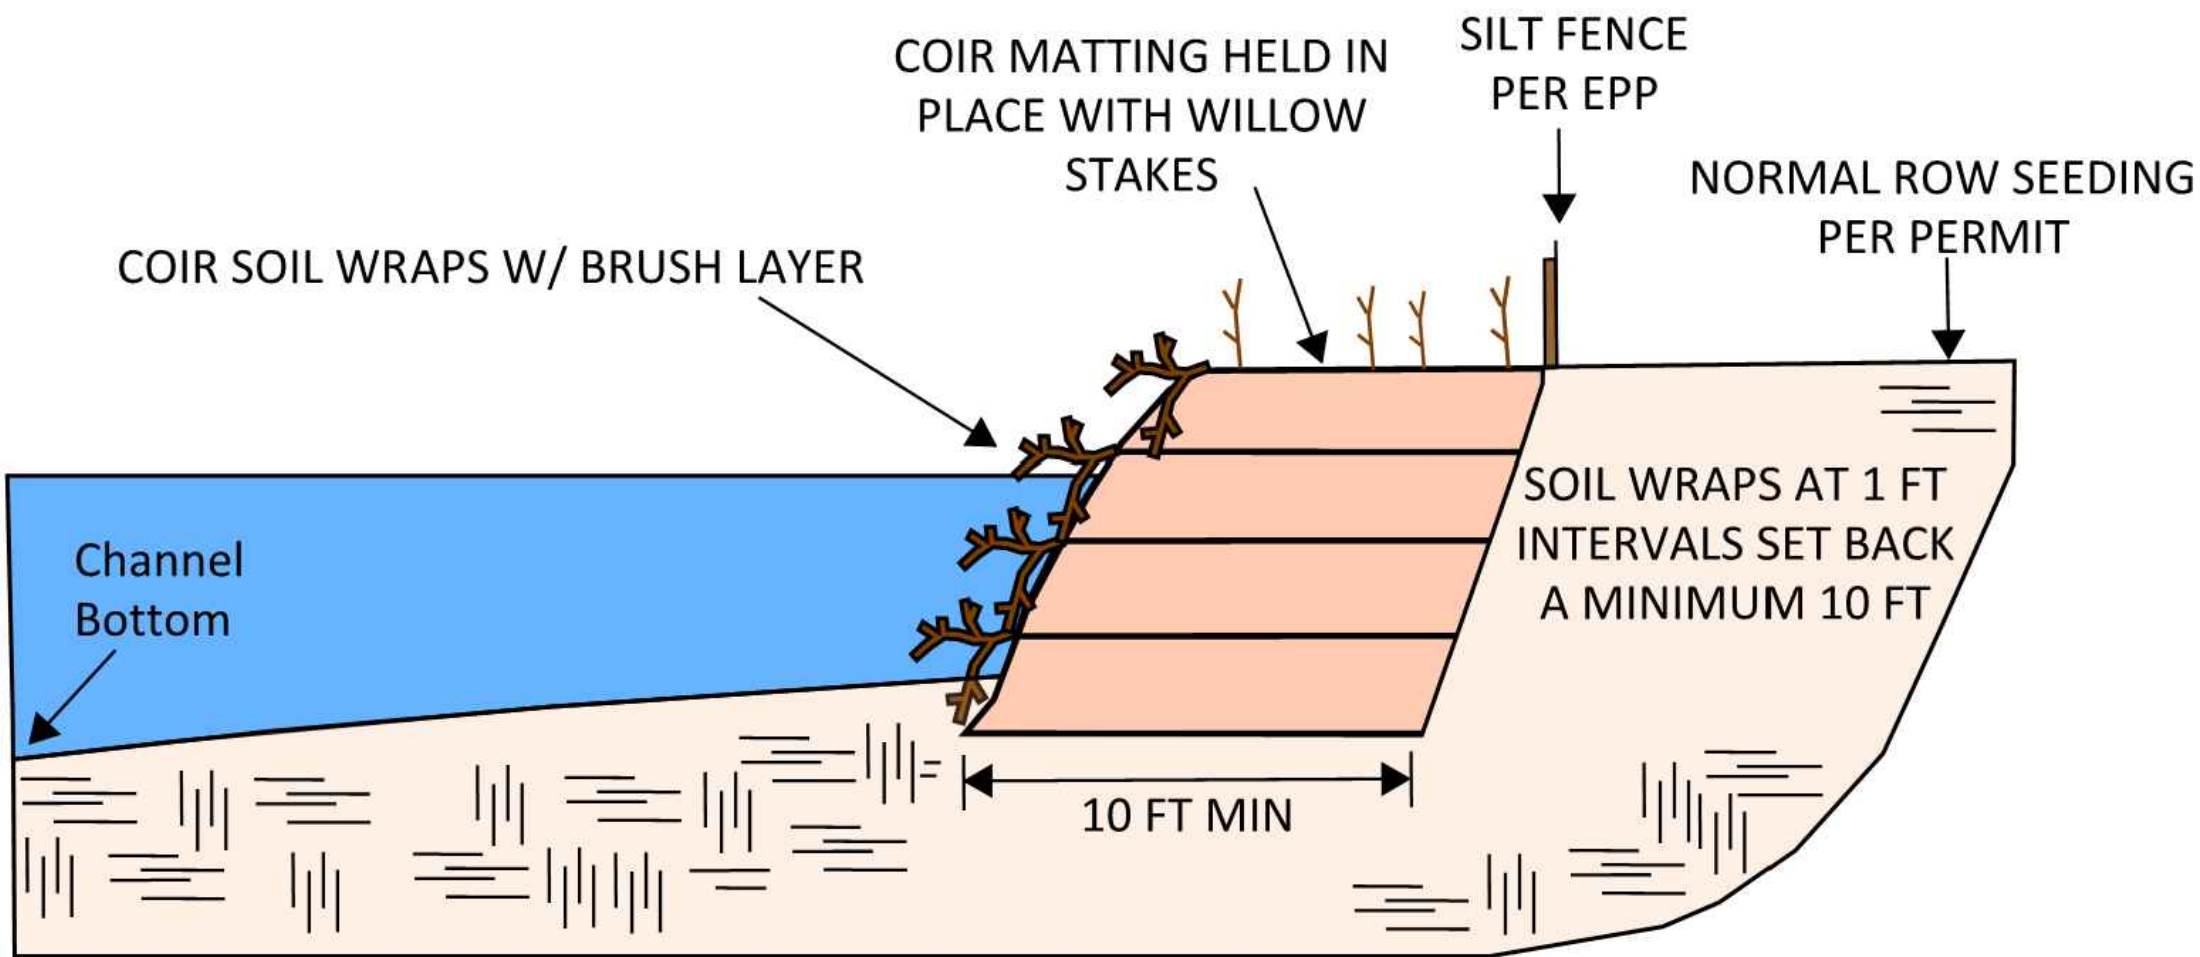
TYPICAL SIDE VIEW OF SOIL WRAPS W/ BRUSH LAYER
