**Line 5 Wisconsin Segment Relocation Project**

**Enbridge Responses to DNR Information Request Dated March 10, 2023**

**Attachment 2**

**Enbridge Line 5 Wisconsin Segment Relocation Project**  
**Responses to U.S. Army Corps of Engineers Data Request dated December 9, 2022**  
**Regulatory File # 2020-00260-WMS**

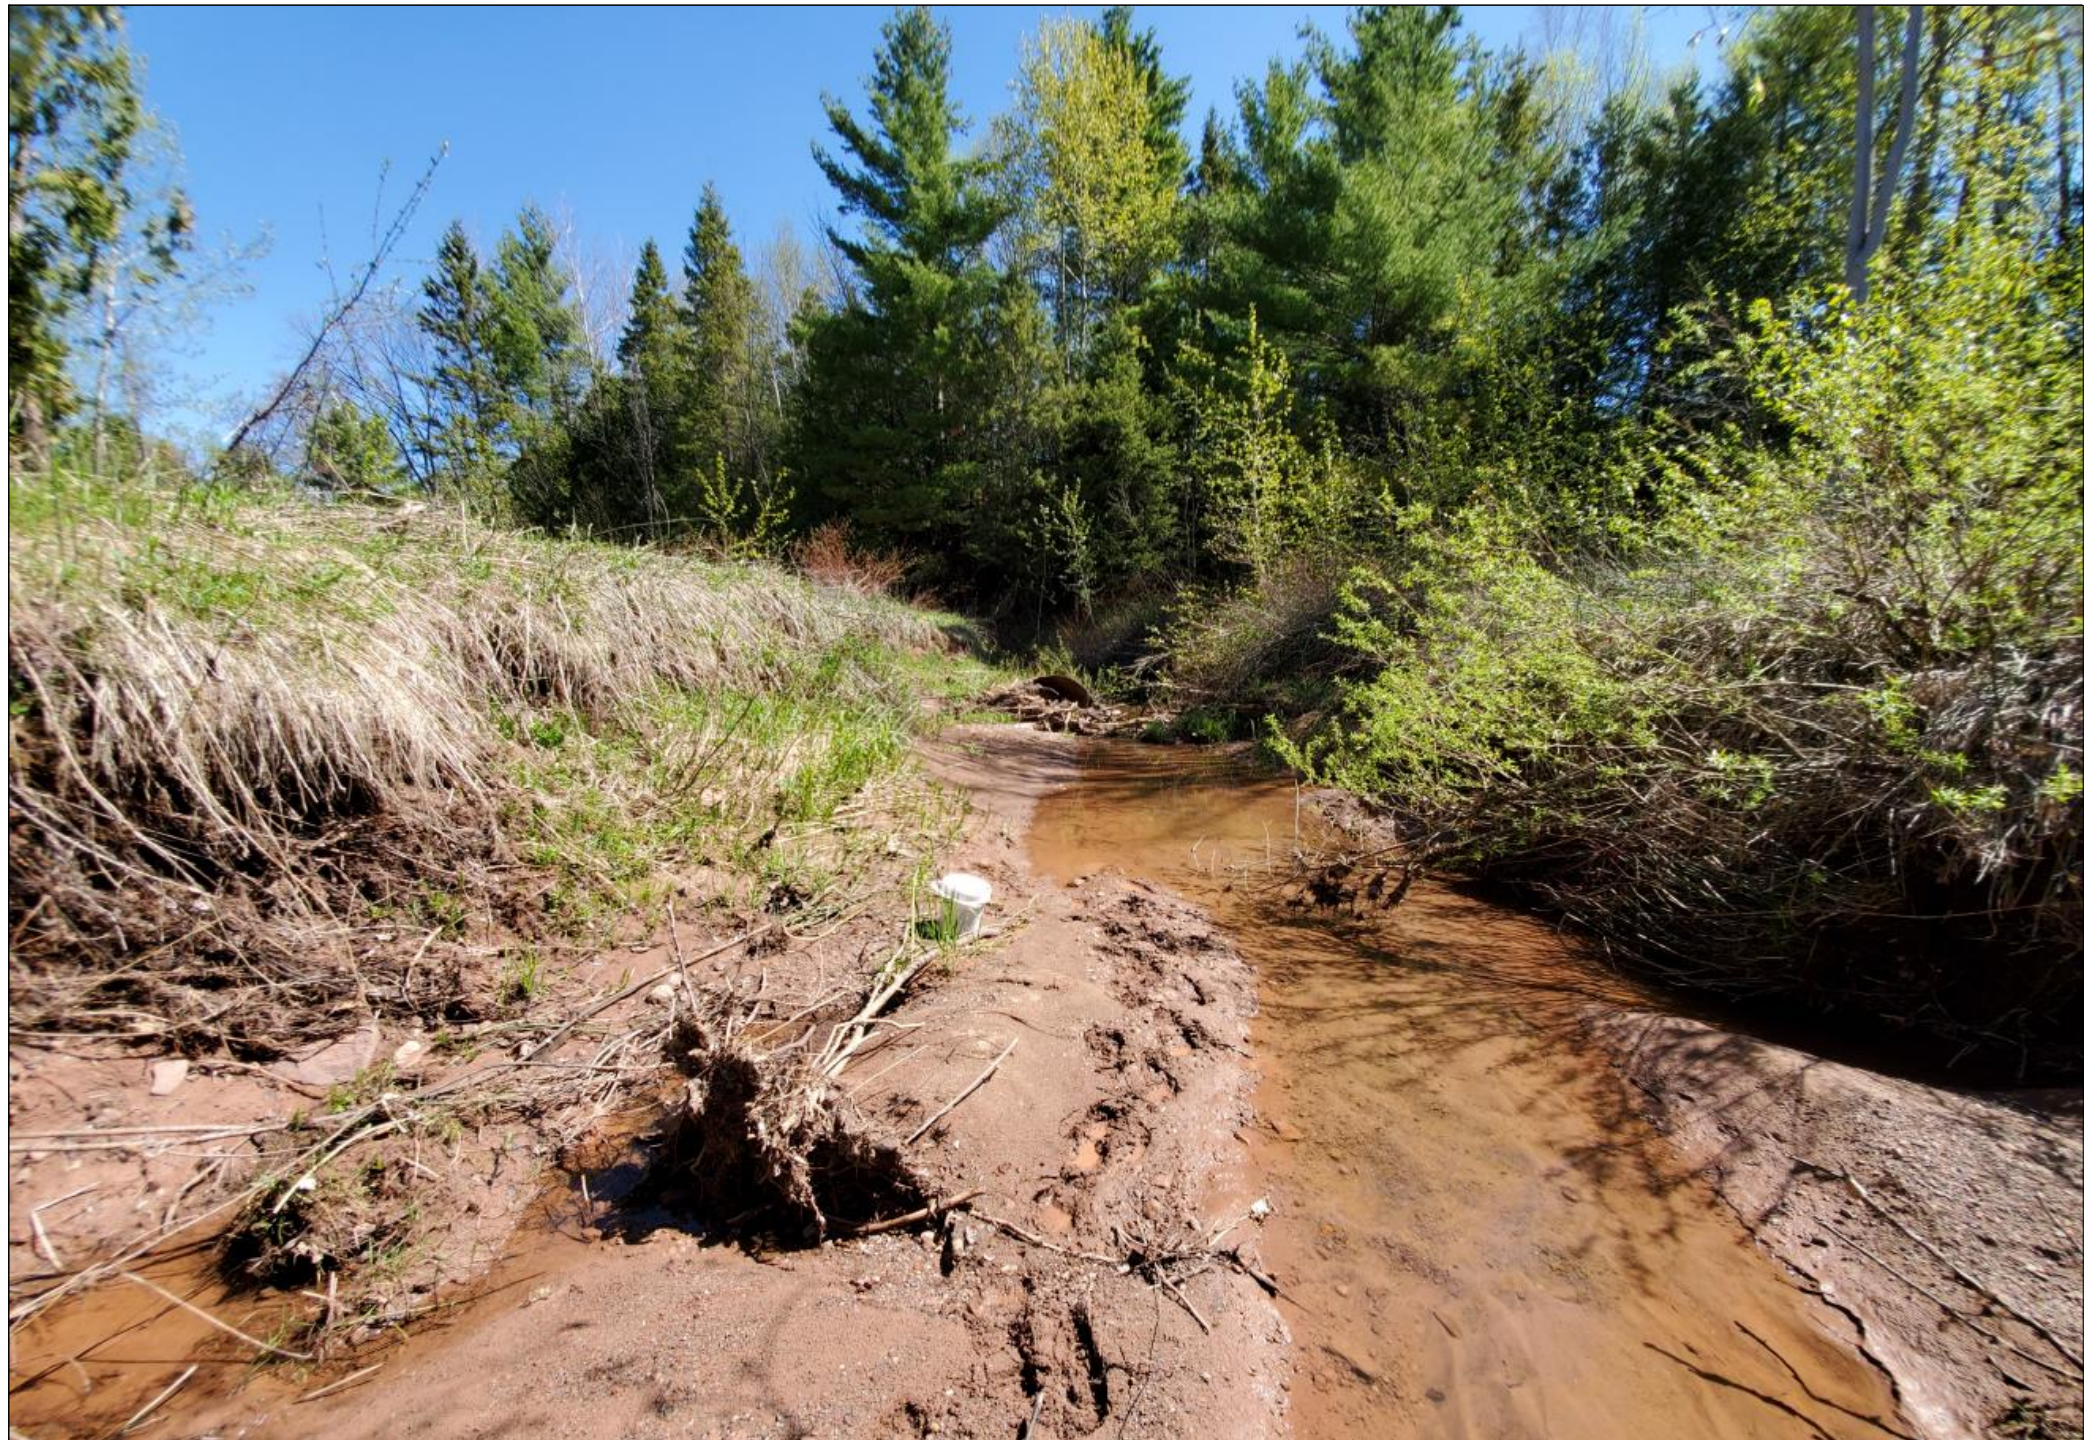
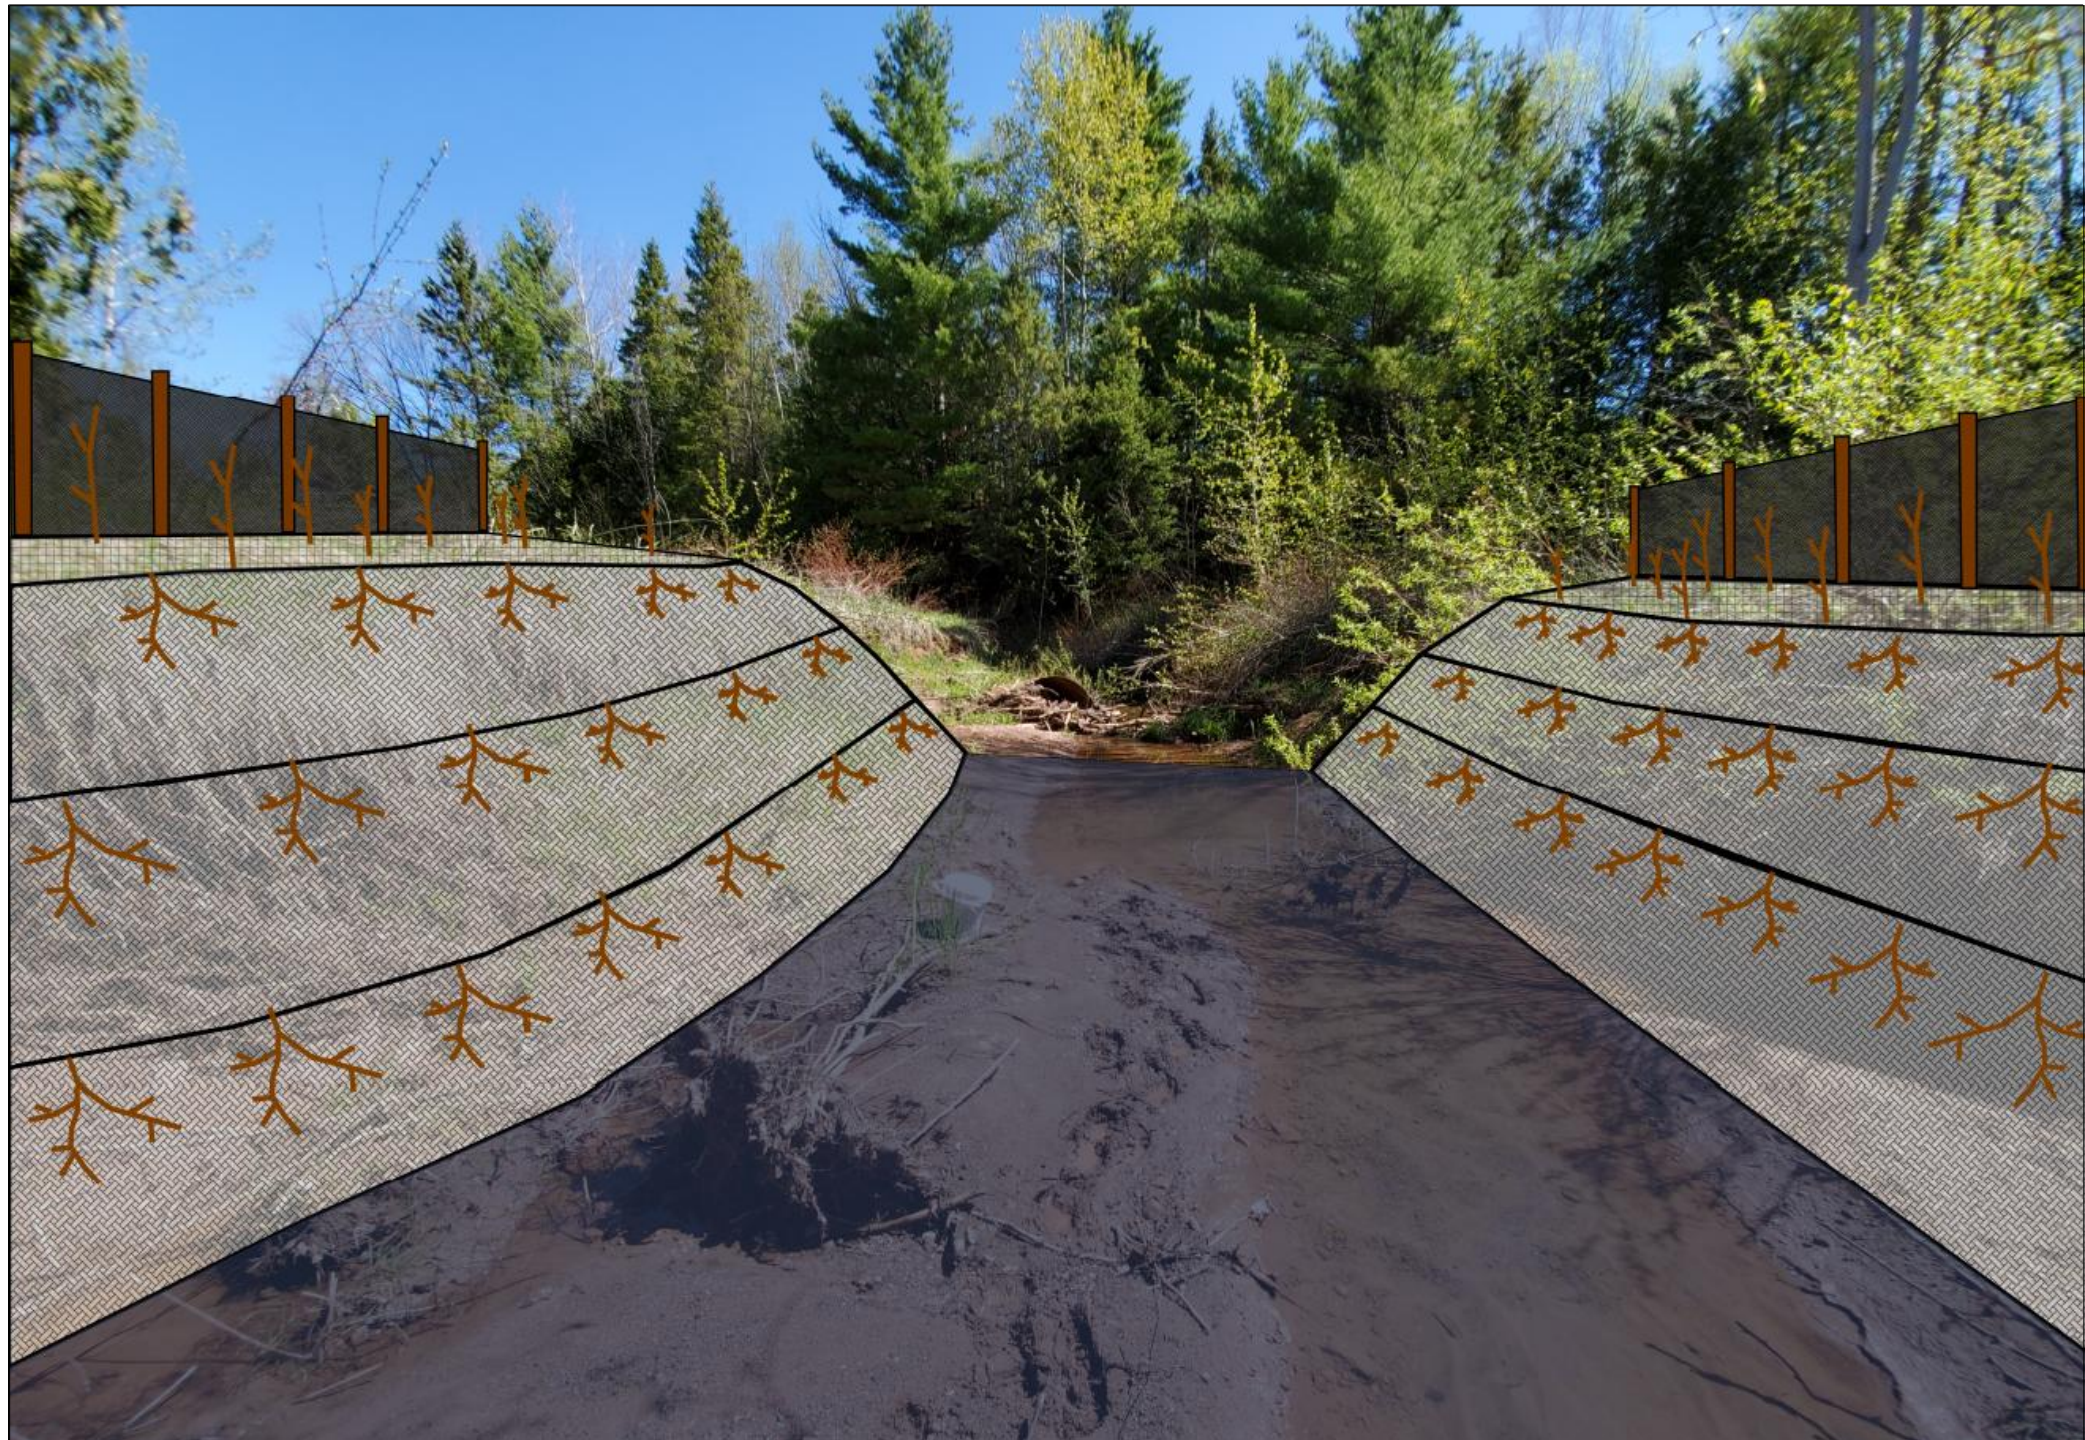
FACING DOWNSTREAM, EXISTING CHANNEL (NORTHWEST BANK LEFT, SOUTHEAST BANK RIGHT)

FACING DOWNSTREAM, PROPOSED CONCEPT (NORTHWEST BANK LEFT, SOUTHEAST BANK RIGHT)

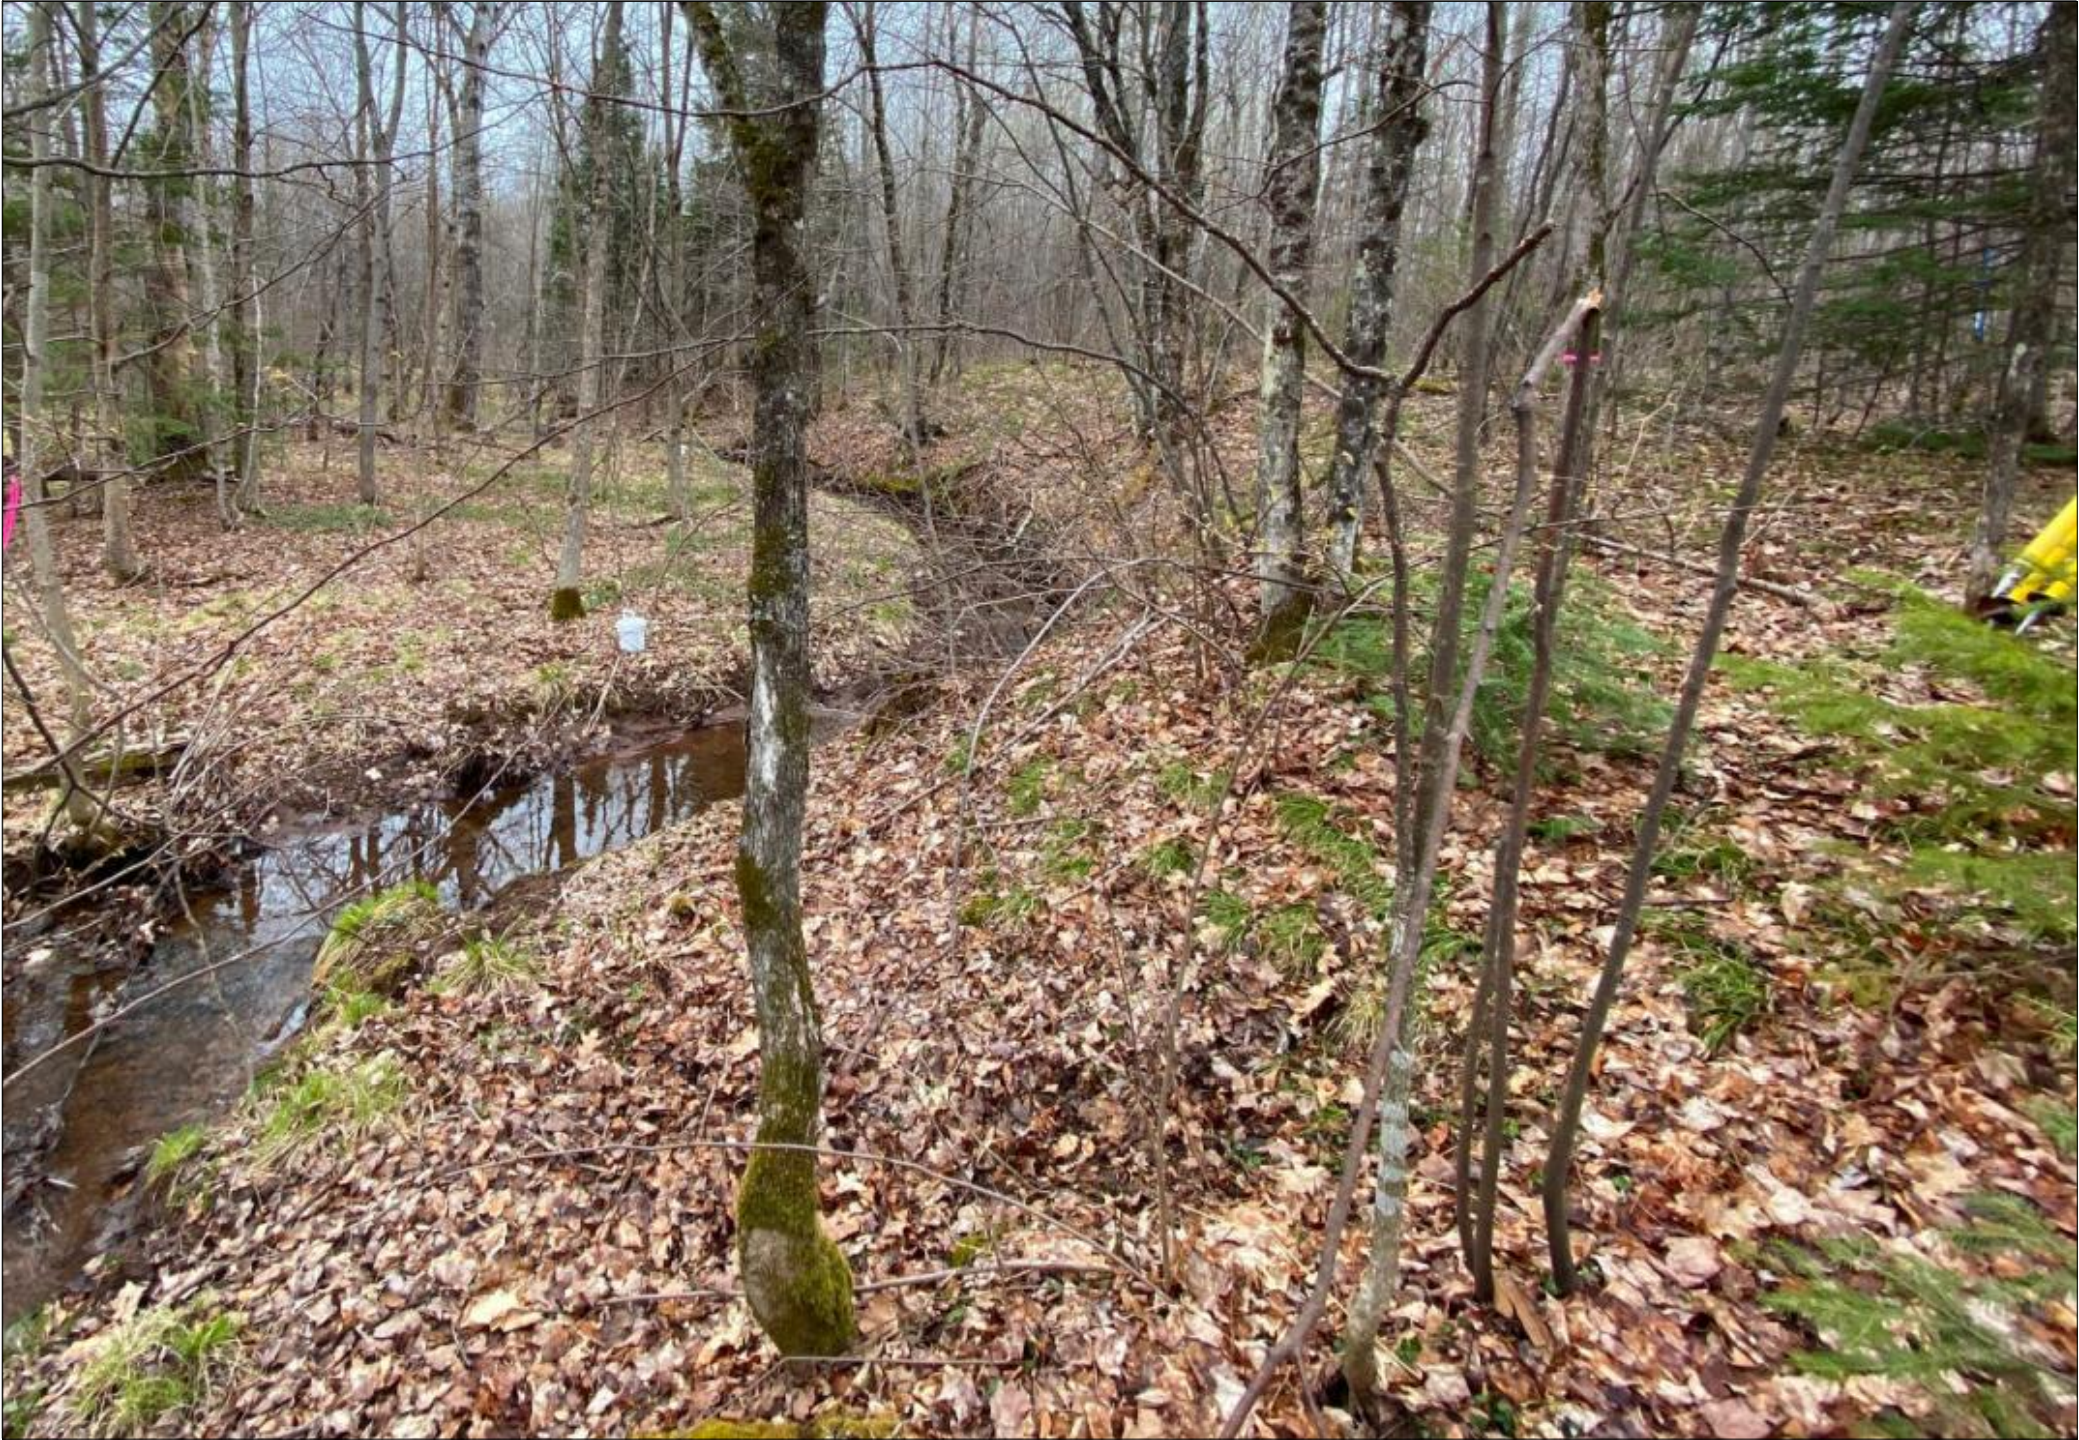
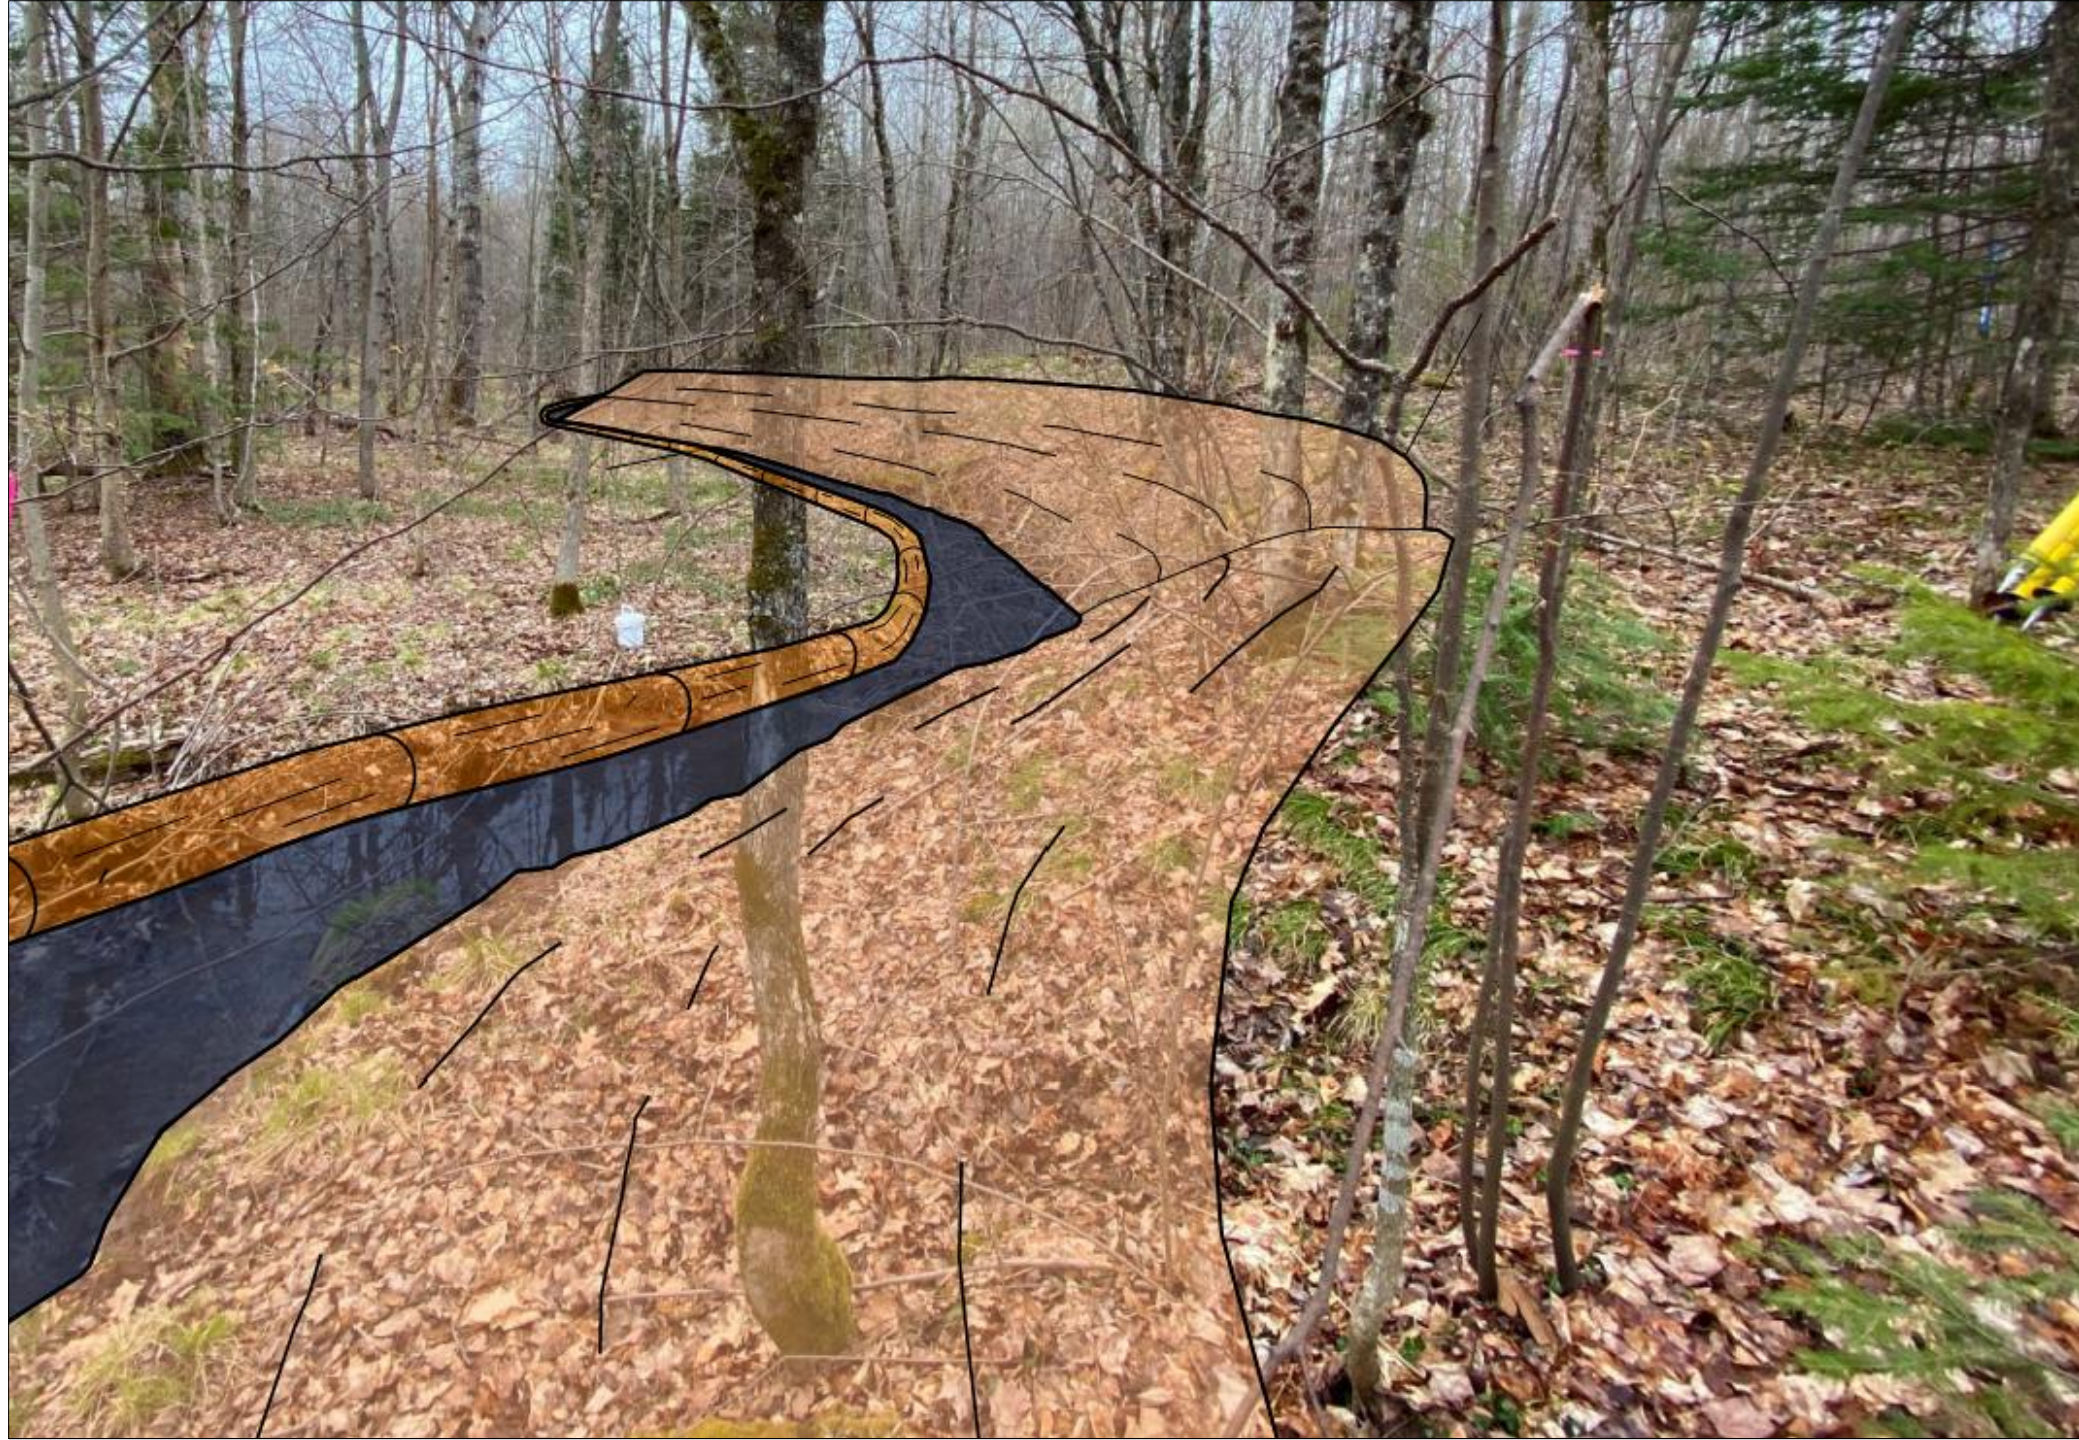
FACING UPSTREAM, EXISTING CHANNEL (EAST BANK LEFT, WEST BANK RIGHT)

FACING UPSTREAM, PROPOSED CONCEPT (EAST BANK LEFT, WEST BANK RIGHT)

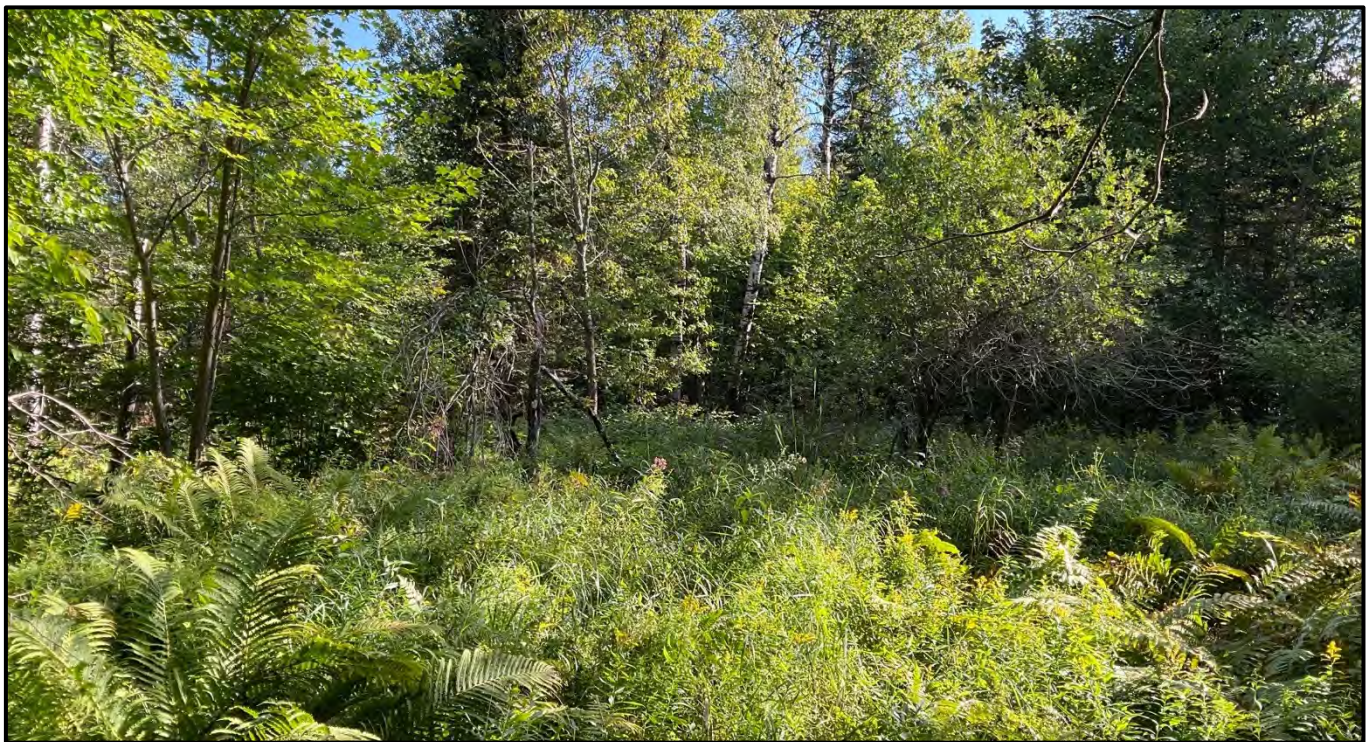
wasw023ss facing northeast - milepost 28.7

wasw023ss	Ashland	Originally classified by the delineator as an alder-thicket. Part of an overall wetland complex that includes a forested component excluded here. Open portions dominated by <i>Calamagrostis canadensis</i> , <i>Eutrochium maculatum</i> , <i>Solidago gigantea</i> , <i>Galium asprellum</i> , <i>Clematis virginiana</i> , and <i>Persicaria sagittata</i> . <i>Symphytotrichum lanceolatum</i> is present. Alder thicket associated with darker signature in the south portion of the feature. Includes waterbody flowing through with alder in the shrub layer and ground layer consisting of mostly <i>Carex bromoides</i> , along with <i>Carex scabrata</i> , <i>Equisetum fluviatile</i> , <i>Rubus pubescens</i> , and <i>Equisetum sylvaticum</i> . Only two cattail individuals, assuming <i>T. x glauca</i> but no flowers/fruits. Several <i>Cirsium arvense</i> individuals were observed. Two separate locations with the open portion, each with two individuals. On a slope with discharge as the primary source of hydrology. Southeast corner transitions from wet forest to mesic hardwood forest.	28.7

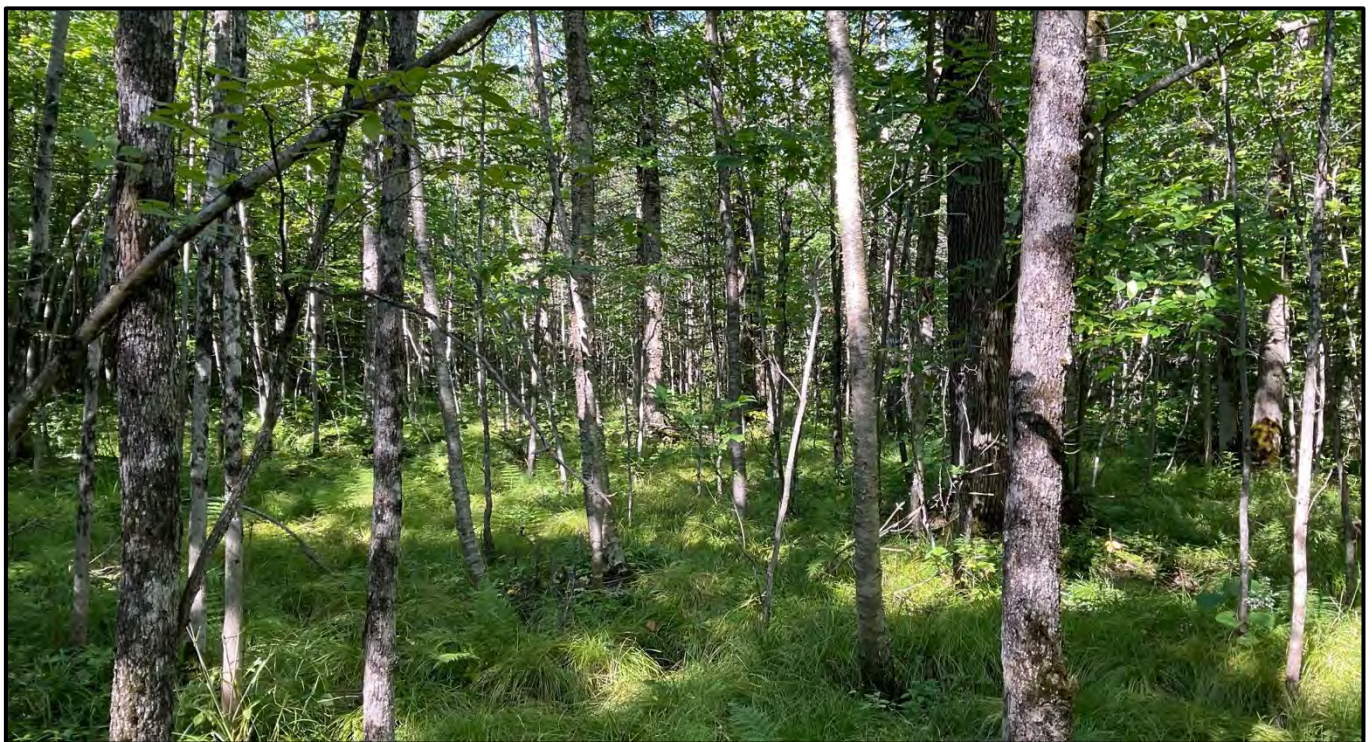
wasw024f facing west - milepost 28.8

wasw024f	Ashland	Sloped forested <i>Fraxinus nigra</i> community with discharge hydrology. Includes upland species like <i>Pteridium aquilinum</i> and <i>Eurybia macrophylla</i> . Ground layer dominated by <i>Carex bromoides</i> where open (shrub layer that is). Good condition. A few individuals of <i>Hieracium aurantiacum</i> found on the east end with <i>Eurybia macrophylla</i> . Strong area of seepage in the southeast portion of the feature. Seepage area consists of <i>Scutellaria lateriflora</i> , <i>Galium asprellum</i> , <i>Impatiens capensis</i> , and <i>Chrysosplenium americanum</i> .	28.8
wasw021f	Ashland	Mostly mesic hardwood species. Ground layer dominants include <i>Carex pedunculata</i> , <i>Mitchella repens</i> pool, <i>Acer saccharum</i> saplings, <i>Maianthemum canadense</i> , and <i>Pteridium aquilinum</i> . Also includes <i>Quercus rubra</i> . <i>Carex disperma</i> observed in one location.	29.4

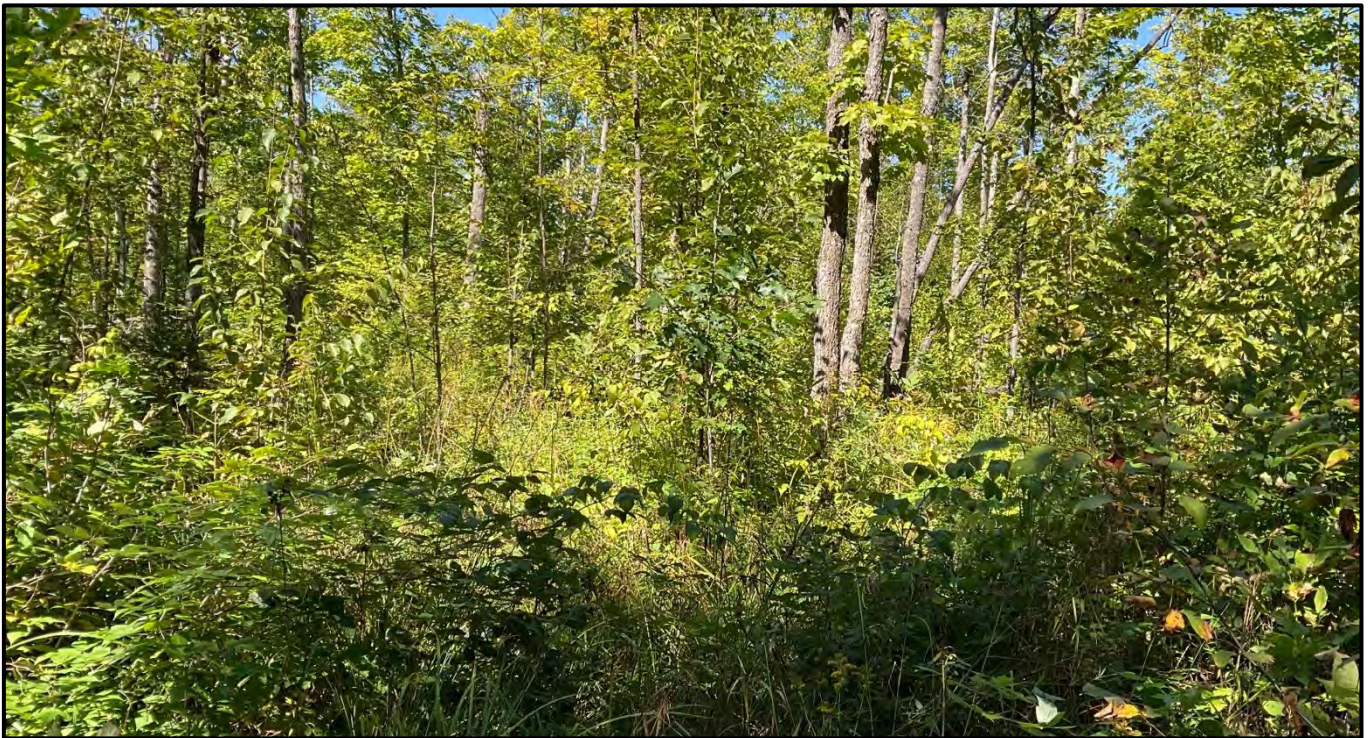
wasw026f facing north - milepost 29.5

wasw025f/wasw026f	Ashland	Mosaic of upland and wetland on the south end. Canopy of <i>Acer saccharum</i> with <i>Fraxinus pennsylvanica</i> , <i>Ostrya virginiana</i> , and <i>Acer rubrum</i> . Canopy is patchy to interrupted; low-lying areas in the open include <i>Scirpus cyperinus</i> , <i>Calamagrostis canadensis</i> , and <i>Persicaria sagittata</i> . Upland areas with thinned <i>Acer saccharum</i> and ironwood in the understory and a ground layer of <i>Lonicera canadensis</i> , <i>Carex pedunculata</i> , and <i>Fraxinus pennsylvanica</i> saplings. The second photo of a small open depression is dominated by <i>Calamagrostis canadensis</i> and <i>Scirpus cyperinus</i> , with <i>Carex crinita</i> , <i>Solidago gigantea</i> and <i>Onoclea sensibilis</i> .	29.5
wasw013ss	Ashland	The feature is a beaver complex with pockets of wet meadow, alder thicket, and hardwood swamp. Overall, shrub cover in the mapped wetland is around 50%, but sizeable areas without shrubs (e.g., wet meadow) are present. The hardwood swamp to the southwest also grades into the wetland, hence the presence of more forest-associated species. The ground layer is variable overall, but red raspberry is abundant in the open and shrub-dominated portions. There is a beaver dam present on the northeast side of the feature.	29.8

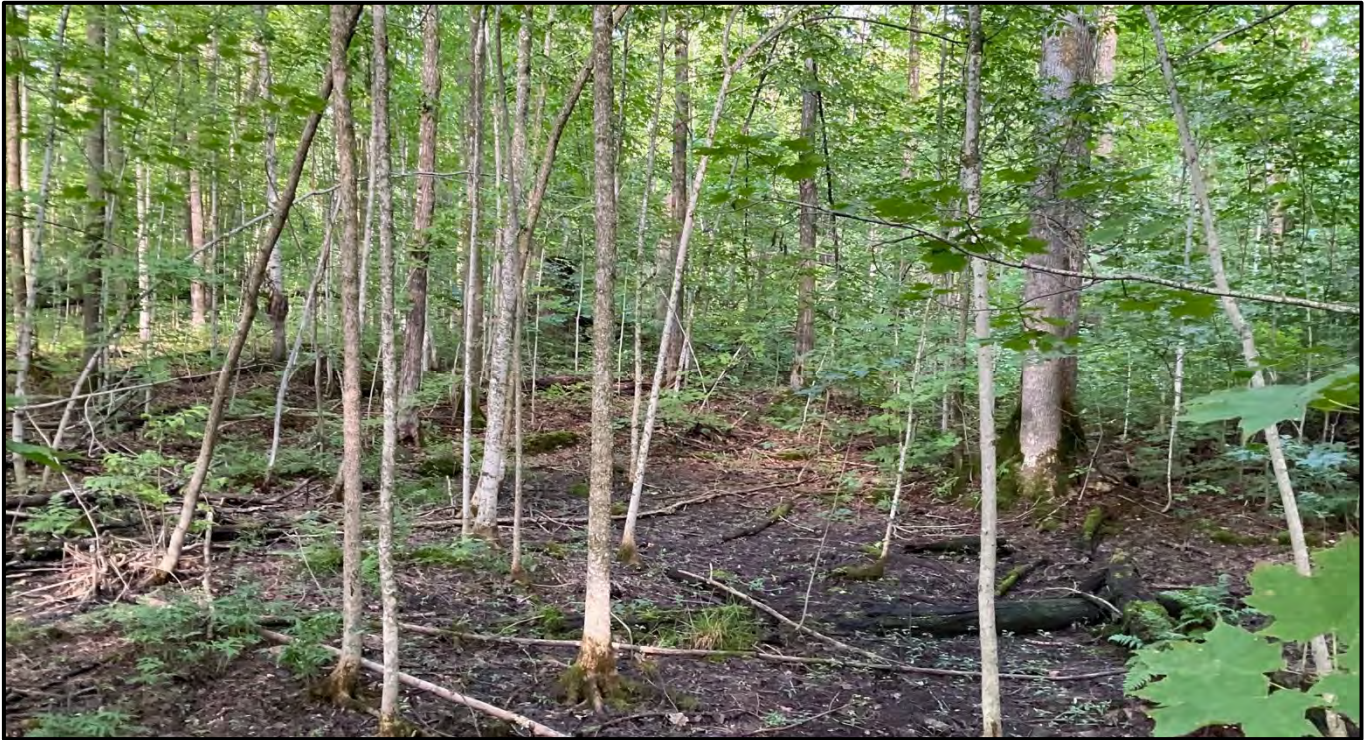
wirb1005f facing northeast - milepost 30.8

wirb1005f	Iron	Vernal pool with <i>Fraxinus nigra</i> along the perimeter. Pool devoid of vegetation with the exception of <i>Fraxinus nigra</i> seedlings. Most herbaceous cover is restricted to the perimeter of the feature. Species poor and excessively wormed.	30.8
wirb1006f	Iron	Degraded forested drainage features, sloping north, with shallow bedrock. Primarily <i>Acer saccharum</i> mixed with <i>Fraxinus pennsylvanica</i> , very little ground layer, heavily wormed with little to no leaf duff. Hydrology is questionable at this time of year. A number of uprooted trees with wetland. Reed canary grass and <i>Cirsium arvensis</i> in one location near start of tributary. Nipplewort coming in from the trail.	30.9
wirb1007f	Iron	Large wet forest complex; earthworms an issue. Forested seepage pockets dominated by <i>Carex scabrata</i> with <i>Equisetum scirpoides</i> , <i>Athyrium filix-femina</i> , <i>Fraxinus nigra</i> , and <i>Betula alleghaniensis</i> . One individual <i>Epipactis helleborine</i> is present.	31.3

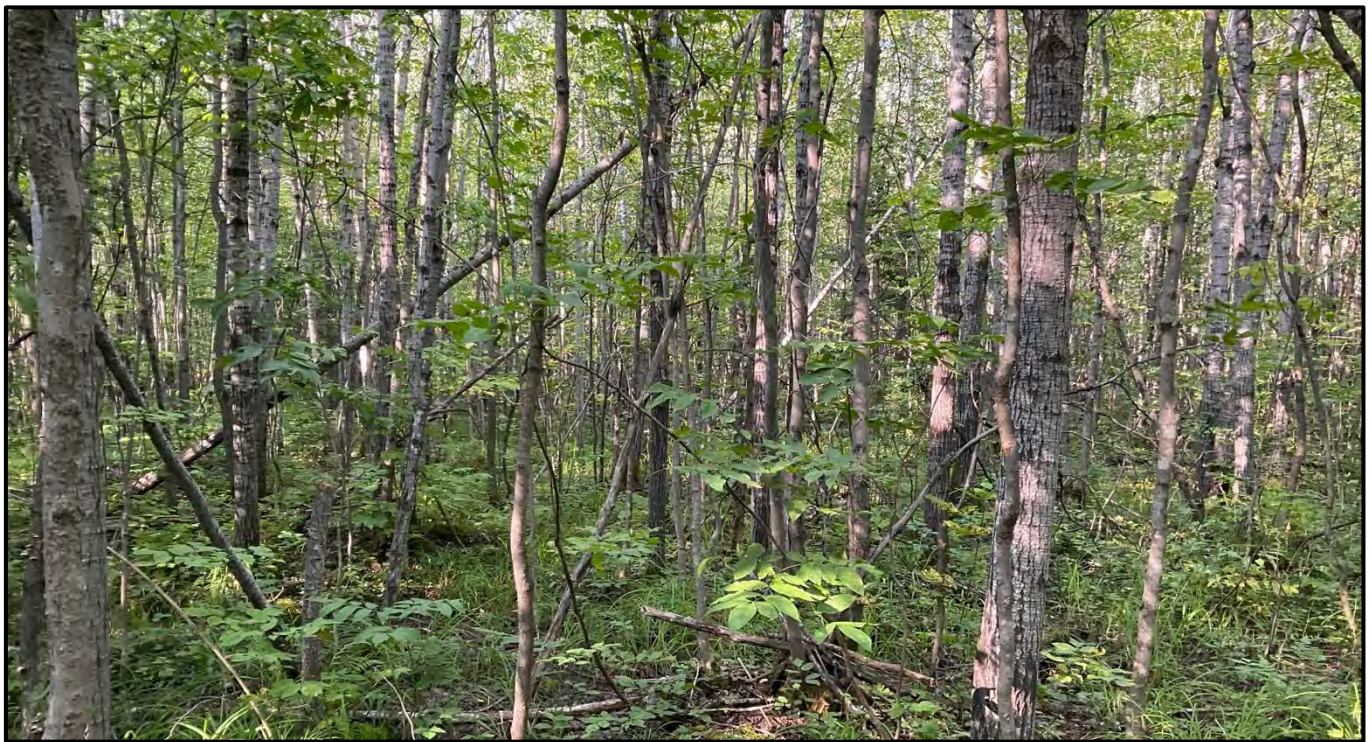
wirb046f facing north - milepost 33.4

wirb046f	Iron	Small forest depression on shallow bedrock. Mix of <i>Populus tremuloides</i> with <i>Fraxinus nigra</i> . The ground layer includes <i>Carex crinita</i> , <i>Mitchella repens</i> (elevated), and <i>Rubus pubescens</i> . Shallow dry pools.	33.4
wirb042f	Iron	The portion to the south is an intact Black ash swamp with a continuous canopy cover of <i>Fraxinus nigra</i> and a ground layer of <i>Calamagrostis canadensis</i> , <i>Carex crinita</i> , and <i>Doellingeria umbellata</i> . <i>Rubus pubescens</i> is present but restricted to elevated mounds.	33.6
wirb039s	Iron	Depression over shallow bedrock with small, elevated rises within. Really a wet meadow but has enough shrub cover to be a PSS thus shrub-carr. Not representative of a natural wetland community. Likely affected by logging in the past. Includes a linear finger of <i>Fraxinus nigra</i> .	33.7
wirb037s	Iron	Riverine fringe floodplain wetland, that includes a linear vernal pool. Not a truly definable wetland plant community, but rather a floodplain feature.	34.0
