**SWAN LAKE FIRST NATION – MATRIX SOLUTIONS
INC. PARTNERSHIP**

INDIGENOUS CONSTRUCTION MONITORING

WEEKLY REPORT

OCTOBER 15TH TO OCTOBER 20TH

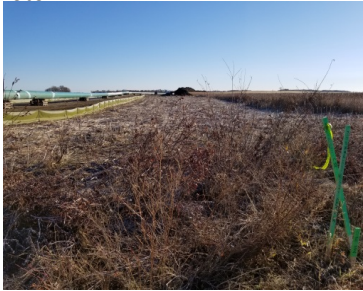
Description & Location KP 829+253

Photo taken facing east
Photo of the wetlands
No concerns

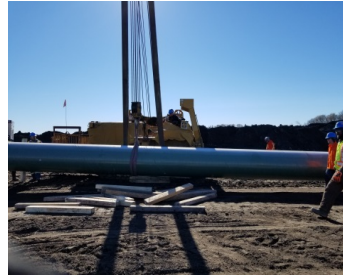
Description & Location KP 865+167

Photo taken facing south
Side booms moving the pipe
Welders to start the welding.

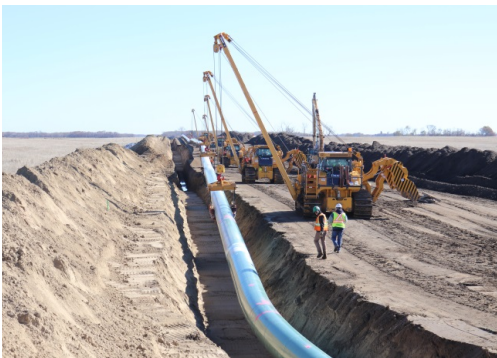
Description & Location: SSKP 828+000

Lowering In crew
Lowering in section into trench
Water in trench from wetland
Facing east

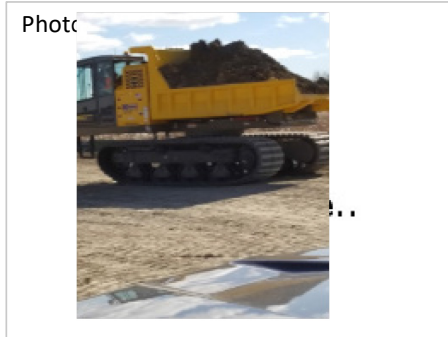
Description & Location KP- 829+400

Photo taken facing south
Nodwell hauling soil to wetlands ramps

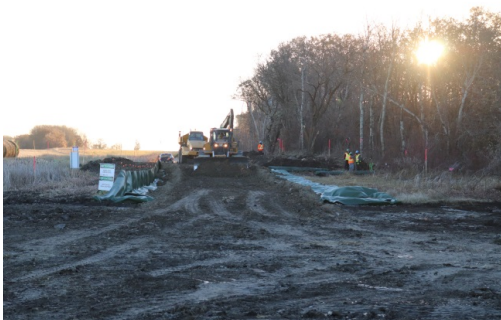
Description & Location: SSKP 889+240

Access crew
Building wetland ramps in two areas
MB-115 & MB-116 wetlands
Facing east

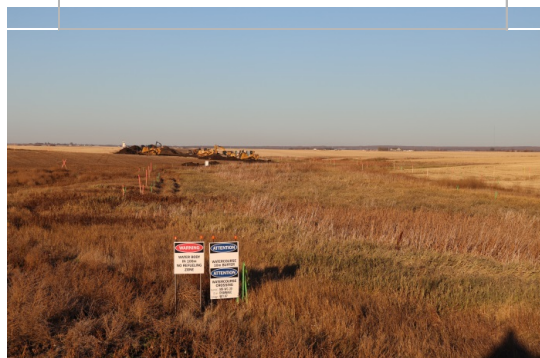
Description & Location: SSKP 902+160

Watercourse Drainage MB-WC30
Grade Crew in top of picture
Wetland ramp to be built tomorrow
Facing west, will monitor tomorrow

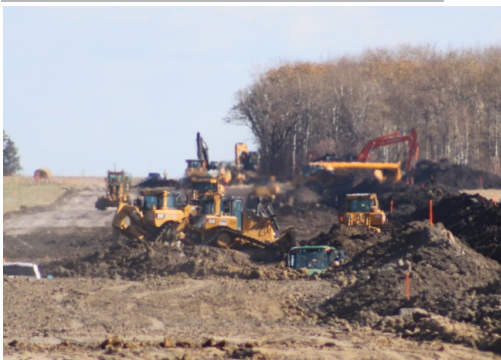
Description & Location: SSKP 888+000

Grade Crew
Stripping and pushing topsoil
Also in wetlands MB-113 & MB-114
Facing east

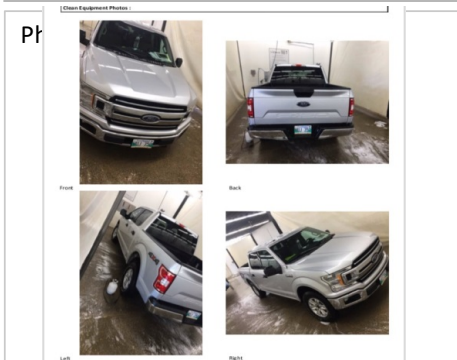
Description & Location: Car Wash Brandon

New truck disinfected and clean
Good for ROW driving
Old truck was recalled switched vehicles

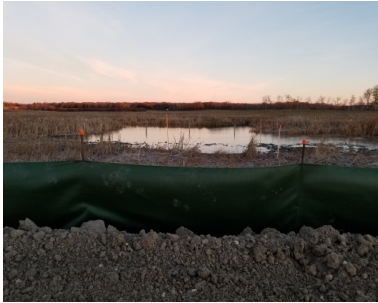
Description & Location KP-886+600

Photo taken facing north.
Ice and frost on pond and surrounding area.
No activity.

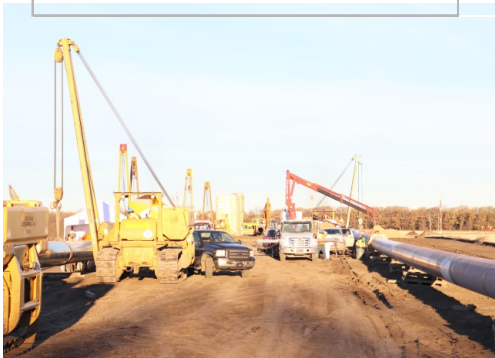
Description & Location: 908+000

Souris River HDD section
Coating on right coating HDD section
Welders on Left welding wing section
Facing west

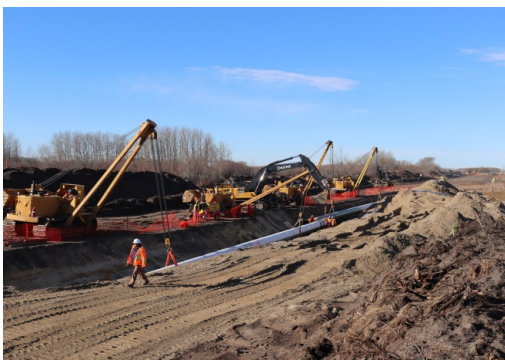
Description & Location: SSKP 817+472

Tie In crew
Getting lined up to make cut on pipe
Tie in once cut is made
Facing southwest
