**SWAN LAKE FIRST NATION – MATRIX SOLUTIONS
INC. PARTNERSHIP**

INDIGENOUS CONSTRUCTION MONITORING

WEEKLY REPORT

SPREAD 8

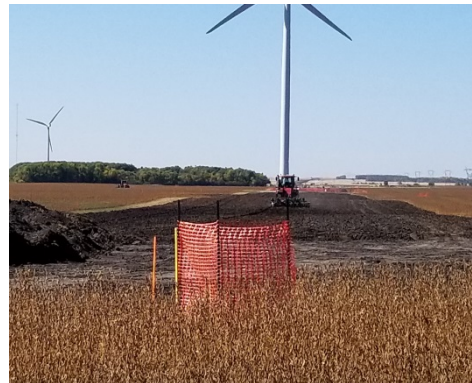
Sept 10/18
Photo facing west
SF 48

Attend morning meeting. SF 43A Top soil stripping was taking place. Dozers worked to strip the top soil and pile it on the South side of the ROW. SF 43 Flaggers were onsite crossing two excavators and one dozer. Proper PPE was worn. SF 44 (KP 984+835) Top soil stripping and approach installation taking place. Dozers stripped the ROW and piled soil on the South side of the ROW. Dozers had spotters in area. Crew members placed culvert in proper area and laid out CAEPLA cloth overtop of the culvert. An excavator and a dozer worked to place and compact the soil to complete the approach. Silt fencing was also installed. SF 44 (KP 984+923) Top soil piles were checked, none exceeded the boundary line. Seconds pile was kept separate from top soil pile. SF45 Cat making approach on West side, Grader moving transition. SF 47 Approach finished on East side. Goal posts are also done. Pads dropped off for the approach on West side. SF48 Tractors discing. Goal posts up on West side.
