SGS MUSCOWPETUNG

ABORIGINAL CONSTRUCTION MONITORING

WEEKLY REPORT

NOVEMBER 26TH TO DECEMBER 2ND, 2018

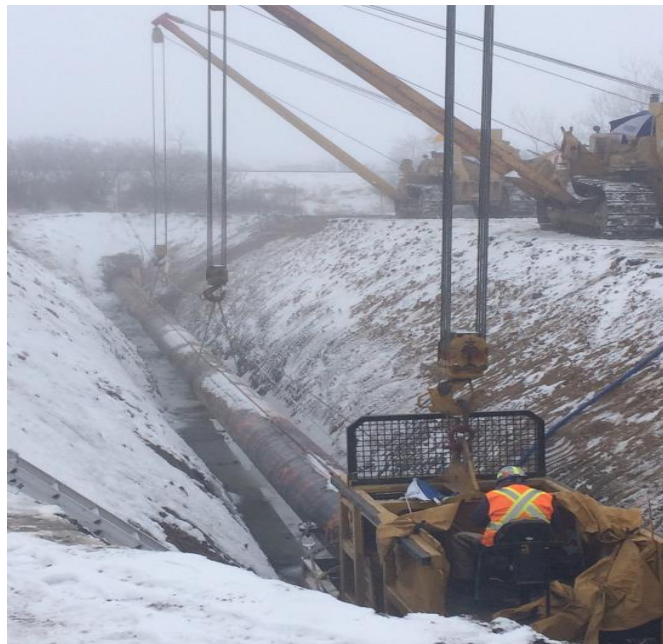
795 + 877 Cradle bore under the tracks

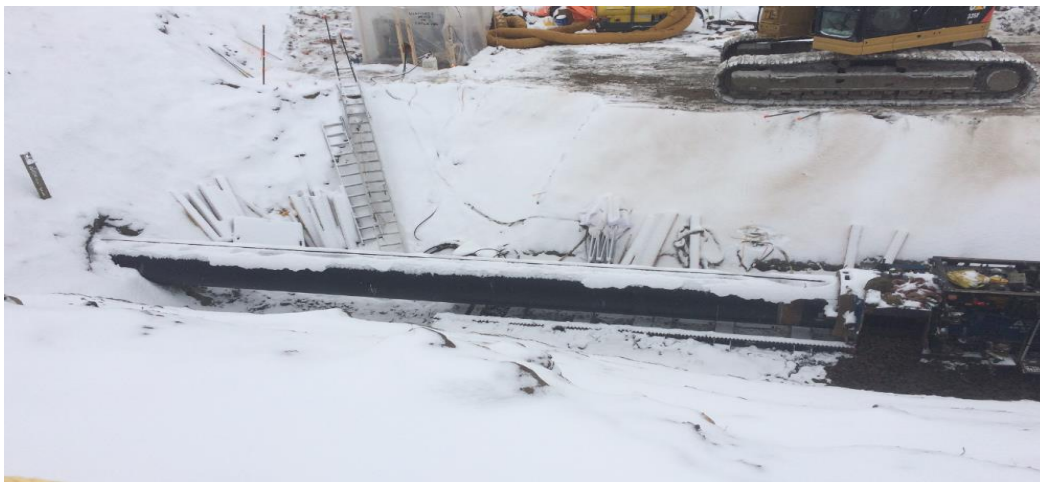
| Field Observation | # of occurrences | Description and Mitigation Measures | Mitigation Status | Further Action Required (Yes/No) |
|--|---|--|--|---|
| Rock Formations (rocks of significance, tipi rings, etc.) | 1 | Pipestone Creek Area of interest will be bored under to preserve the location | Bored through, product pipe set in. | Yes, continue to monitor |

803 + 494 Pipestone Creek track bore under the Tracks and area of interest
