**SGS MUSCOWPETUNG**

**ABORIGINAL CONSTRUCTION MONITORING**

**WEEKLY REPORT**

**MAR 11<sup>th</sup> TO MARCH 17<sup>th</sup>, 2019**

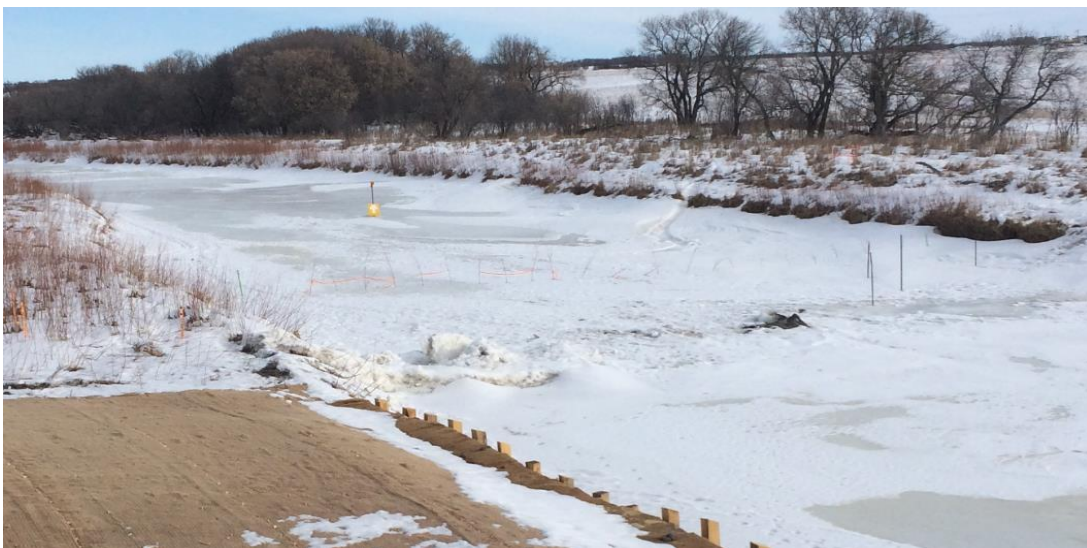
805 + 600 The Pipestone Creek MB 1010

805 + 200 – 806 + 200 HER 147, 148,149,150,151,152, Wing walls were down due to deer crossing over the matted area protecting the rocks of interest. The area of interest with the no foot traffic signage was still in place. MB 1010 The Pipestone Creek – Silt fencing across the bridge is partly taken down. On the Creek observed the amber light with signage and willows sticks with ribbon attached and one pylon. Our team followed up the following day and the items on the creek were removed. Further observed the ice bridge cut for water flow through and an additional berm built on south side. Observed Heritage Resource 189 at 802 + 500 & Heritage Resource 147, 148 and 149 at 801 + 500 - 802 + 500 (no concerns) 787 + 500 SK WC 89 Observed the crew cleaning up the area on west side of the creek. 786 + 500 Heritage Resource 140 right of way clean up completed. Observed 788 + 700 Heritage Resource area of interest roped off with the nine Heritage markers. (no concerns). 776 + 900 – 779 + 500 Jackson Creek – observed the area (no concerns) – 778 + 900 labour monitoring the brush pile burning. 746 + 950 Observed the area for any debris left behind. Little pieces of geotextile and piles of brush were cleaned up the next day Heritage # 46 TLU area no further concerns. 747 + 920 Observed and assessed the area (no concern's) Heritage # 137 TLU SK WC 86.
