SGS MUSCOWPETUNG

ABORIGINAL CONSTRUCTION MONITORING

WEEKLY REPORT

DECEMBER 10TH TO DECEMBER 16TH, 2018

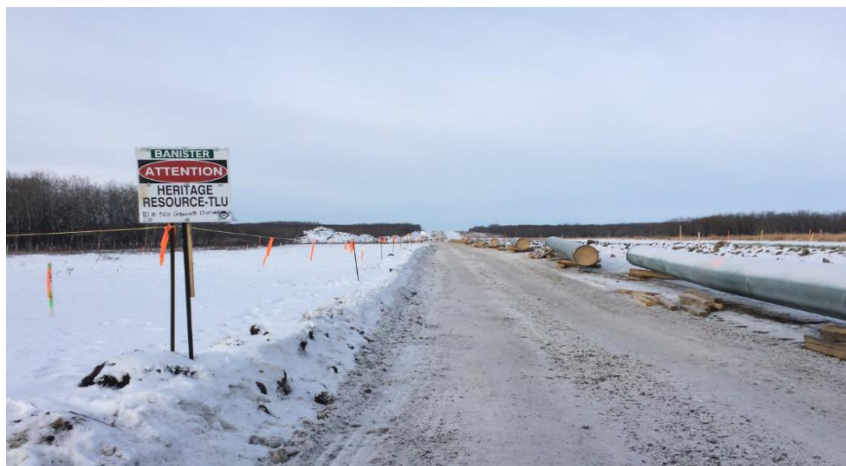
785 + 200 Area of interest roped off pipe strung along right of way

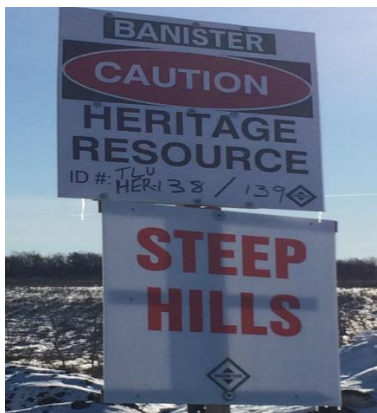
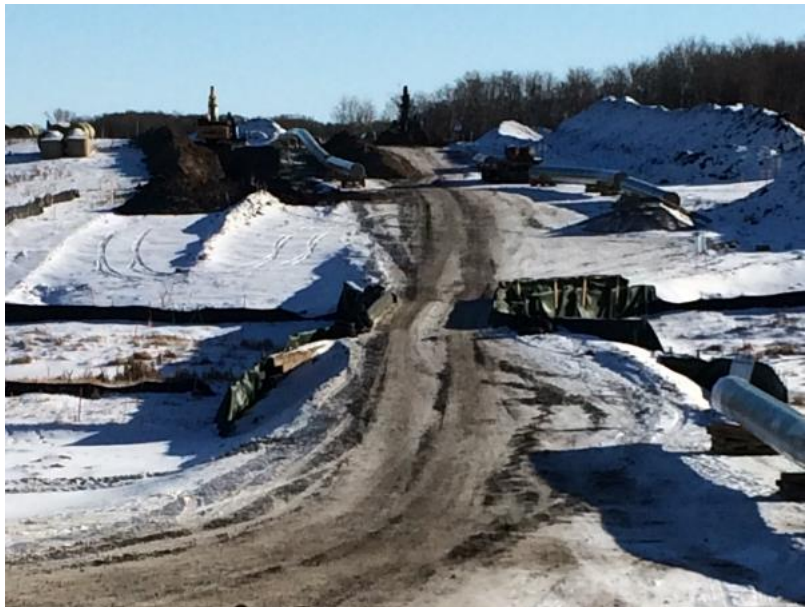
749 + 600 Little pipestone SK WC 87 Creek HER 138 and 139 – Side boom crossing bridge with spotter – pipe strung along right of way and HER sign

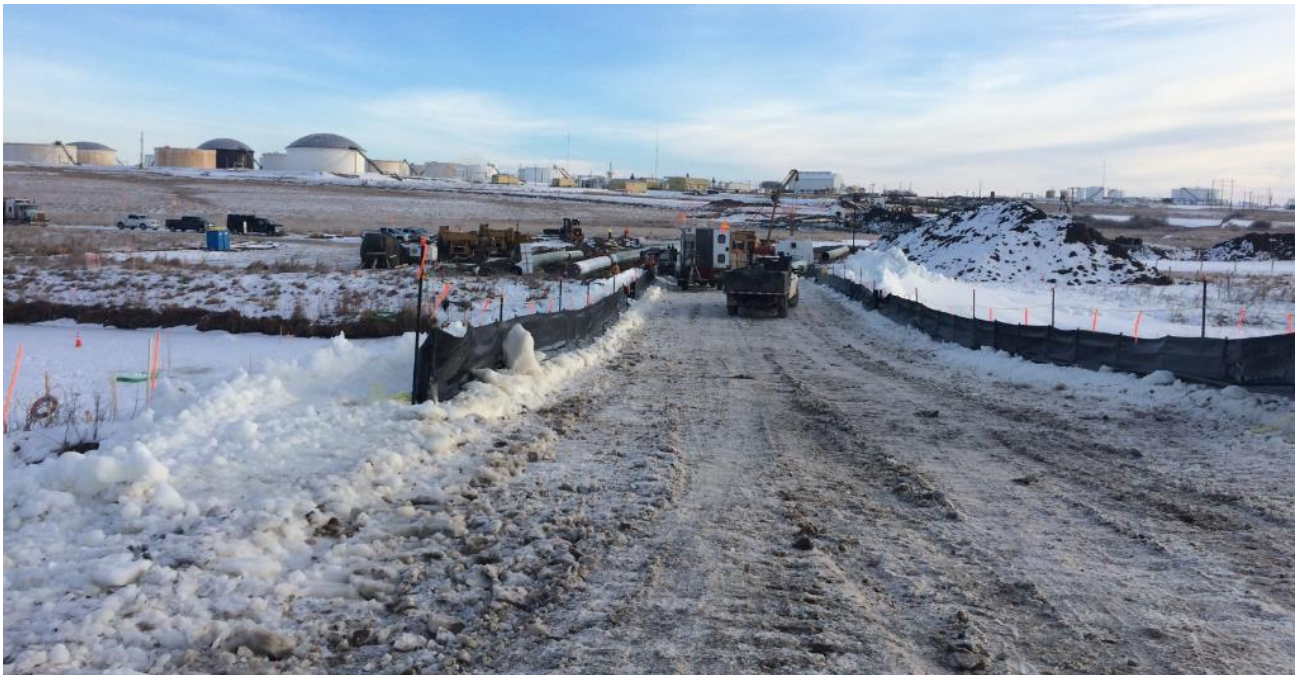
MB 1010 Pipestone Creek Ice bridge

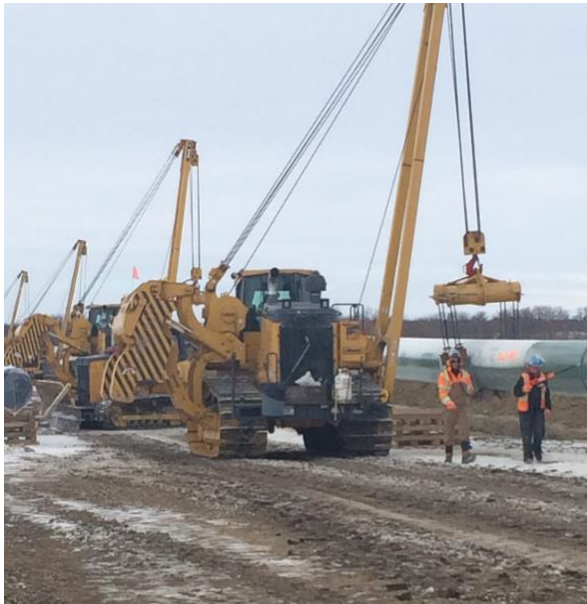
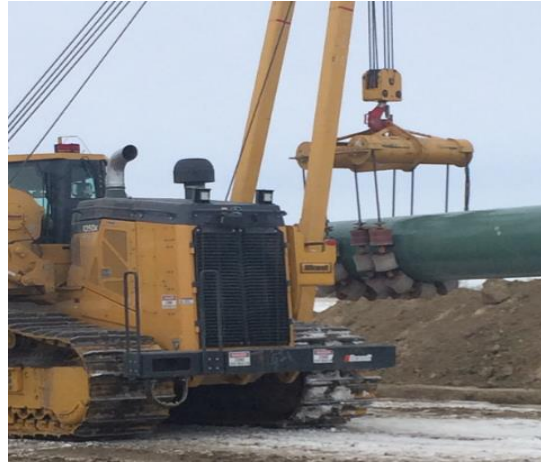
747+300 sidebooms cradle pipe and lowering in ditch with spotters
- middle picture below trackhoe shading pipe with spotter
